Coastal Slope Stability Assessment

Saltair - Cowichan Valley Regional
District

February 14, 2022

Stantec Consulting Ltd.
In association with Palmer

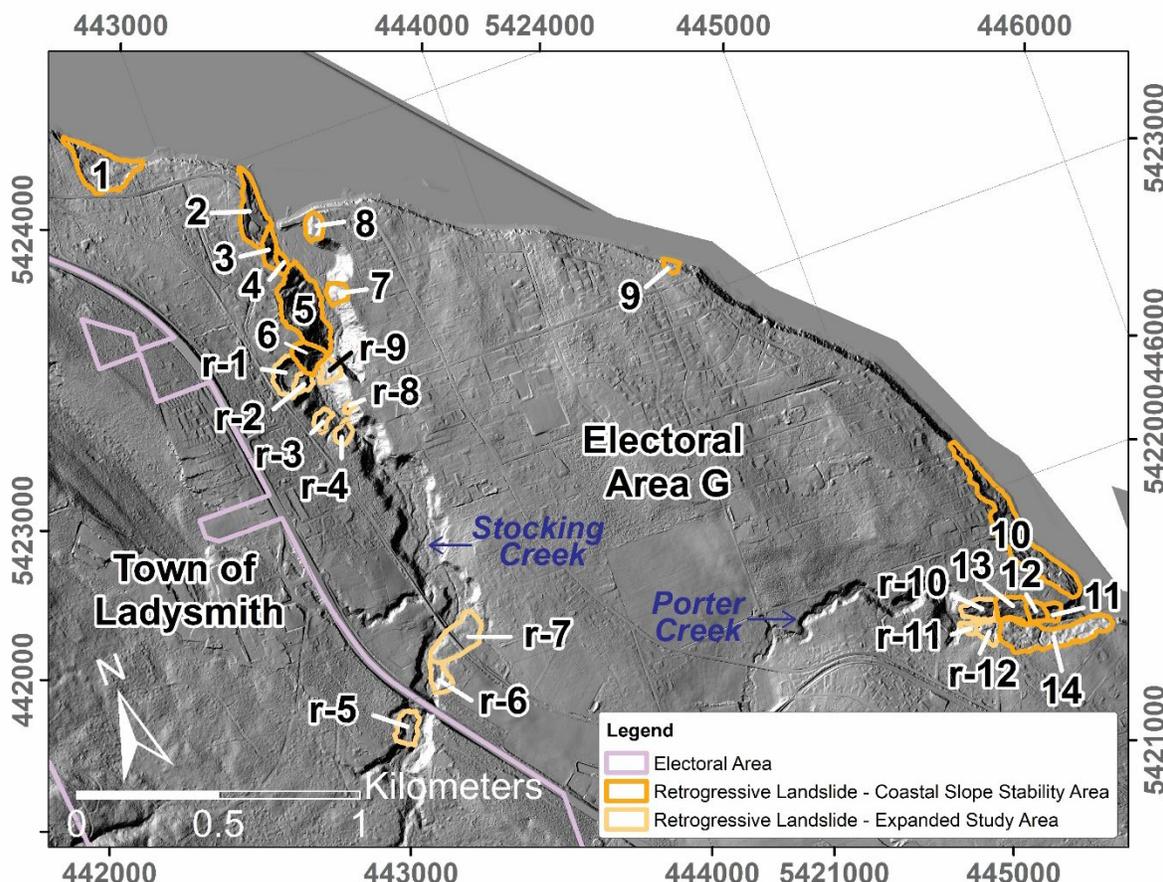
Figure 5. Mapped retrogressive landslides.

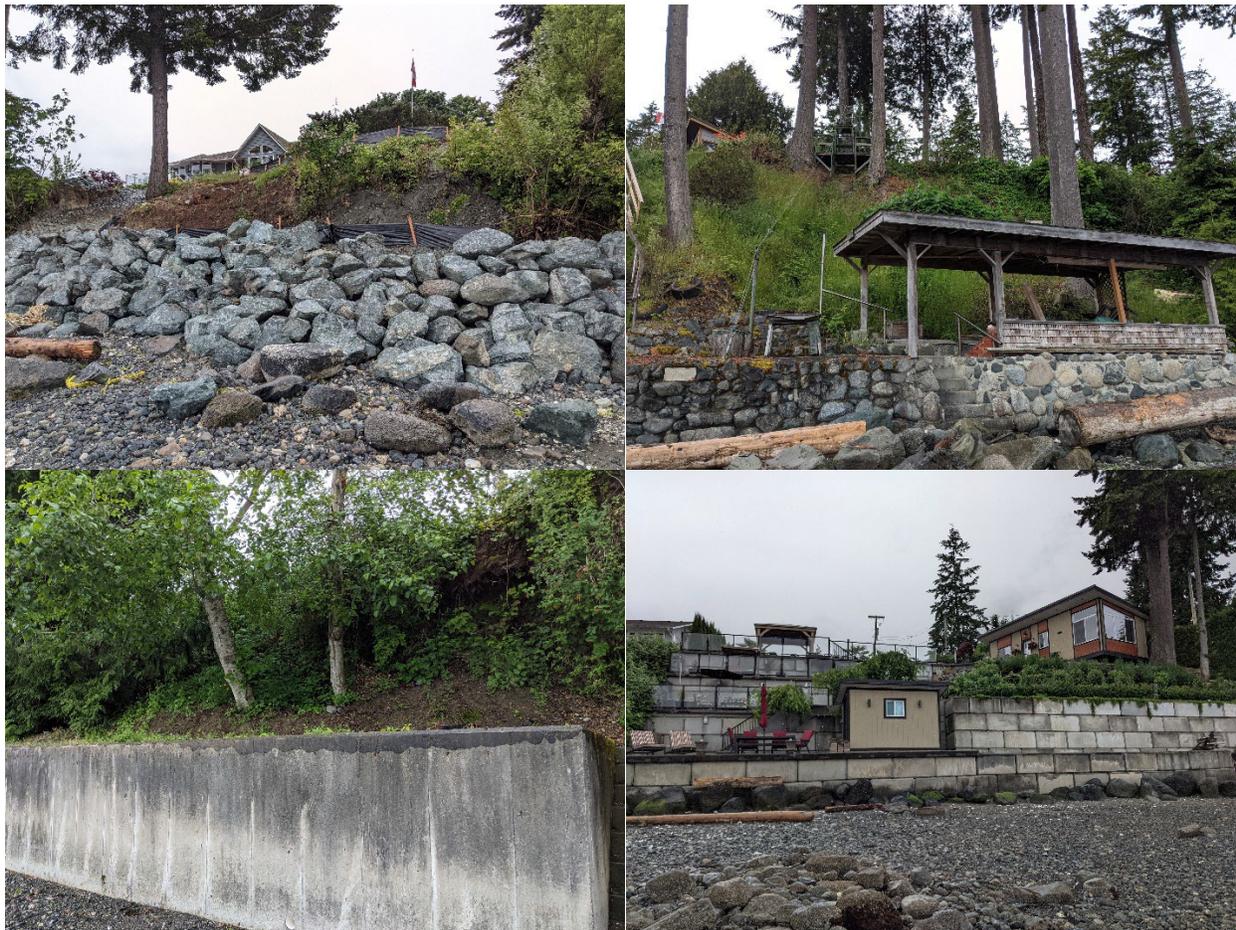
Coastal erosion within the coastal slope stability study area is predominantly mitigated by riprap revetments, lock block structures, or seawalls (Figure 6). Relatively few unprotected, natural shoreline segments remain. In the majority of remaining natural shoreline segments, erosion and undercutting (0.3 m to 1.8 m) was observed at the base of the bluff (Figure 7). In addition, failure of some mitigation works was observed (Figure 8).

Figure 6. Example erosion mitigation observed along the study area shoreline.

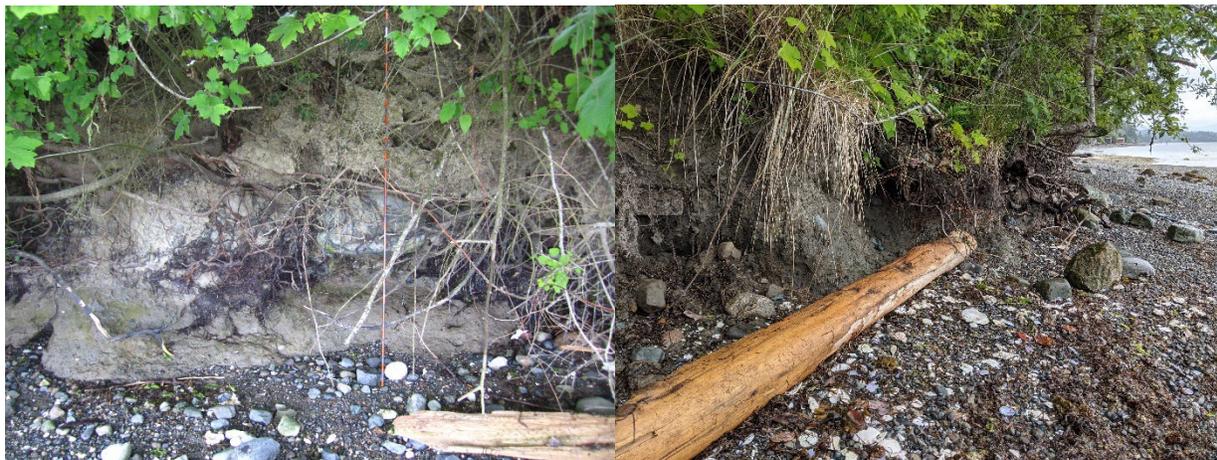
Figure 7. Erosion and undercutting of natural shoreline segments.

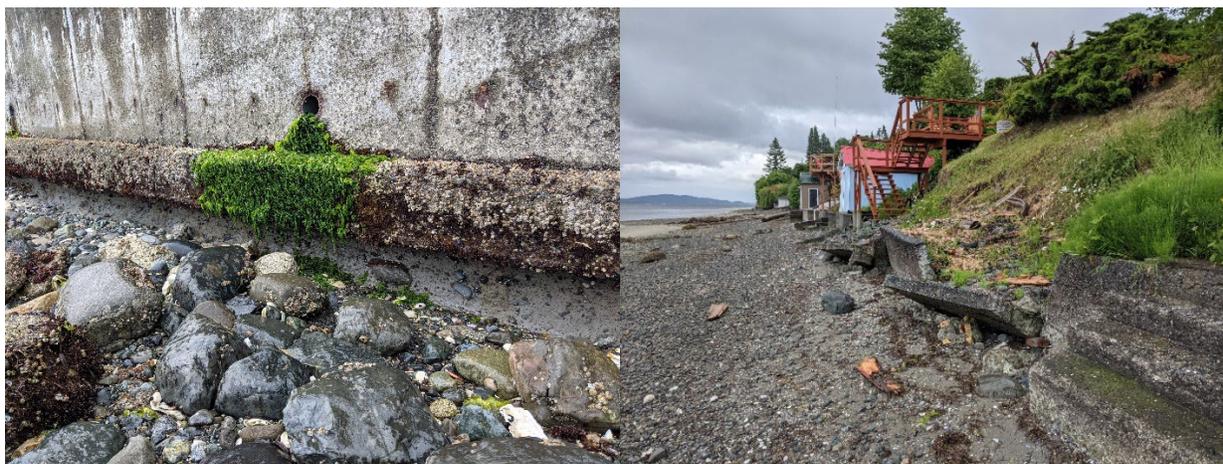
Figure 8. Observed undercutting of a seawall within the study area with consolidated till visible below concrete footing (left). Shallow landslide and failed retaining wall/seawall (right).

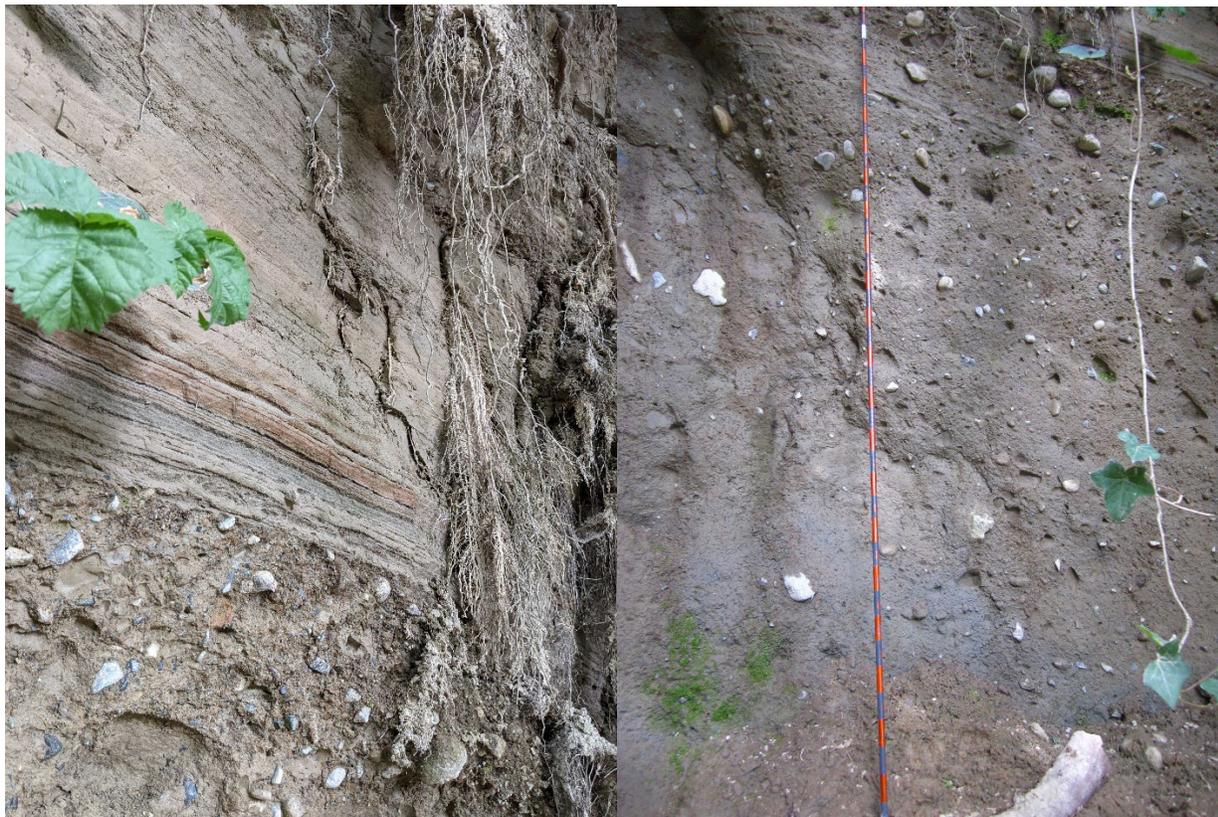
Figure 9. Observed stratigraphy at the landslide below the intersection of Stuart Road and Seaview Crescent. Gently dipping laminar sands are shown on the left, transition from blue-grey (lower extent) to brown (upper extent) till shown on the right.

Numerous stormwater discharge and stream outlet points were observed along the bluff. Uncontrolled stormwater discharge onto the coastal bluff was observed at two locations: (1) at the above-described landslide below the intersection of Stuart Road and Seaview Crescent; and (2) at the Bazan Road beach access. Uncontrolled stormwater discharge at these locations was inferred to be contributing to local slope instability.

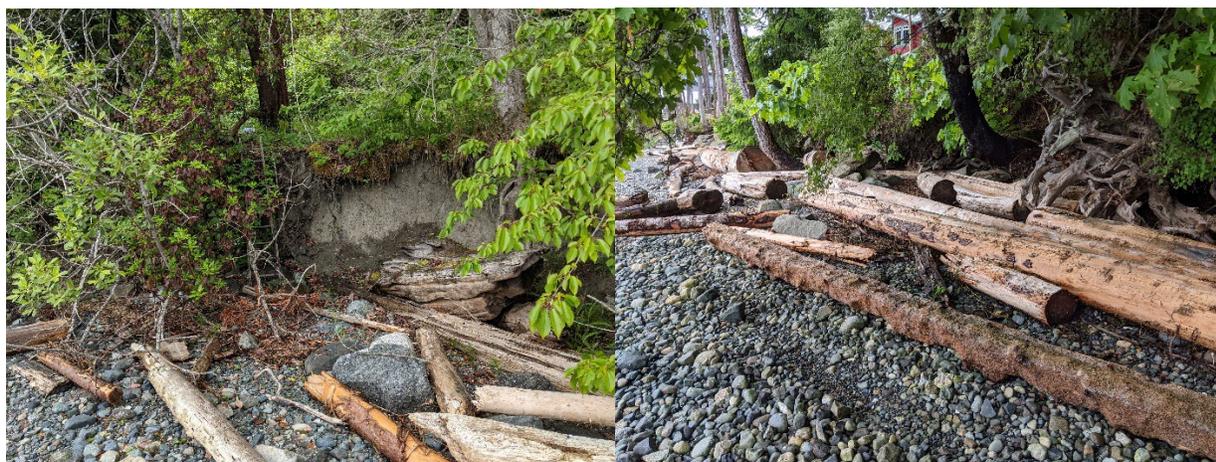
Driftwood accumulations at the base of the bluff are common (**Figure 10**). Although they help protect the shoreline from wave attack, they are transient features subject to longshore or offshore transport. Large woody debris can also contribute to shoreline erosion through percussive wear during high water levels.

Figure 10. Driftwood accumulations in the backshore.

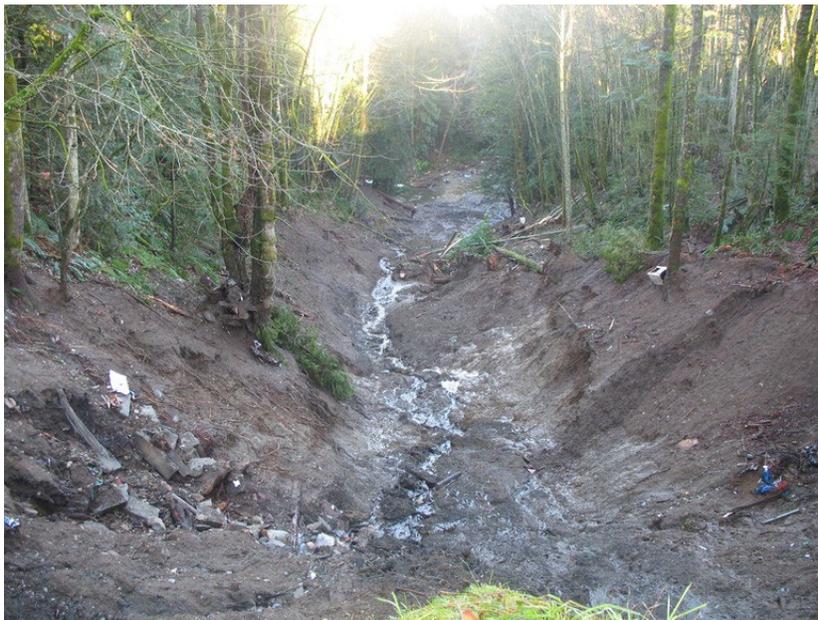
Stantec and Palmer also found public record of a shallow landslide that occurred in the expanded study area at the end of Knudsen Road (Figure 12). According to David Judson (personal communication, 17 January 2022), President of the Ladysmith Sportsmen Club, the failure occurred in 2007 following heavy winter precipitation on a slope over-steepened from the dumping of refuse. Failure is also attributed to an improperly built stormwater system (personal communication, Kate Miller, 4 February 2022).

Figure 12. The 2007 landslide viewed downhill from the end of Knudsen Road into Stocking Creek. Image from the Chemainus Rod and Gun Club (2022).

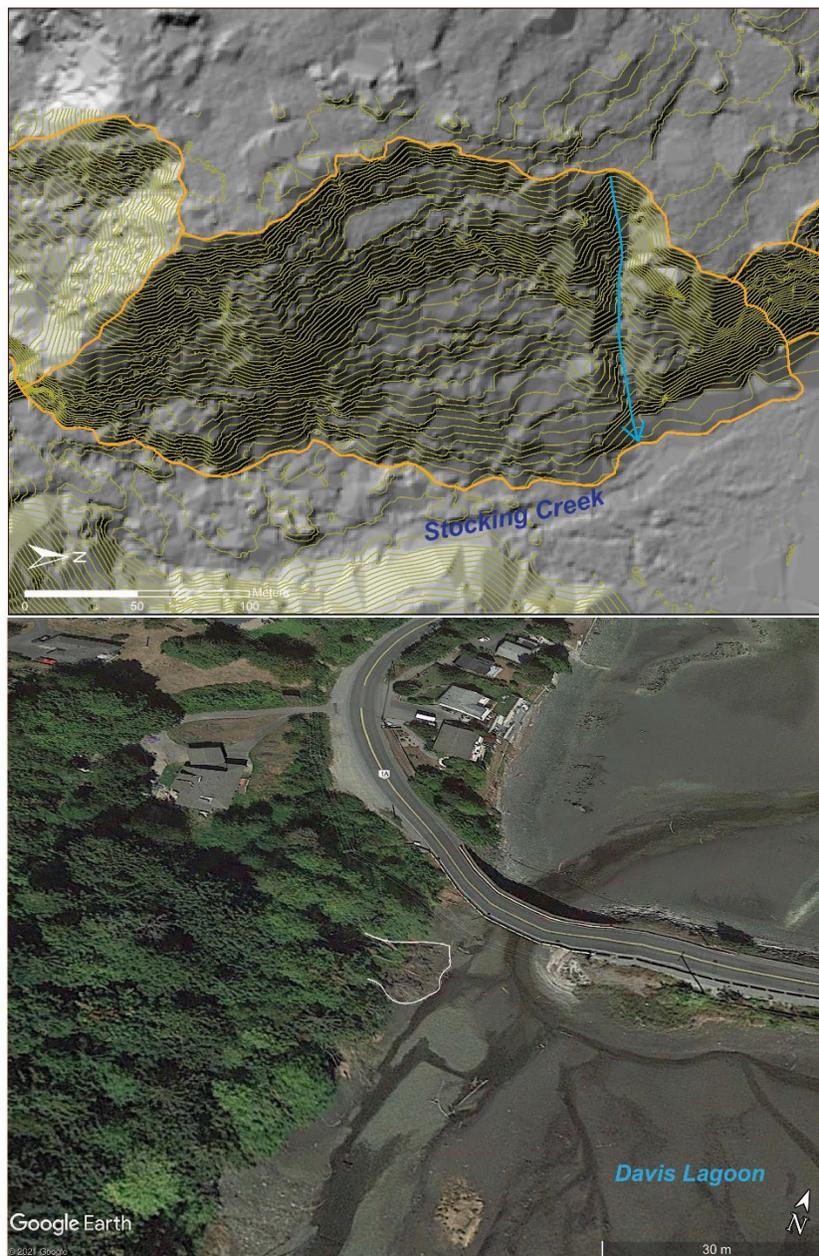
Figure 13. Landslide delineated in orange estimated to have been active within the last 500 years due to observed gully feature shown by blue arrow (above). Landslide estimated to have been active within the last 5 years due to observed deposit delineated in white in 2016 Google Earth imagery but not in available years of previous imagery (below).

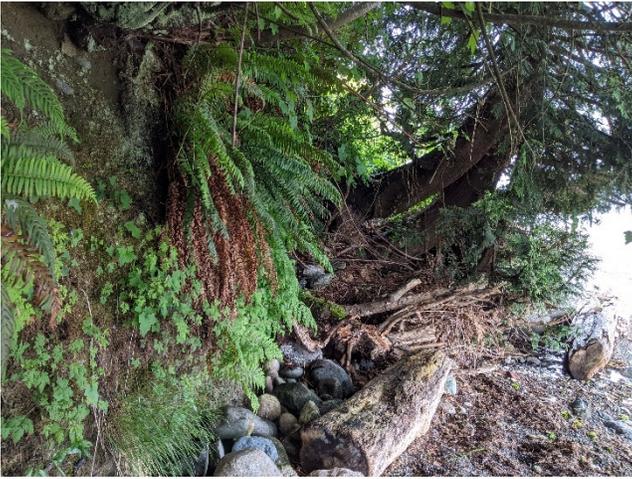
Photo 001: Stream outlet within large woody debris below pistol butt trees. Vertical shoreline of consolidated till with silty sand matrix and pebble to cobble sized inclusions. Undercutting of up to 0.5 m.

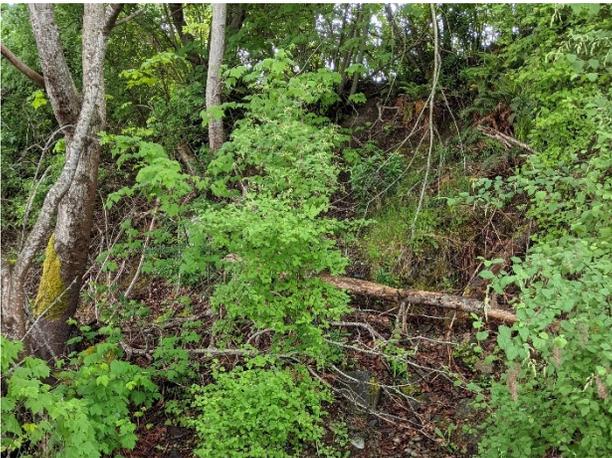
Photo 003: Shallow surficial failure approximately 5 m wide on 45-degree slope along an unprotected shoreline segment.

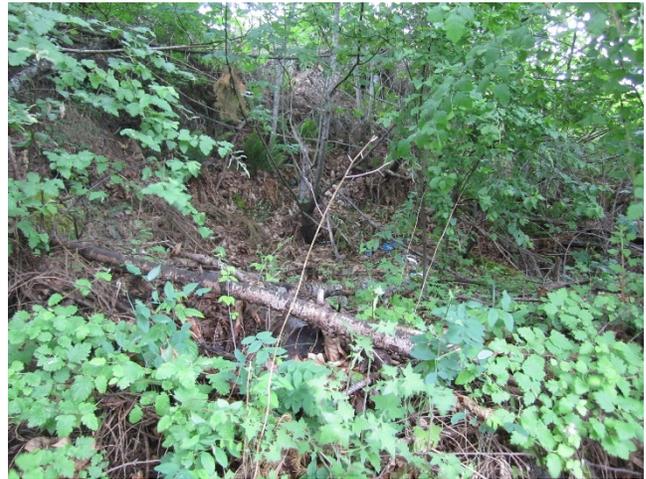
Photo 004: Suspected shallow surficial failure along unprotected shoreline segment. One-metre-high scarp at base of slope along shoreline comprised of suspected colluvium (loose, silty sand with pebble to cobble inclusions).

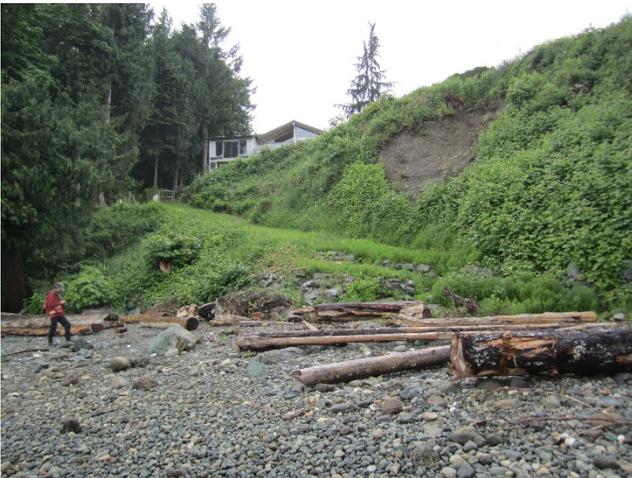
Photo 005: Translational debris slide. Person for scale. Landslide occurred during the 2020-2021 winter (J. Moore, personal communication, May 28, 2021). Approximately 2 m deep and 5 m wide on a 45-degree slope.

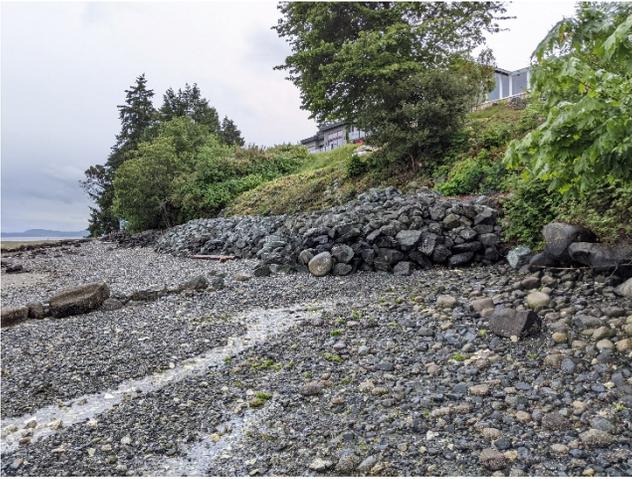
Photo 007: Stream outlet. Recent riprap installation at the toe of the slope/upper beach face. Adjacent natural segments of shoreline are actively eroding till.

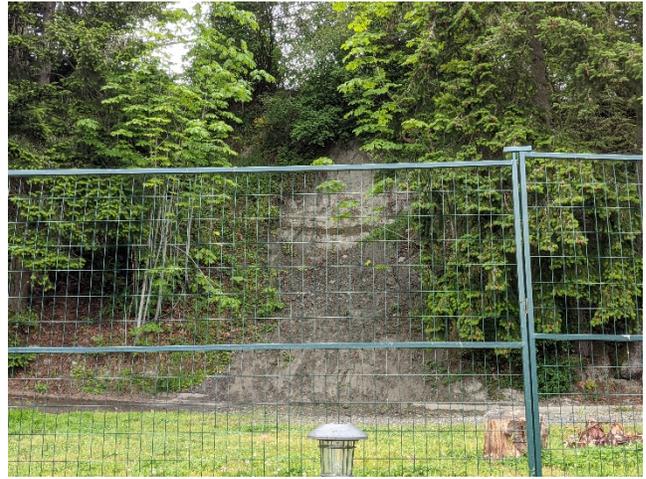
Photo 008: Shallow landslide approximately 5 m wide and 10 m long on escarpment backing property.

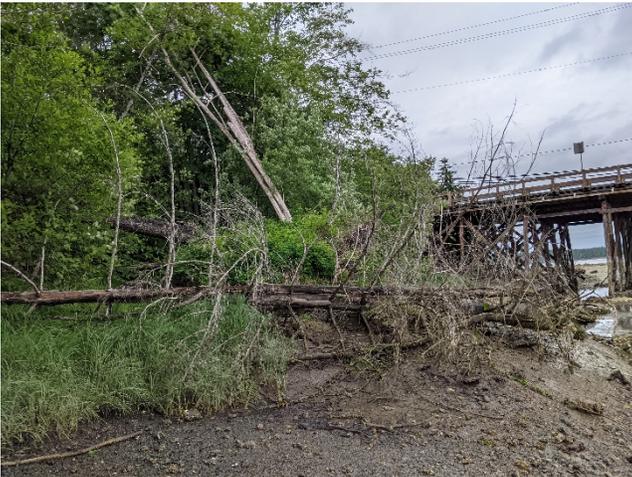
- A landslide on the western slope of Davis Lagoon where a large block was deposited at the base of the slope. Field-textured surficial materials had higher relative clay content and seepage was observed on the slope (Photo 009 of the field photo log, **Appendix C**)
- A landslide observed on private property just south of Gardner Road beach access on a portion of the notably higher bluff segment (Photo 022 of the field photo log, **Appendix C**)
- The above-described failure below the intersection of Stuart Road and Seaview Crescent suspected to be related to uncontrolled stormwater drainage (Photo 023 of the field photo log, **Appendix C**)
- A failure adjacent to (immediately south of) the failure below the intersection of Stuart Road and Seaview Crescent (Photo 024 of the field photo log, **Appendix C**)

Photo 009: Landslide with large block deposited at base of slope rotated to upslope facing position. Saturated upslope material fed by gully and/or seep. Observed material is till with higher clay content relative to shoreline exposures north of Davis Lagoon.

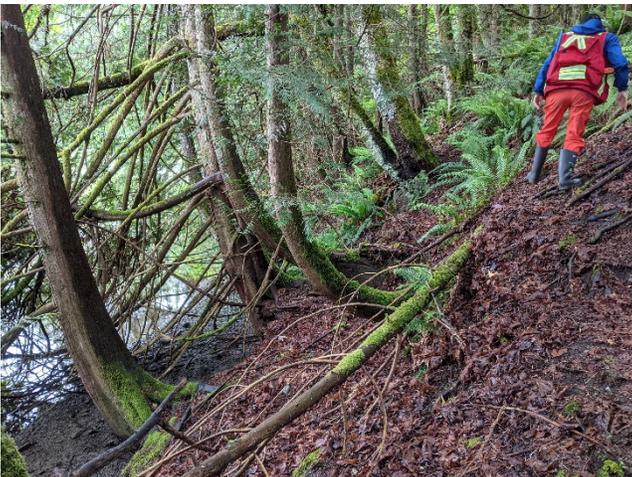
Photo 011: Numerous downed and pistol butt trees.

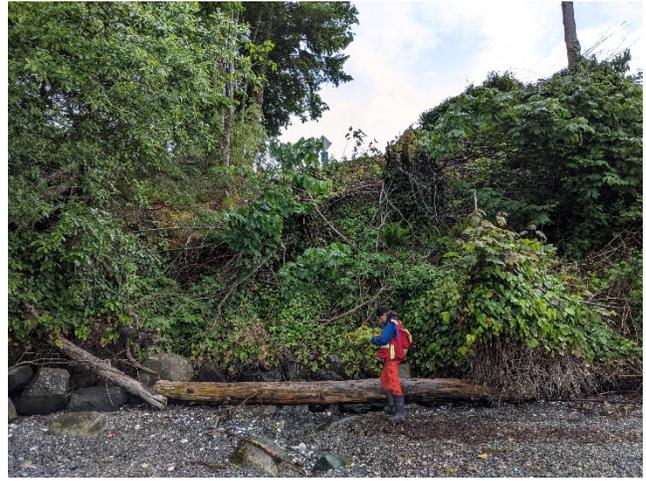
Photo 014: Culvert failure and stormwater discharge onto slope at Bazan Road Beach Access.

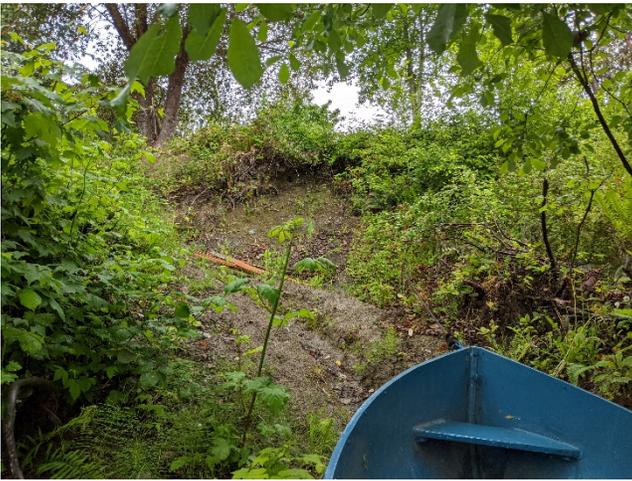
Photo 015: Potential shallow landslide observed on natural shoreline segment. Toe of slopes is 1 m high, undercut erosive scarp.

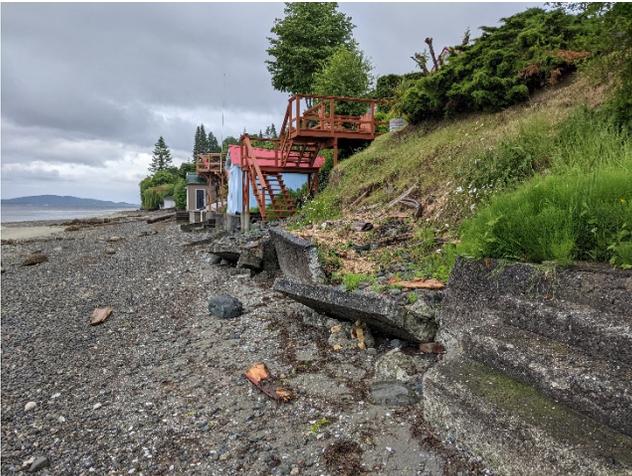
Photo 017: Shallow slope failure and failed retaining wall. Failure is approximately 7 m wide and 0.5 m deep on 32-degree slope.

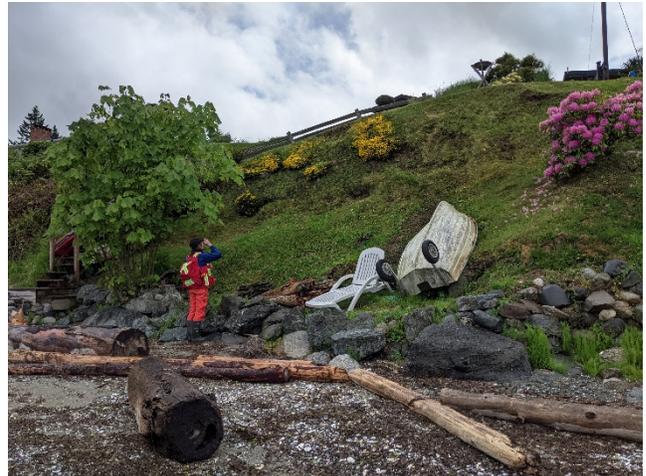
Photo 018: Shallow failure on 45-degree slope.

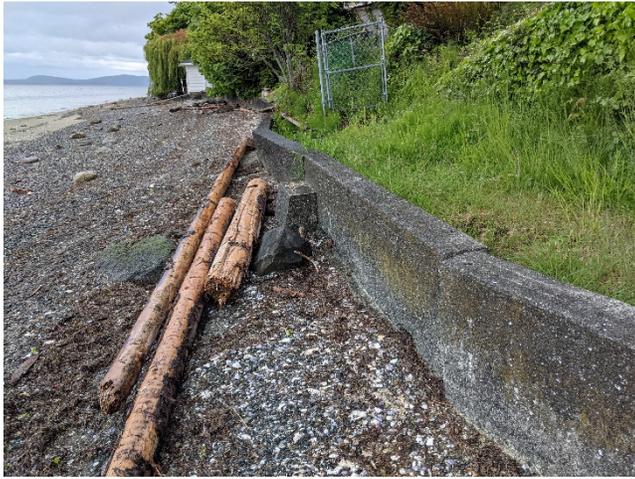
Photo 019: Retaining wall failure and slope bulging at toe.

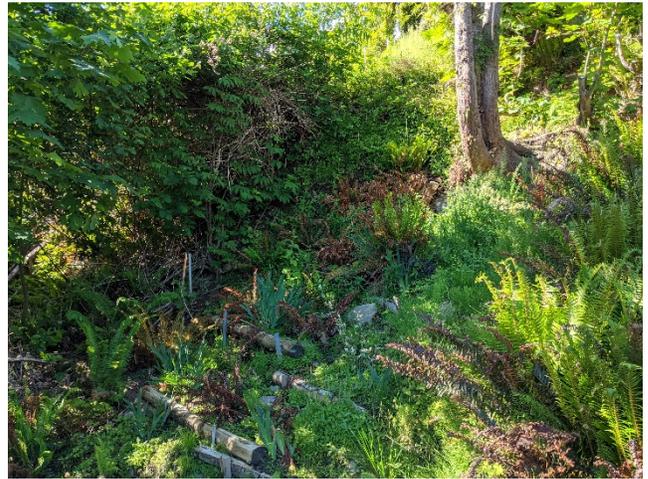
Photo 022: Pistol butt trees and seepage at exposed seam of clay silt. Observed 4 m wide, 0.6 m deep and 8 m long headscarp. Slope 31 to 39-degrees.

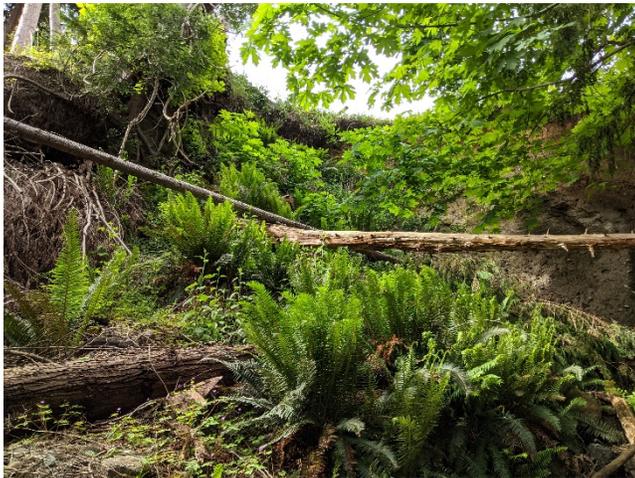
Photo 023: Uncontrolled stormwater discharge onto slope at intersection of Stuart Road and Seaview Crescent. Large 20 m wide failure with semi-circular 6 m high headscarp. Exposure of underlying stratigraphy. Seepage observed in the till.

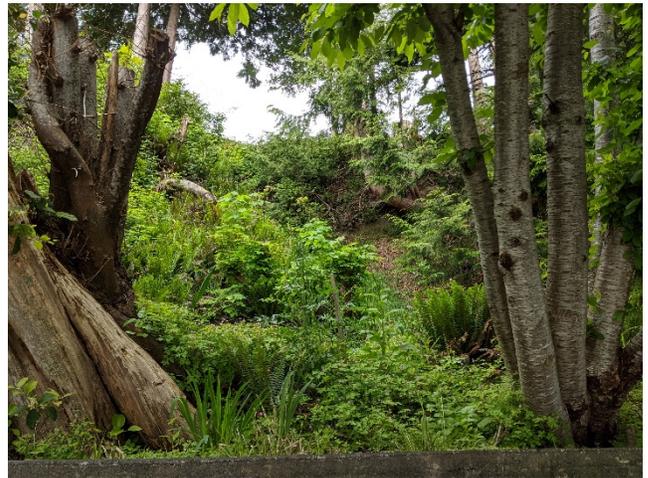
Photo 024: Observed slope failure adjacent to (SE of) feature shown in Photo 023.

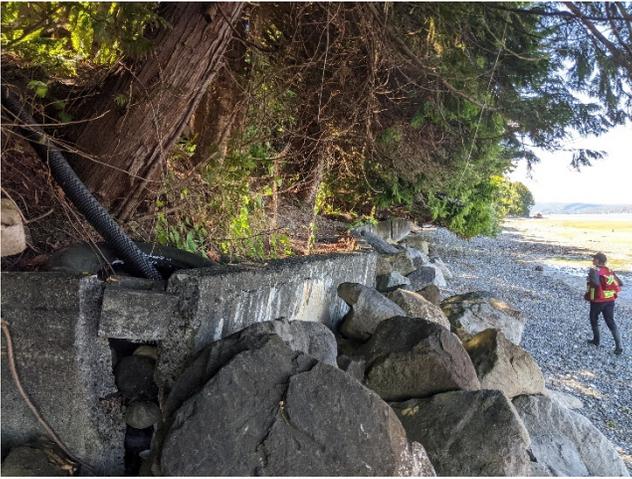
Photo 025: Retaining wall failure and toe of slope bulging.

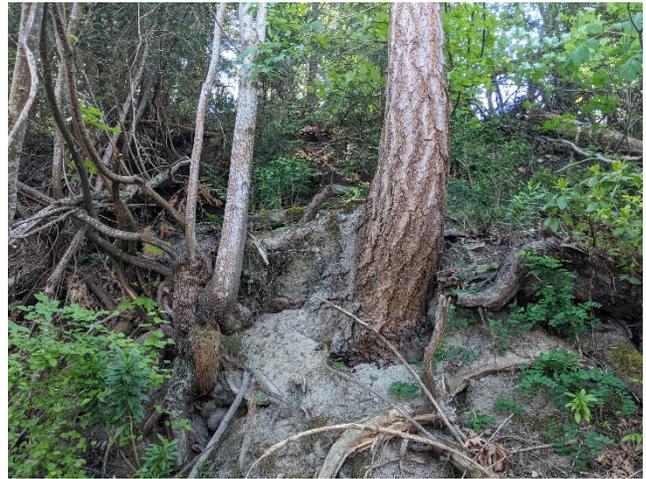
Photo 028: Failure on 39-degree slope. Upper portions of the slope near vertical. Downed tree and rootball exposed.

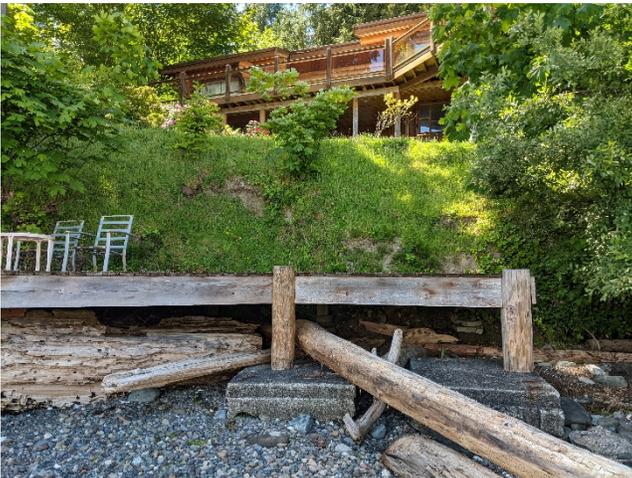
Photo 029: Shallow failure approximately 5 m wide with up to 1 m vertical displacement.
