ELECTORAL AREA SERVICES COMMITTEE MEETING AGENDA

SUBJECT: Saltair Community Centre Facility Condition Assessment

FACILITY CONDITION ASSESSMENT SALTAIR COMMUNITY CENTRE

**3850 South Oyster Road, Ladysmith
British Columbia**

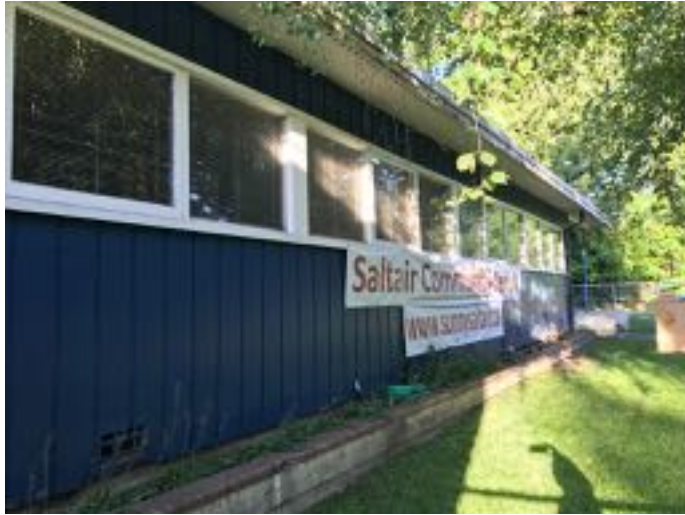
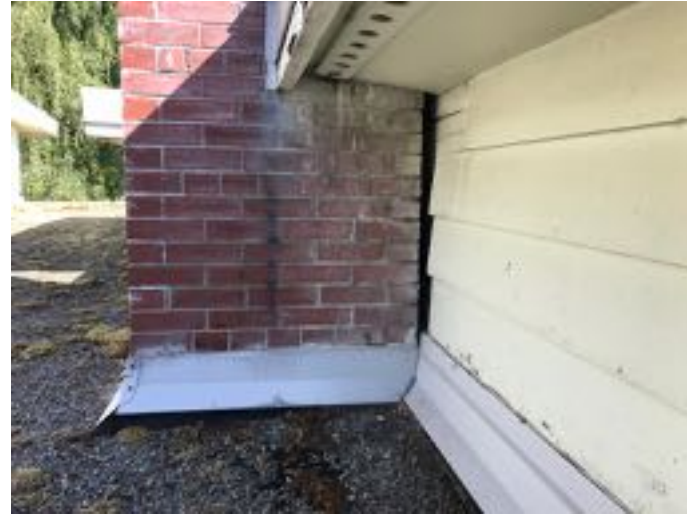
Photo 5 – Painted wood siding on north elevation	Photo 6 – Painted wood siding on southwest elevation	Photo 7 – Poor painted wood siding wall-to-brick chimney interface detail
B2010 – Exterior Walls	Painted Wood Soffit with Vent Strip

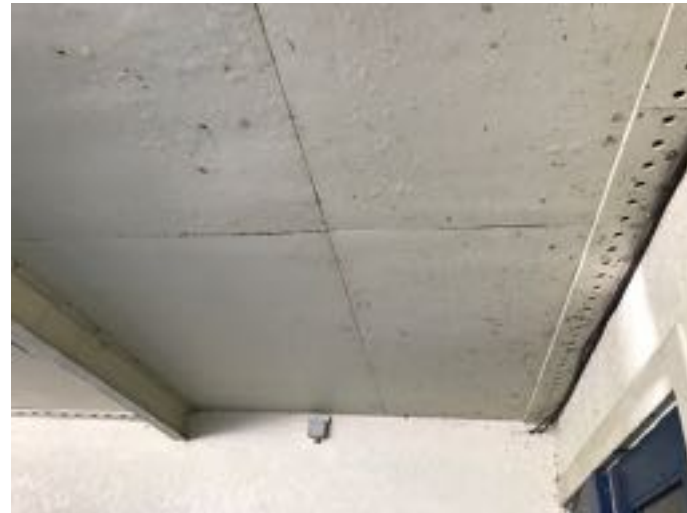
Photo 8 – Typical painted wood soffit with perimeter vent strips	Photo 9 – Painted wood soffit with blistering and microbial growth	Photo 10 – Moisture and microbial growth on painted wood soffit

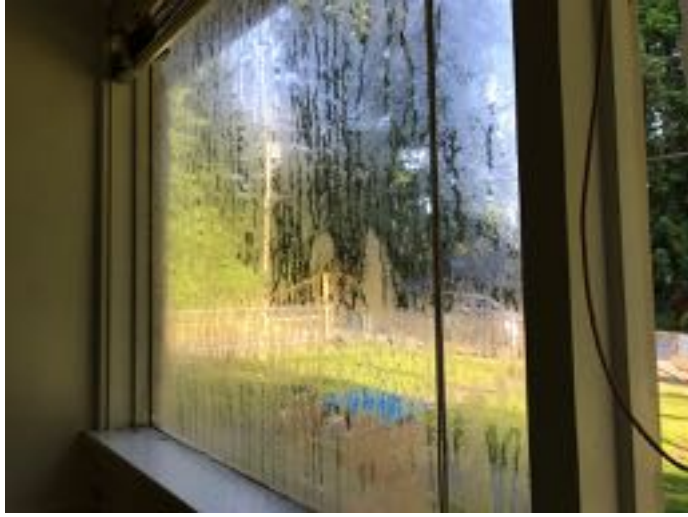
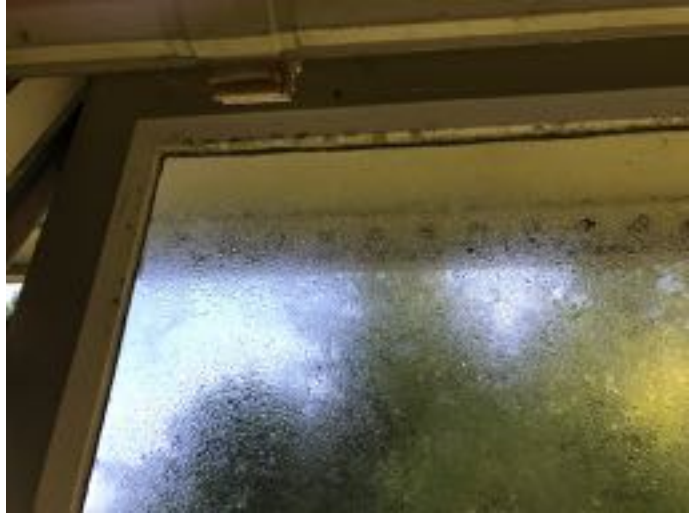
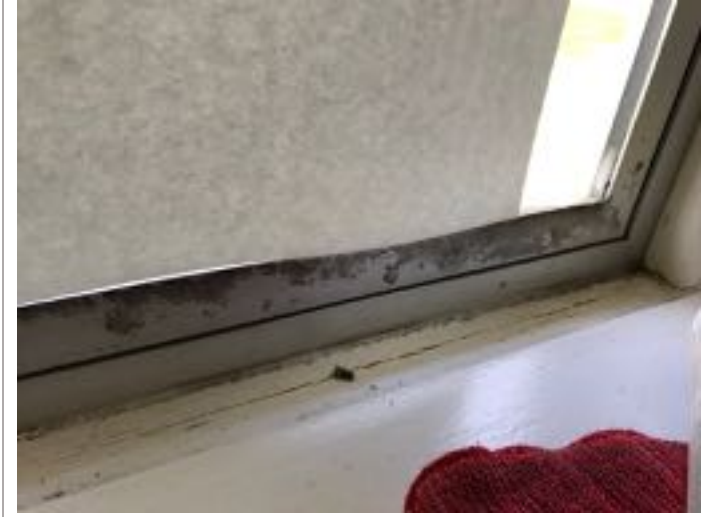
Photo 27 – Close up of condensation on a window pane	Photo 28 – Microbial growth at window perimeter	Photo 29 – Metal frame window replacements found at a few locations

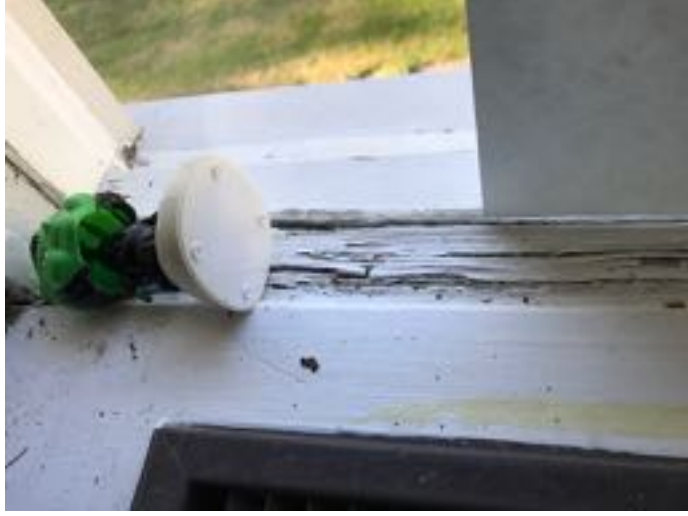
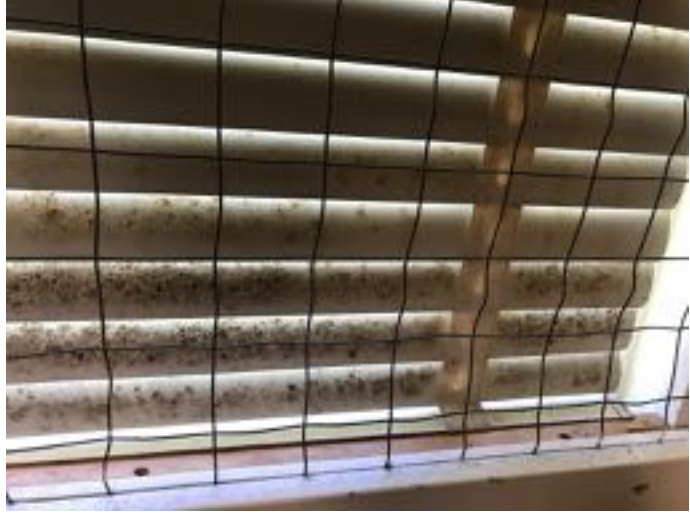
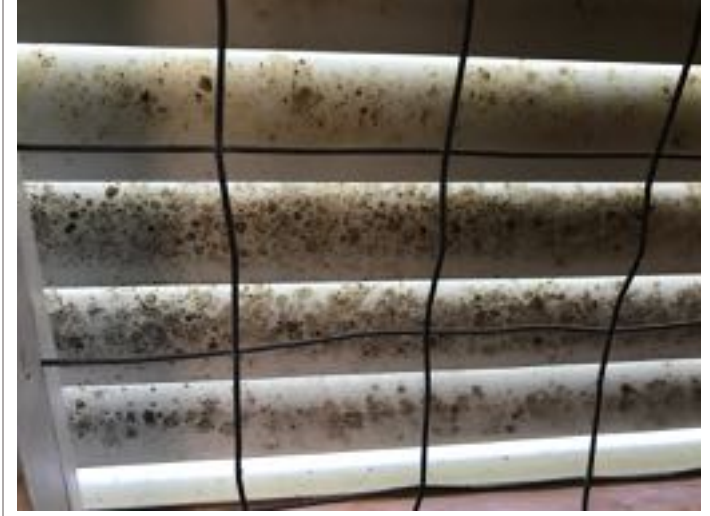
Photo 30 – Deteriorating window sill	Photo 31 – Microbial growth on window coverings at gymnasium storage room	Photo 32 – Close up of microbial growth on window coverings

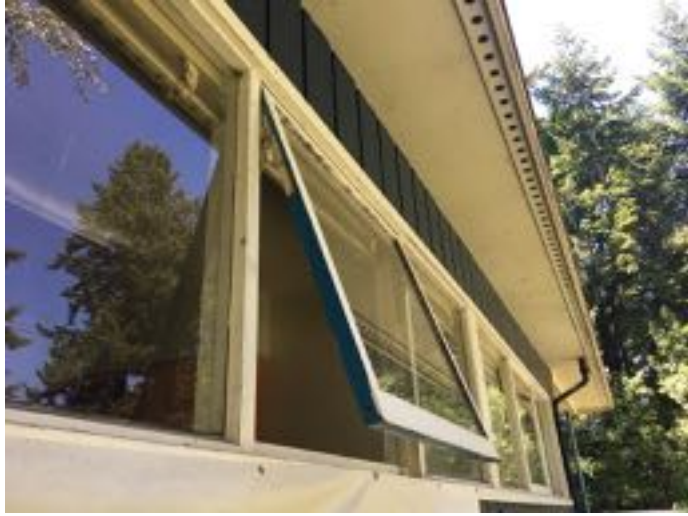
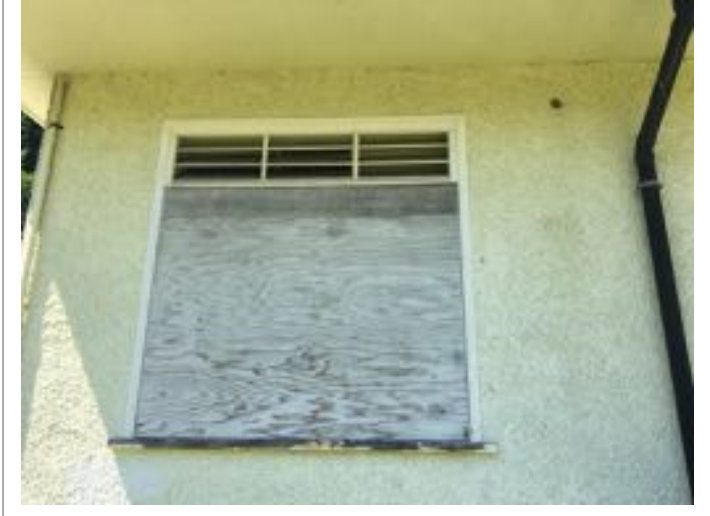
Photo 33 – Typical awning window	Photo 34 – Deteriorating wood frames and paint finishes	Photo 35 – Boarded up window

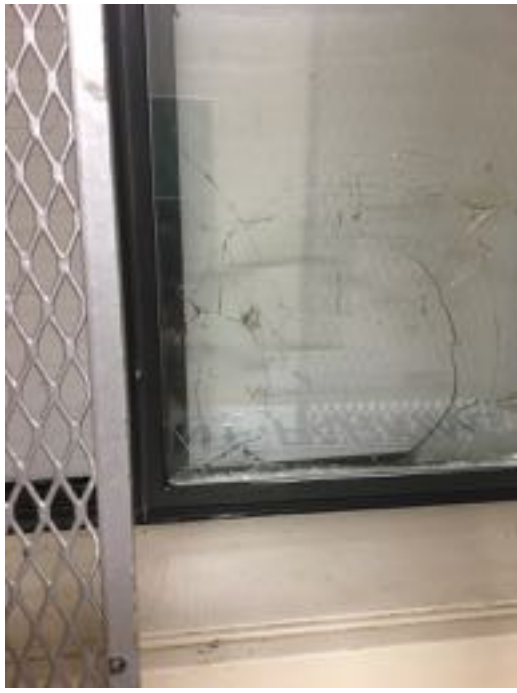
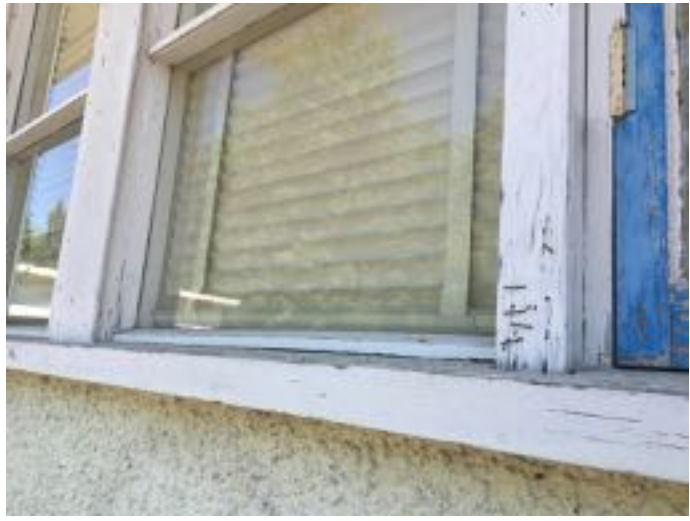
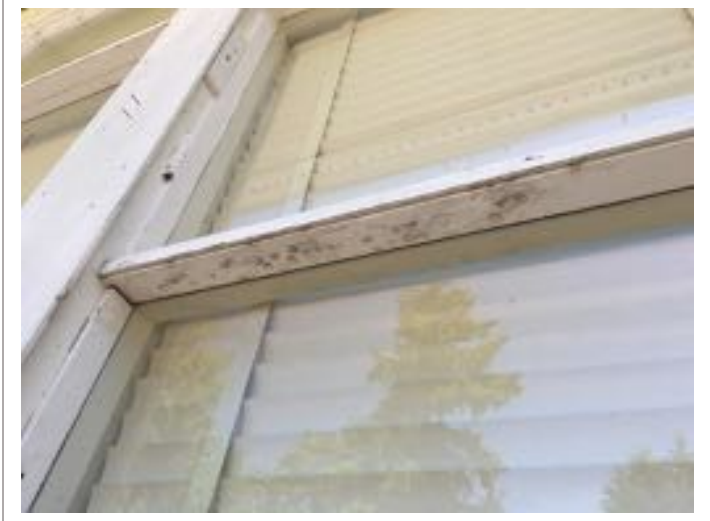
Photo 36 – Broken glazing in Storage Room 20	Photo 37 – Nails in window frame	Photo 38 – Staining and microbial growth on window frames

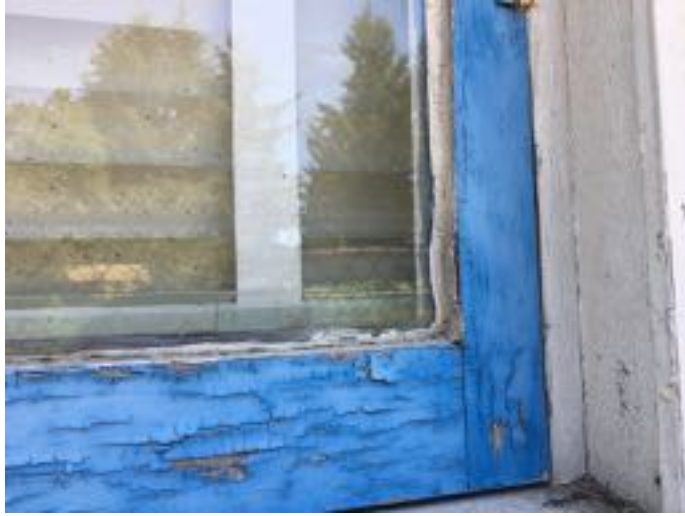
Photo 39 – Deteriorating window frame and paint finishes & deteriorating sealant around glazing perimeter	
B2030 – Exterior Doors	Metal Swing Exit Doors in Wood Frame

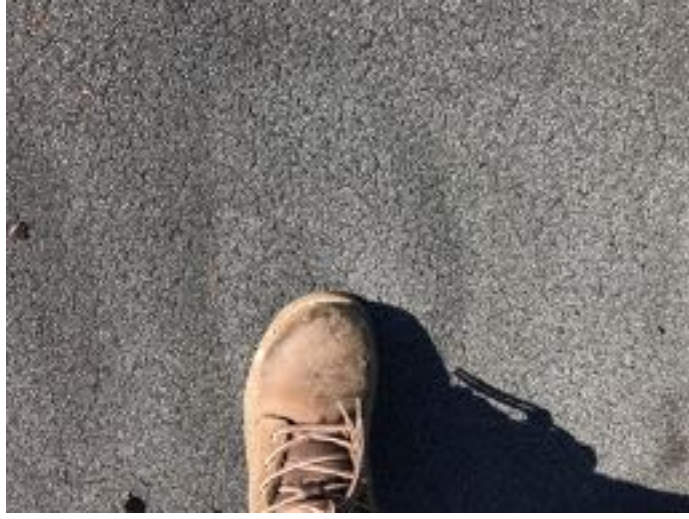
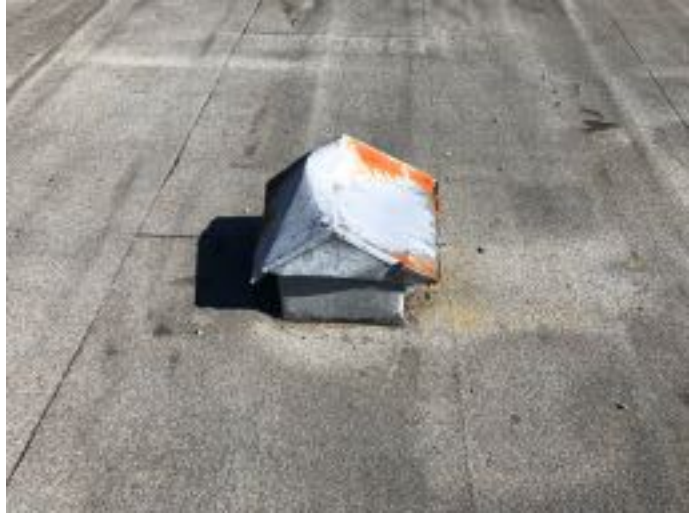
Photo 46 – Alligator cracks and bubbling in SBS cap sheet	Photo 47 – Damaged and corroded mechanical vent	
B30 – Roofing	Tar & Gravel Roofing

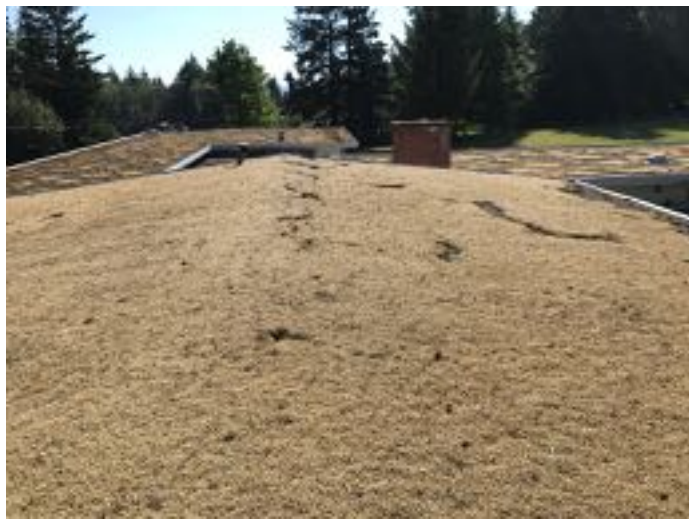
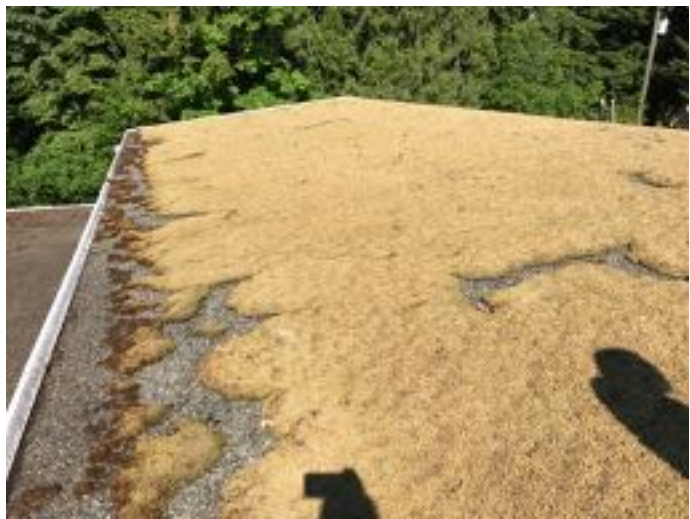
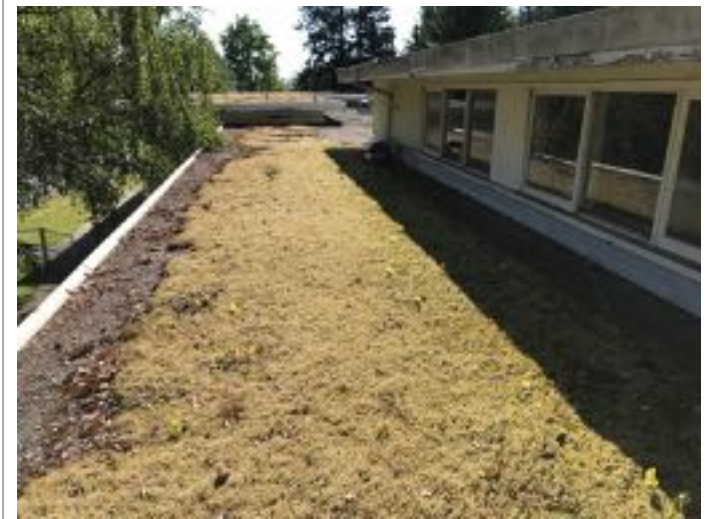
Photo 48 – An overview of tar & gravel roofing	Photo 49 – Extensive moss growth on sloped roofs	Photo 50 – Moss growth on flat roofs

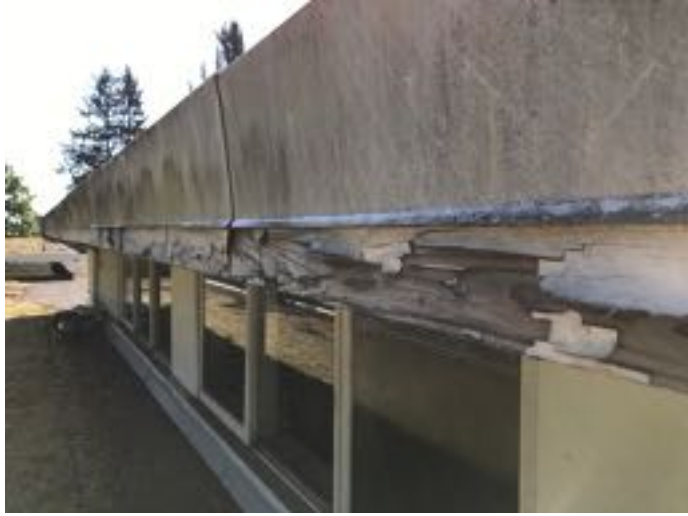
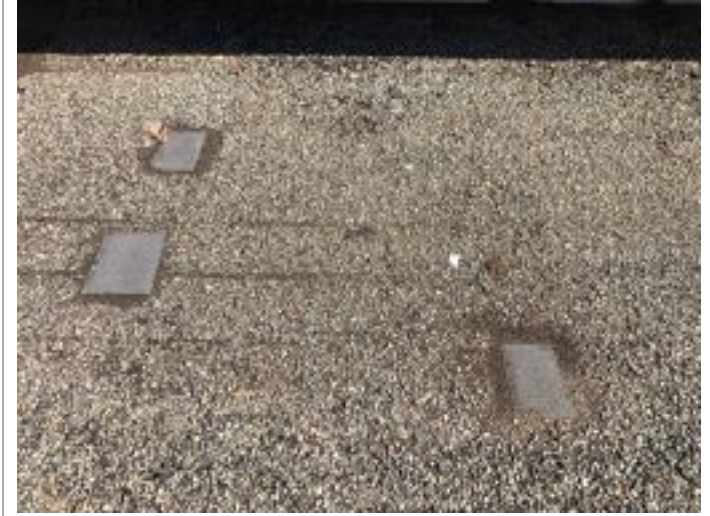
<p>Photo 51 – Peeling paint in fascia boards; staining on perimeter flashing</p>	<p>Photo 52 – Evidence of past repair</p>	<p>Photo 53 – Multiple past repair areas</p>

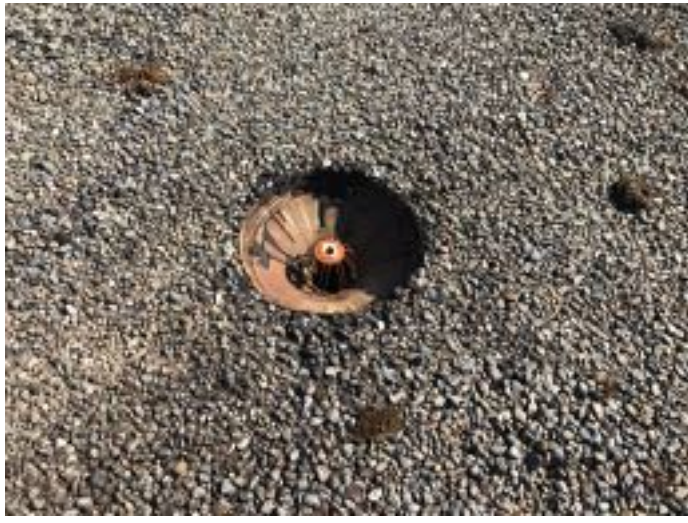
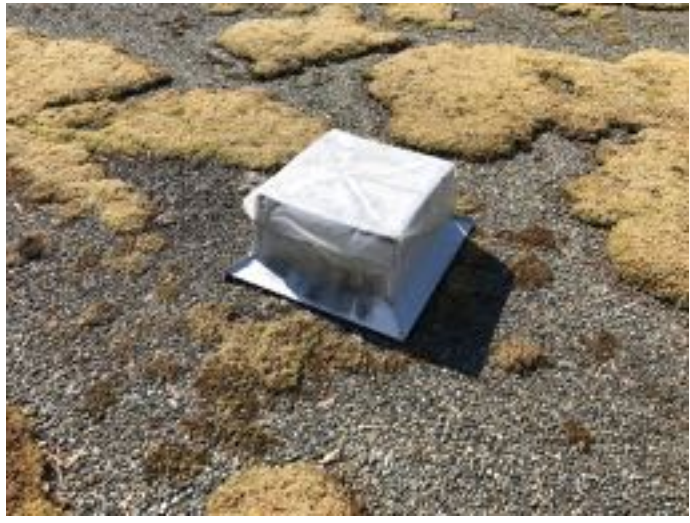
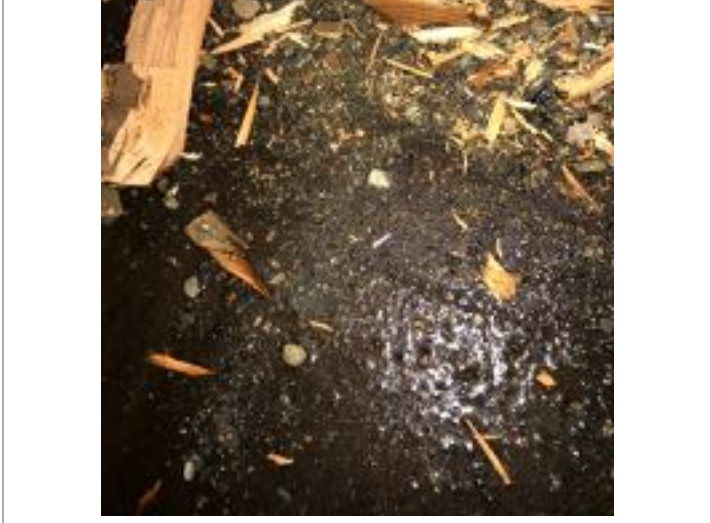
<p>Photo 54 – Typical drain without drain cover</p>	<p>Photo 55 – A mechanical penetration in roof assembly with a plastic seal</p>	<p>Photo 56 – Collection of moisture inside roofing assembly at gymnasium canopy</p>

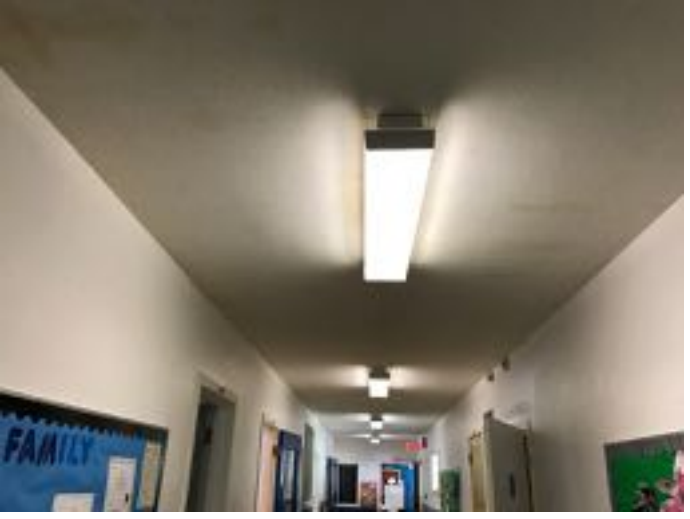
Photo 97 – Typical ceiling view	Photo 98 – Stain found in hallway ceiling	Photo 99 – Stains found in hallway ceiling reported to be from a roof leak

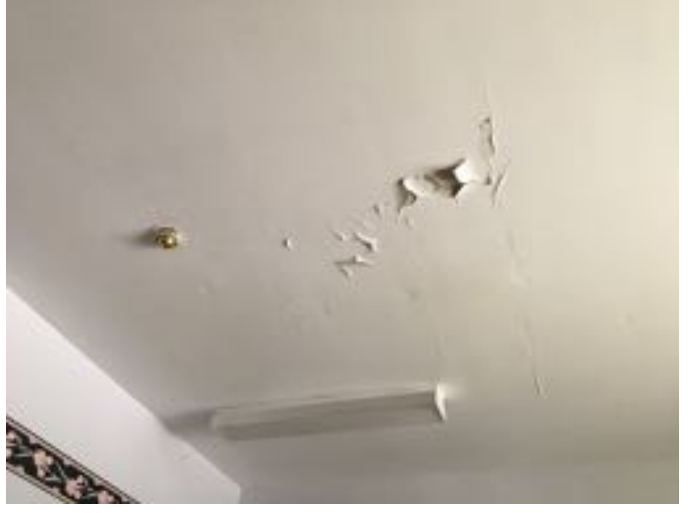
Photo 100 – Peeling paint finishes in Staff Rm 5

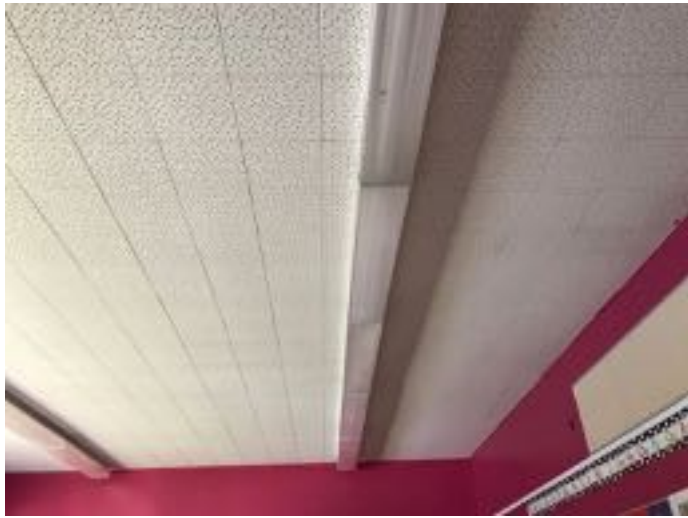
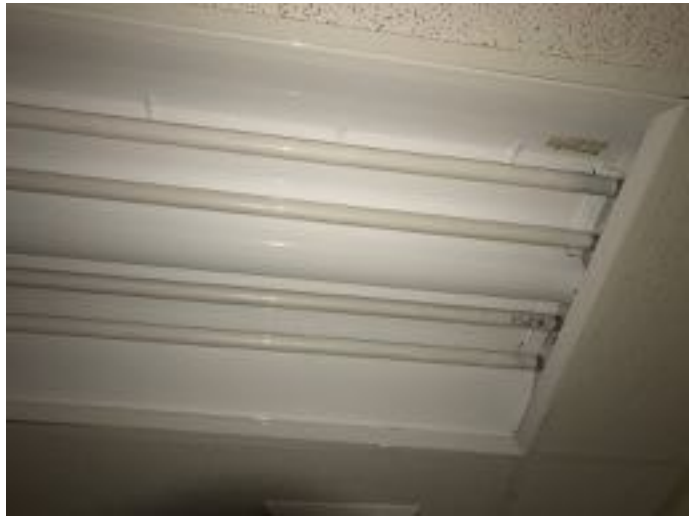
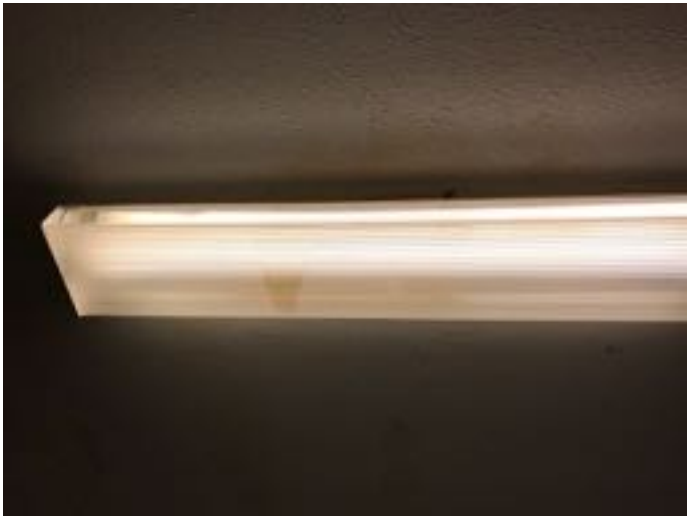
Photo 126 – Typical fluorescent lights	Photo 127 – View of T-8 fluorescent tubes	Photo 128 – A stain inside light fixture
D5022 – Lighting Equipment	Exterior Light Fixtures

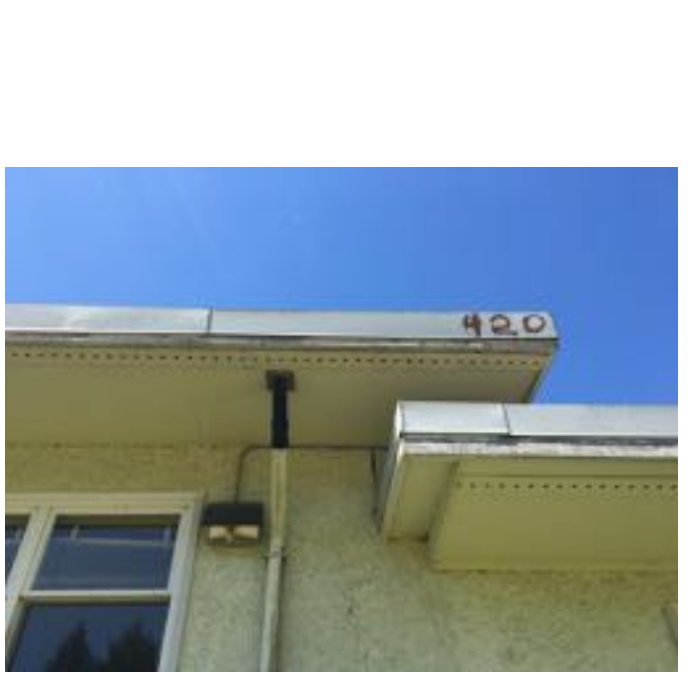
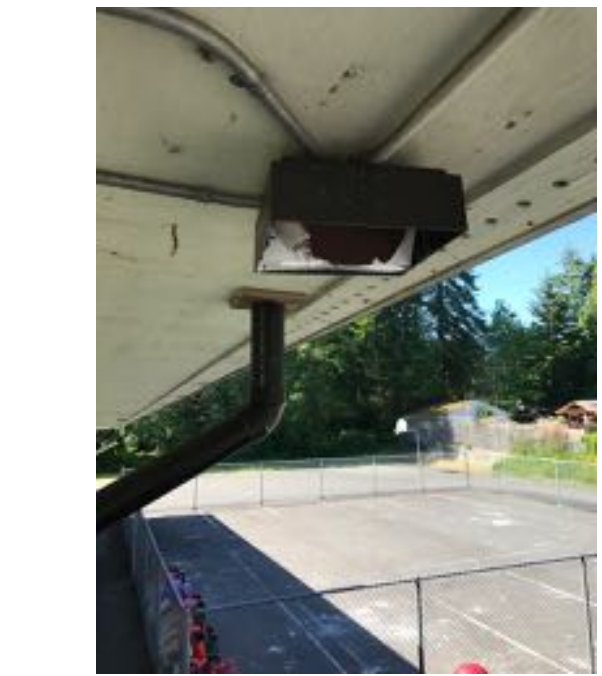
Photo 129 – Typical exterior wall mounted light	Photo 130 – A broken exterior light overlooking fenced play area

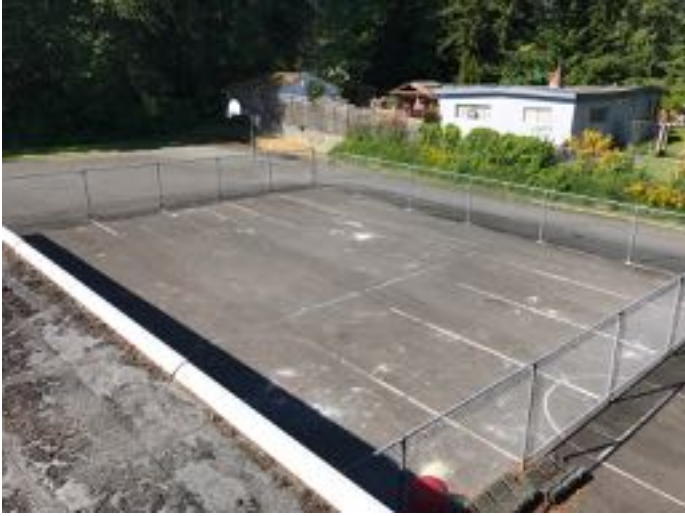
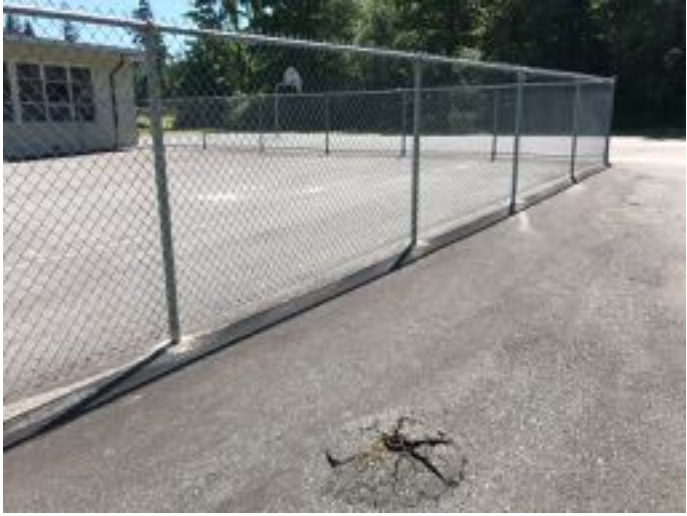
Photo 138 – View of asphalt paved fenced play area	Photo 139 – A potential trip hazard near fenced play area	Photo 140 – Close up of the trip hazard

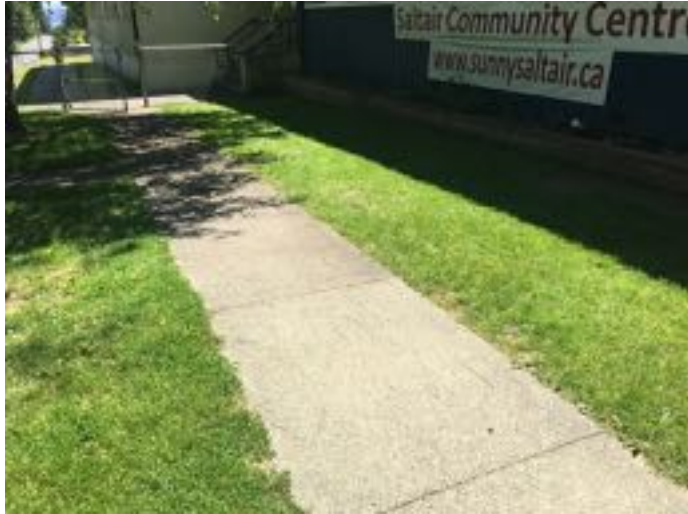
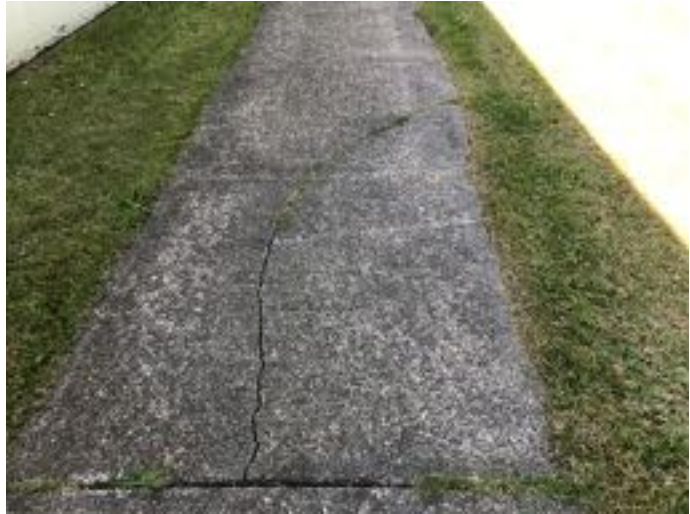
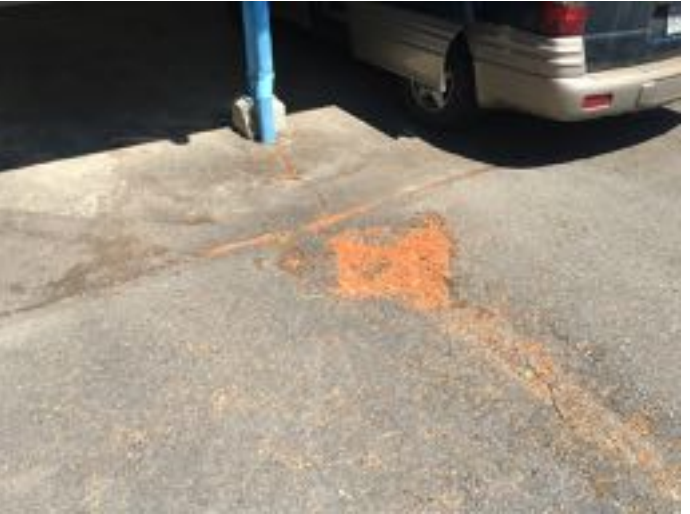
<p>Photo 142 – Typical concrete paved walkway</p>	<p>Photo 143 – Crack in concrete paved walkway</p>	<p>Photo 144 – Uneven walking surface near covered parking area</p>
