**Cowichan Valley Regional District
Parks and Trails Operations**

**Bright Angel Park
Cable Stayed Suspension Bridge
Condition Assessment**

DRAFT – OCTOBER 16, 2013

PROJECT 0635-019

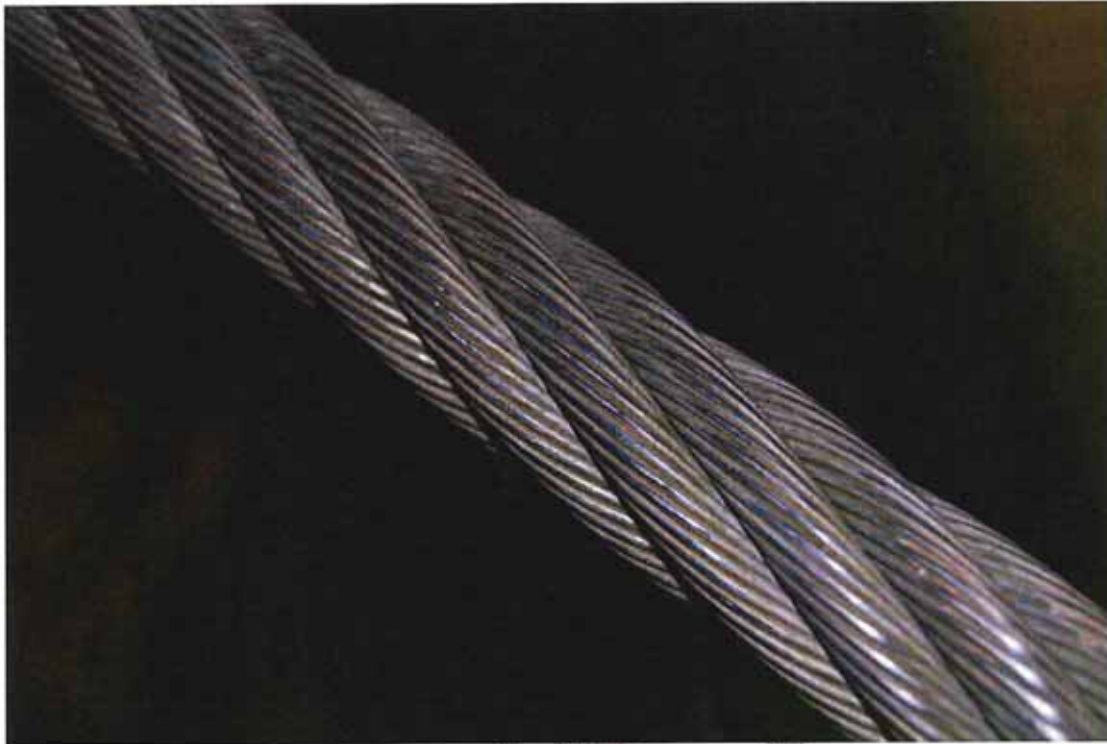
The suspension cables were found to be in generally fair condition with a slight loss of galvanizing and the presence of corrosion between strands being found on the cable at easily accessible locations. At the turn-back eyes the cable ends were noted to be wrapped in plain electrical tape and some unraveling was found as a result.

Figure 3: Main Suspension Cable Close-up

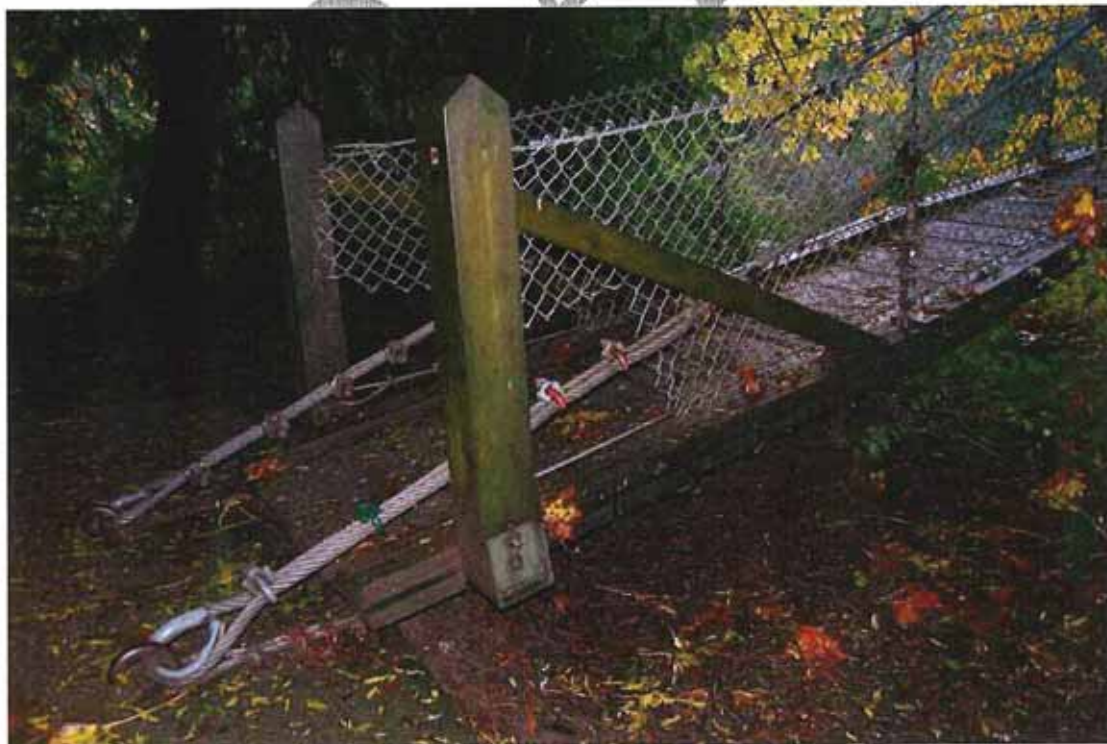
On the West side of the bridge the anchor block is completely buried approximately 2' below grade with all cable terminations being buried as well. On the East side of the bridge the top of the anchor block is located at grade with all cable connections and terminations exposed.

Figure 4: Cable Terminations at East Anchor

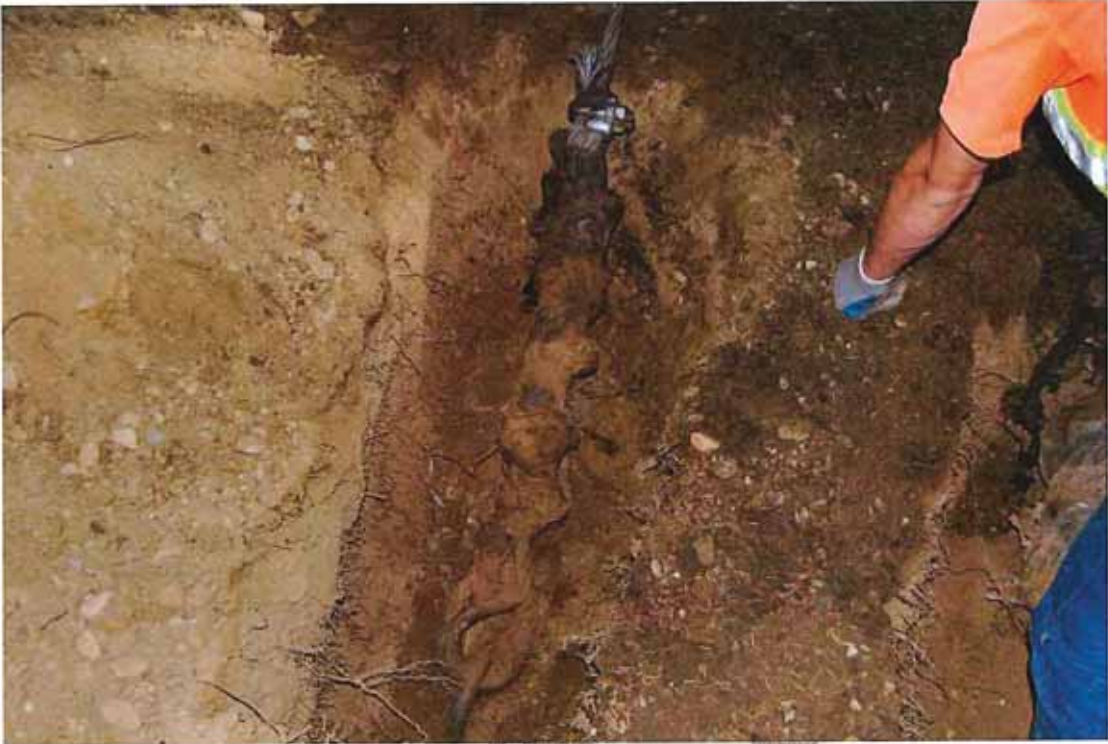
At the West anchor the cables were exposed after hand excavating and were found to be wrapped in a combination of plastic wrap over burlap with the cable coated in grease inside of the wrapping. The layer of burlap was noted to be saturated with water.

Figure 5: Wrapped Cable at West Anchor

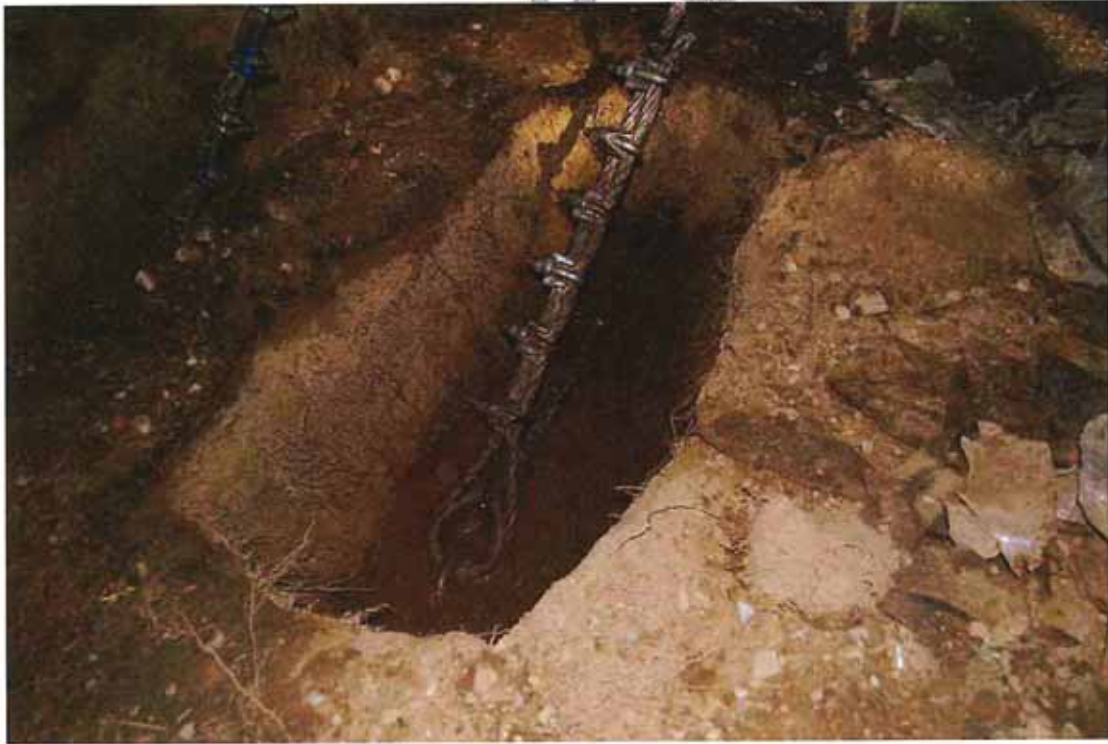
Figure 6: Unwrapped Cables at West Anchor

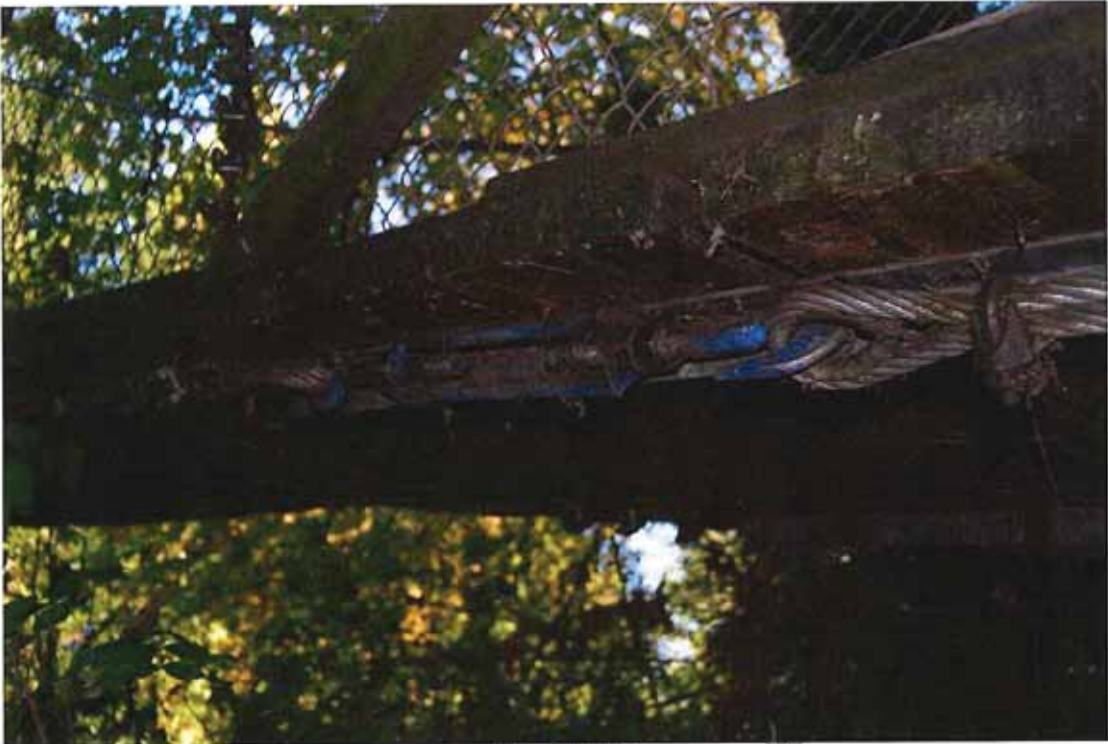
The walkway cables are connected to the anchors at each end utilizing a field assembled turn-back eye with a thimble and clips in the same manner as the suspension cables. Adjacent to the East anchor block there are turn-buckles in-line with the cables providing a means for adjustment of the cable tension. The turn-buckles were noted to have open hooks on one end and a capacity rating could not be seen on the turn-buckles in their current orientation. A cable splice made with clips was noted at the West end of the North cable immediately East of the West tower.

Figure 7: Walkway Cable Turnbuckles

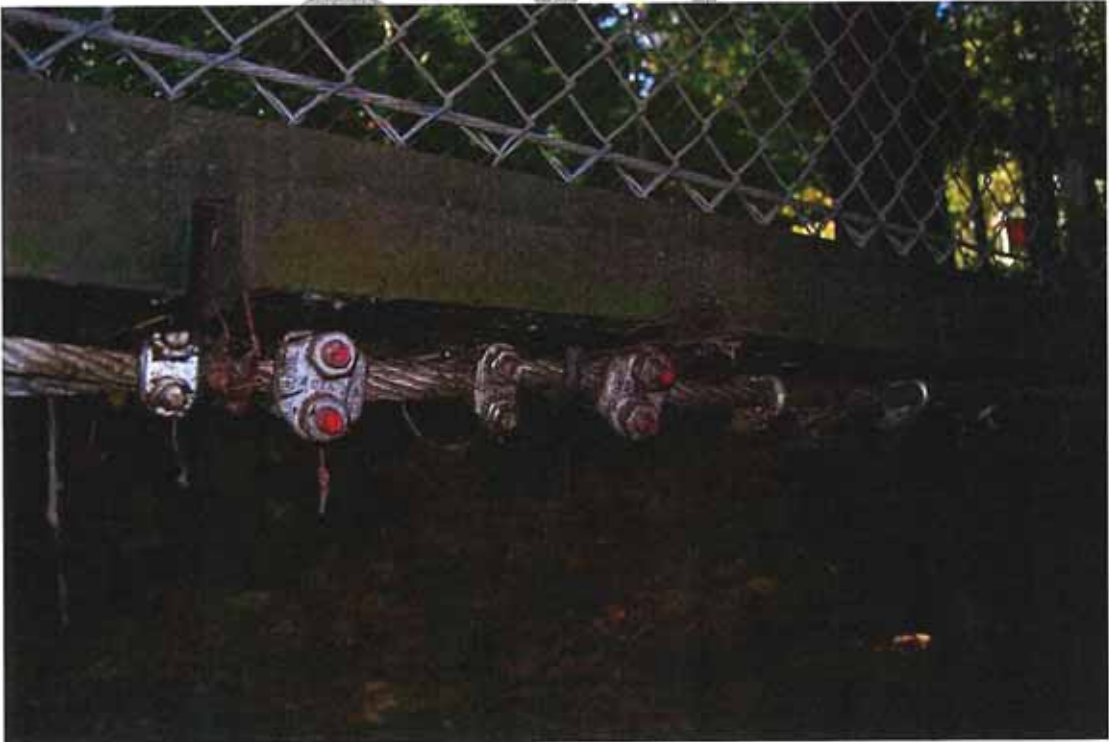
Figure 8: Walkway Cable Splice

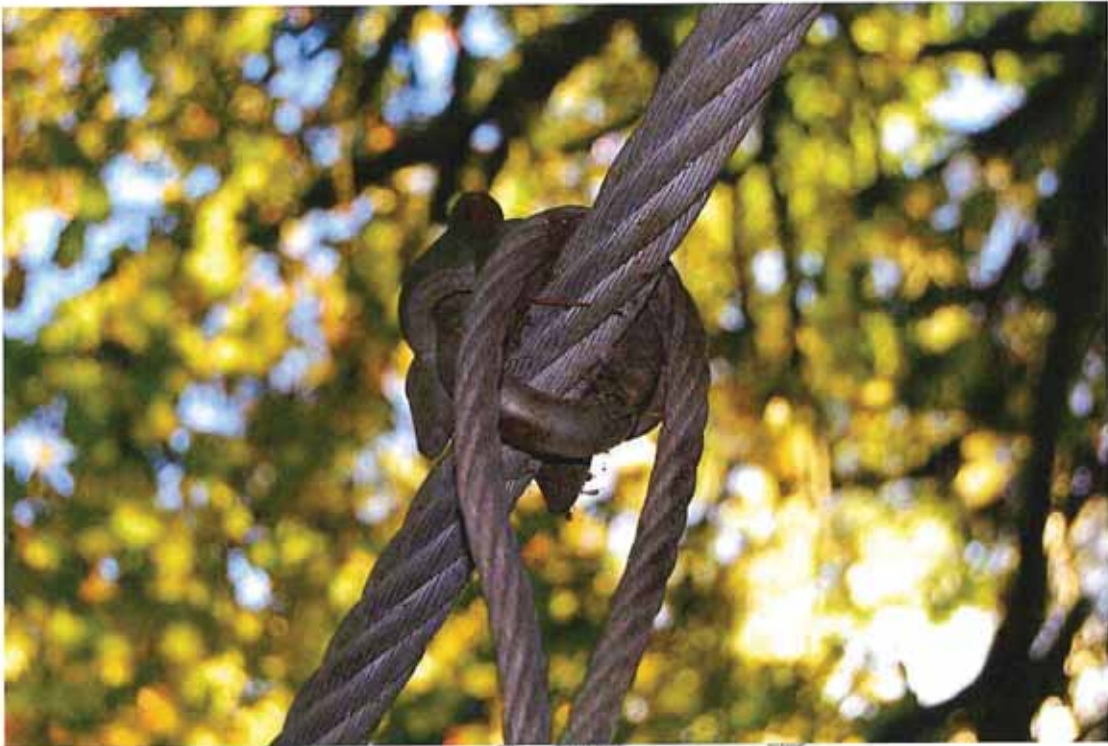
The hanger cables are connected to the suspension and walkway cables by turn-back eyes with clips on each end, with the eyes wrapped around the large cables. No thimbles are used in the turn-back eyes. At the hanger locations on the suspension cable, 1 1/8" clips are used to stop the hanger cables from sliding down the suspension cable while at the walkway cable the eyes are located between sections of deck planking which are affixed to the walkway cable.

Figure 9: Typical Top Hanger Connection

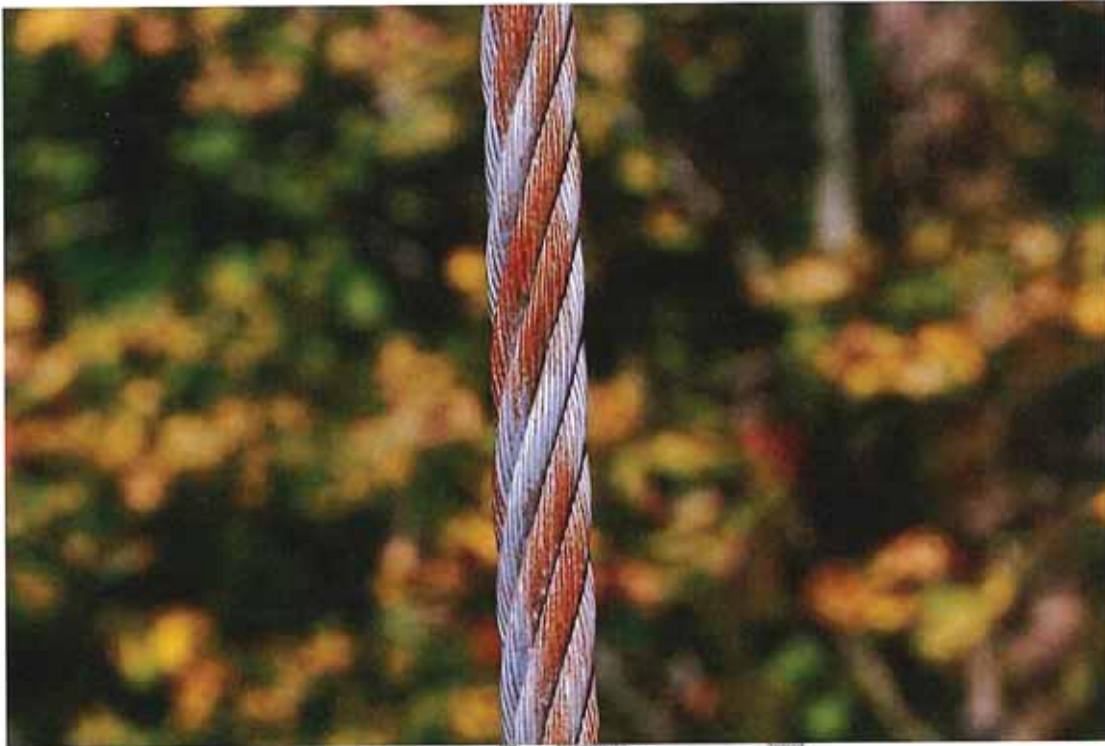
The hanger cables were generally in fair to good condition without signs of distress however it was noted that surface rust was present on some cables, despite the lack of any source of abrasion or additional moisture and that the corrosion was most prevalent at the bottom connection where the cables run between the deck planks. One hanger cable on the South side of the bridge, East of the East tower was noted to be in immediate need of replacement due to cable damage at the lower connection.

Figure 11: Surface Corrosion on Hanger Cable

- Adjust hanger cables to level the bridge deck.
- Provide tamper-proof cable connections.
- Continue to replace deck planks and hanger cables as required.
- Ensure that the hanger cable material being used has sufficient corrosion protection.
- Implement maintenance policies that recognize the unique requirements of structural cable construction.

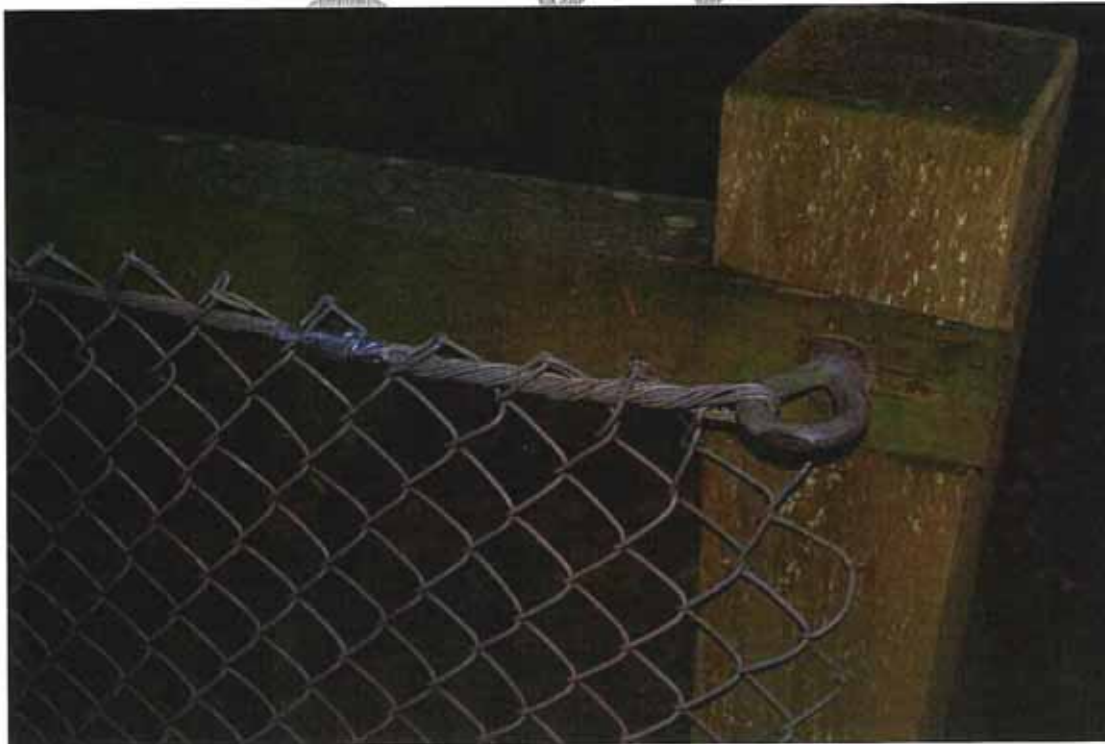
The connections of the handrail cable to the timber posts were noted to consist of a turn-back eye with no thimble and 2 clips at the South West post and loosely spliced eyes with no thimbles or clips at the other three locations.

The handrail cables were in generally good condition however the attachment and splicing of the cables appears deficient and the overall level of tension would be considered too low for usage as a "guard" despite being of sufficient height above the walking surface.

Figure 12: Spliced End Connection At Hand Rail Cable

- Tighten all cable clips to recommended values. ✓ Parks Staff
- Provided proper connections at the ends of the walkway handrail cables and re-tension the cables.
- Apply thread-locker or apply other anti-tampering measures to cable clips at accessible locations. - Parks Staff
- Have solid hangers inspected and re-welded if required. -

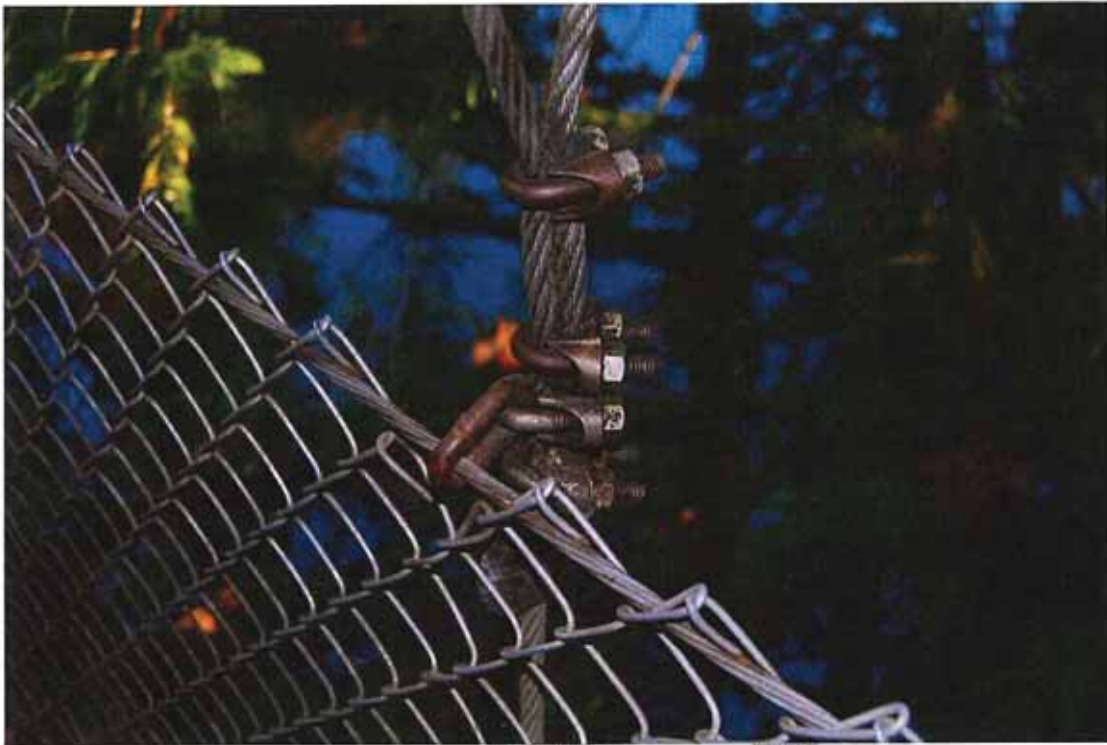
The walkway handrail cables are strung between the suspension and walkway cables and are used as handrails and to support chain-link fencing material used as a guard along the sides of the bridge. The handrail cables are connected to timber posts at each end of the bridge and are attached to the hanger cables using wire rope clips and links of chain along the length of the bridge. At mid span where the suspension cable is below the level of the top of the chain-link material an additional cable has been added, although the purpose of the cable is not clear.

Figure 13: Typical Hand Rail Cable to Hanger Connection

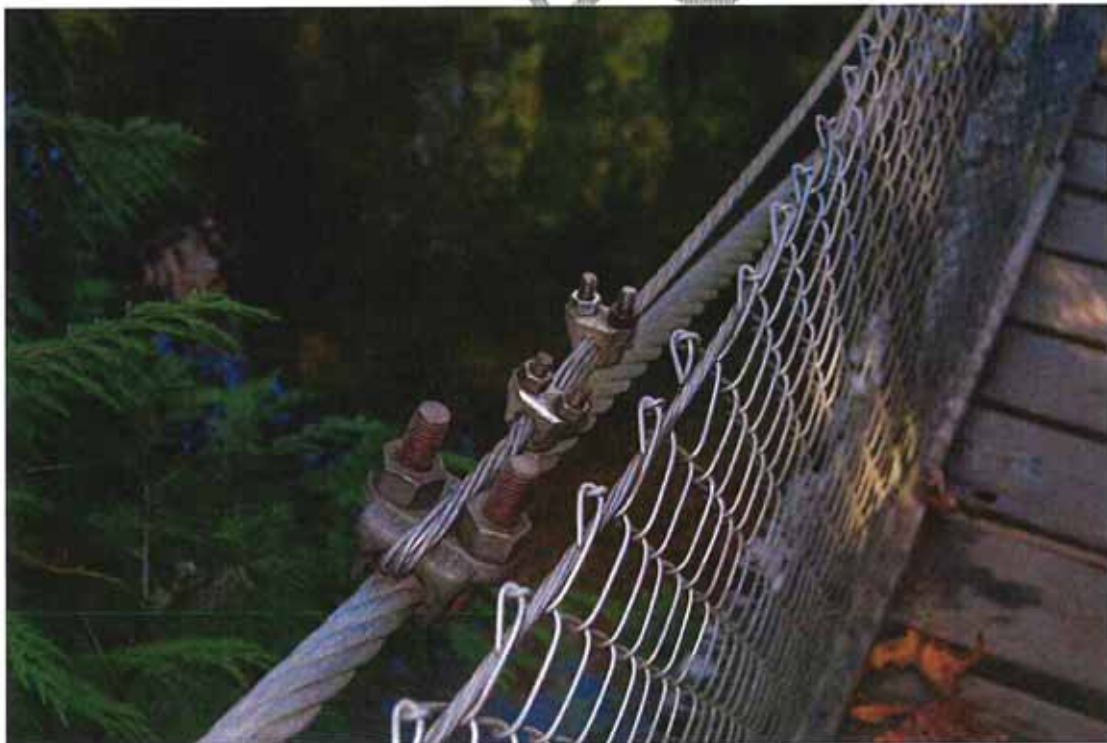
Figure 13: Additional Hand Rail Cable Connection at Mid Span

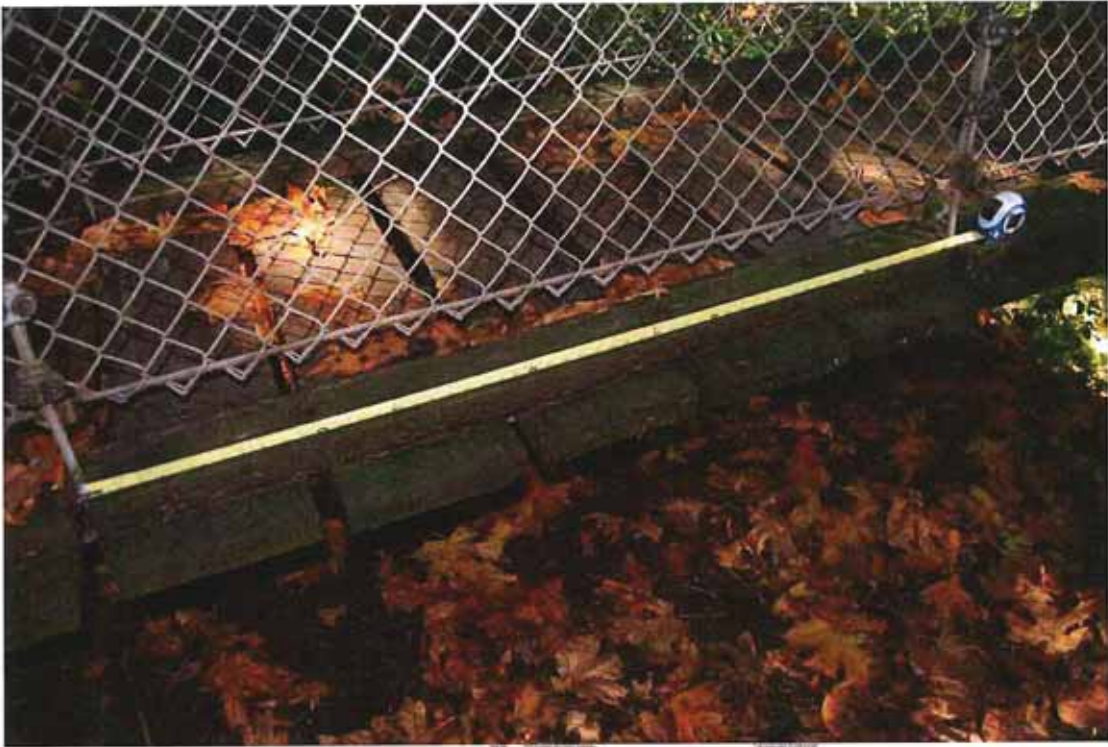
The walking surface of the bridge consists of 2"x10" planking bearing directly on the walkway cables and held in place by a top cap on each side which is connected to the cable via eye-bolts that are installed between deck planks. The walking surface is approximately 36" wide with the deck planks typically measuring 48" wide.

The floor beams were noted to be in moderate to fair condition with some abrasion from cables and fittings noted, as well as some decay and softness at the ends of the planks.

Figure 15: Typical Decking Construction

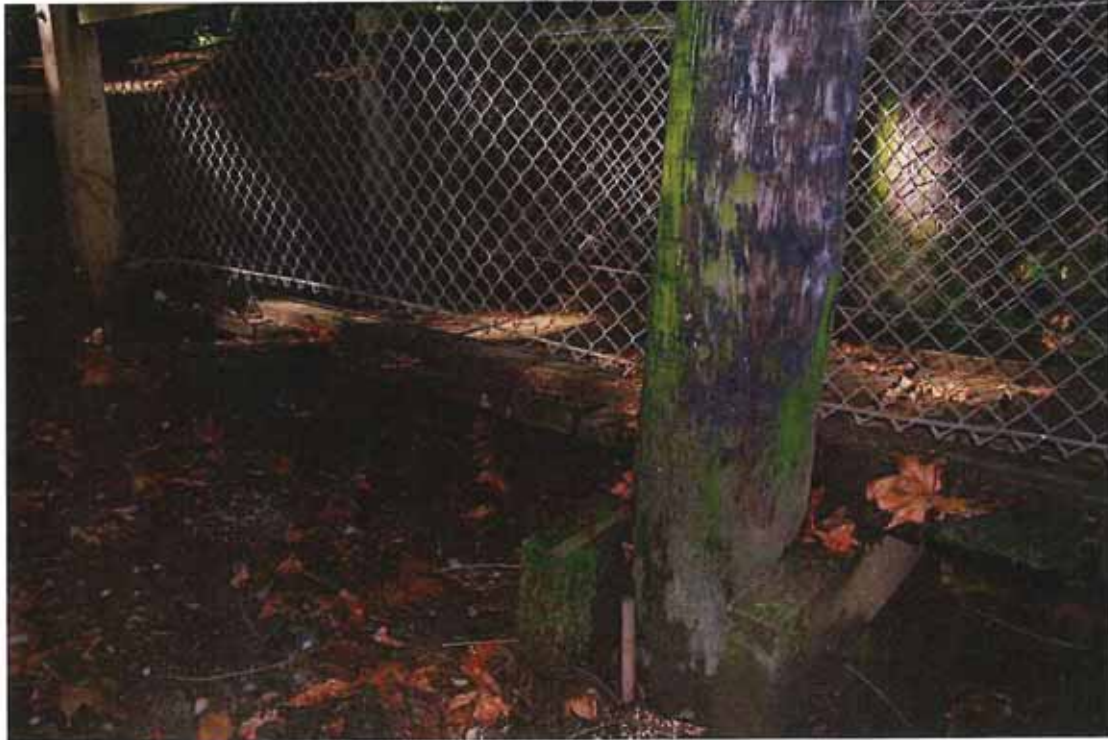
A sounding of the tower posts indicated that some changes in density were evident in the bottom portion of the posts, immediately above the piers. Further probing of the posts with a drill revealed that the posts have significant decay throughout the core of the posts in the bottom 24"-36", with pockets of decay above that.

In assessing this bridge structure it has been determined that while the cable elements are generally sound, the main timber posts in the towers supporting the cables have significant decay at their bases and should be replaced if continued future usage of the bridge is to be assured.

Figure 14: Tower Post Base with Decay

- Replace posts in tower to address decay.

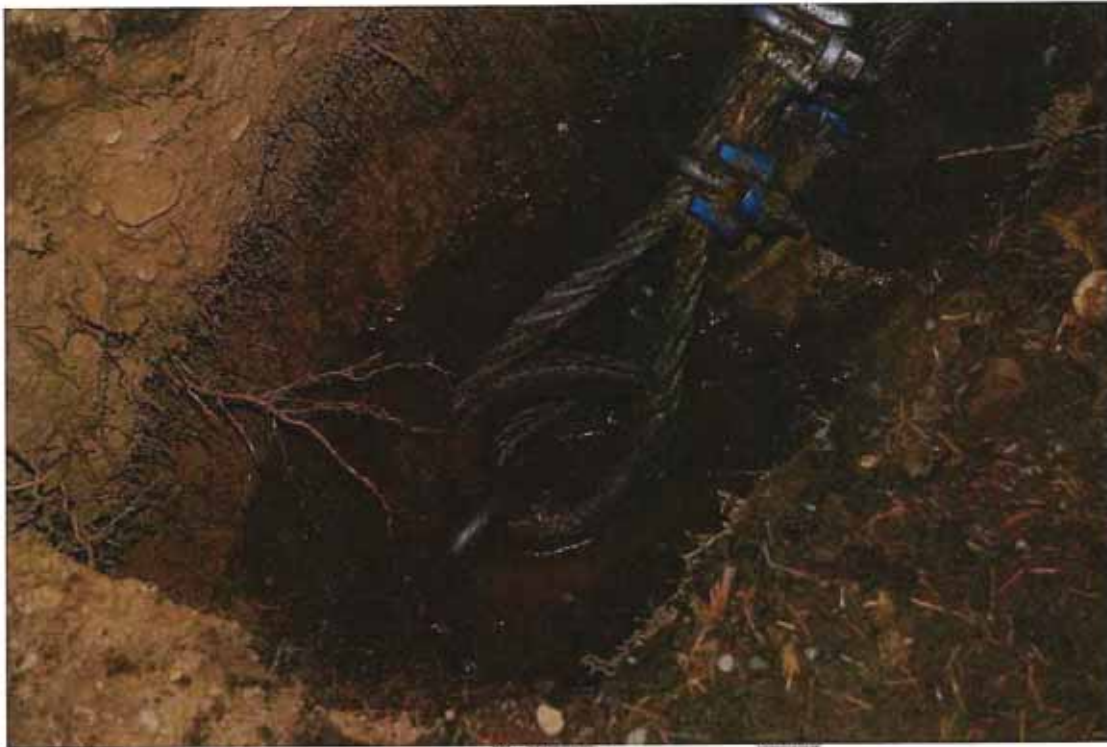
At turn-back eyes where thimbles are used the clips are typically too far from the thimble, allowing the cable eye to open and the thimbles to rotate in the eye.

Figure 15: Improperly Clipped Turn-Back Eye with Rotated Thimble

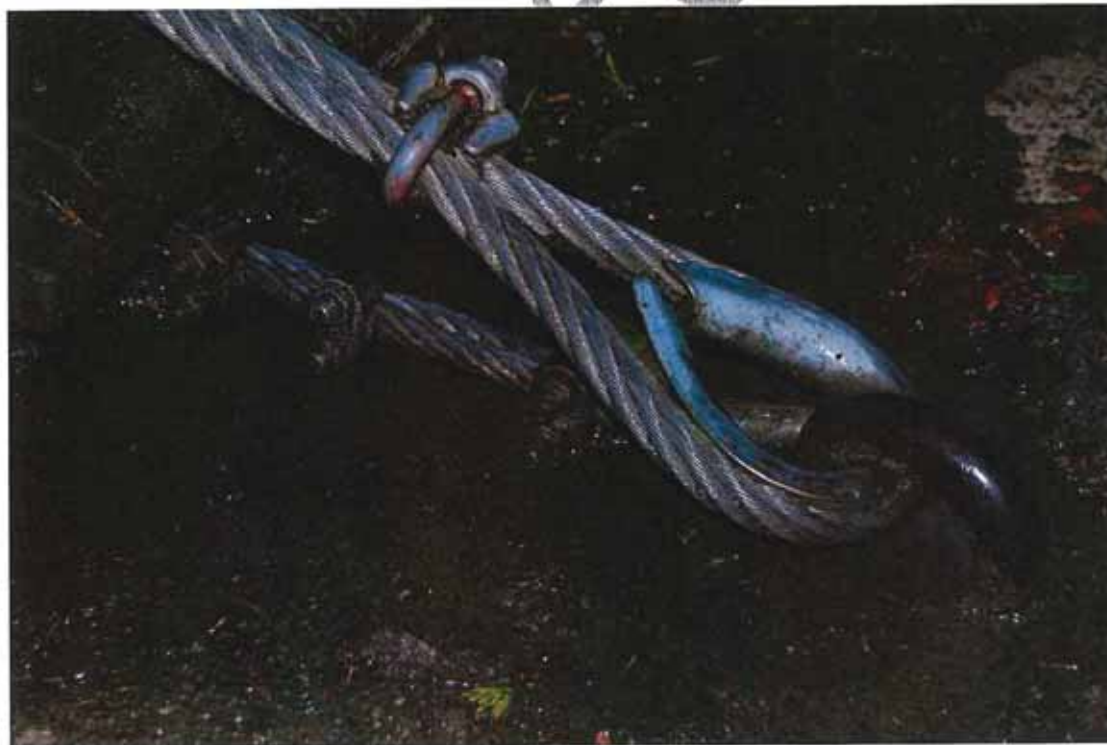
Figure 16: : Improperly Clipped Turn-Back Eye with Thimble

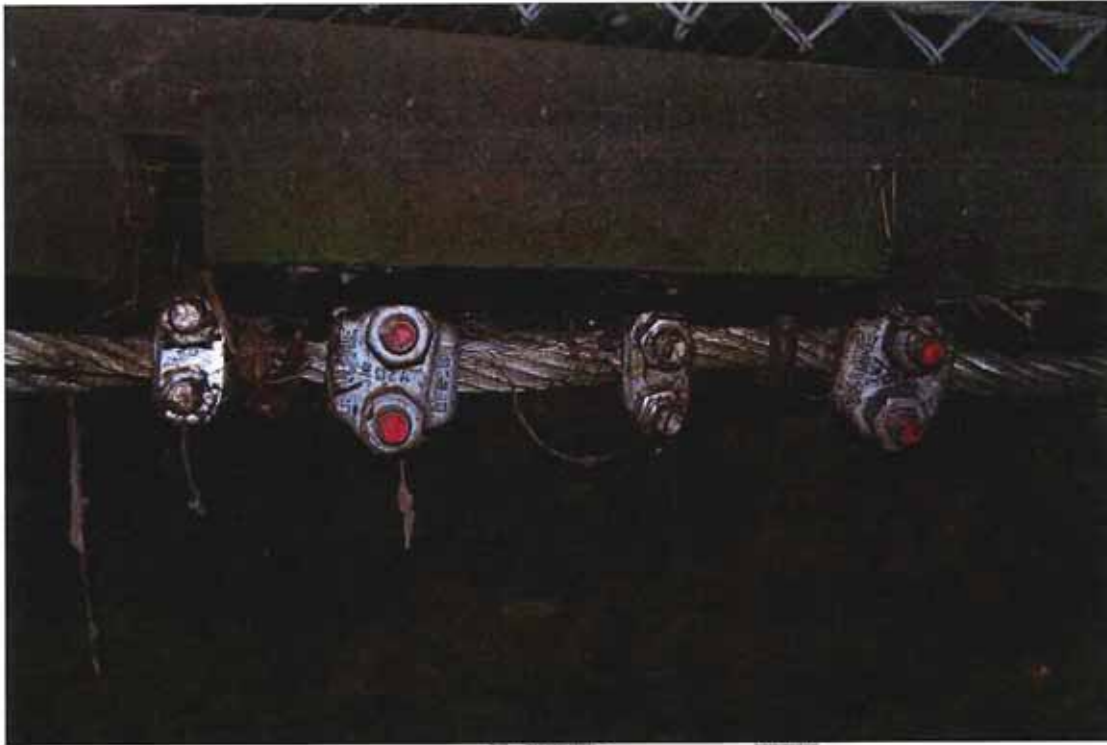
A mixture of branded (i.e. Crosby) cable clips and unbranded clips were found on the structure. The use of unbranded or poorly marked hardware is not recommended as the capacity of such items cannot readily be confirmed.

Figure 17: Cable Clips from Varying Suppliers

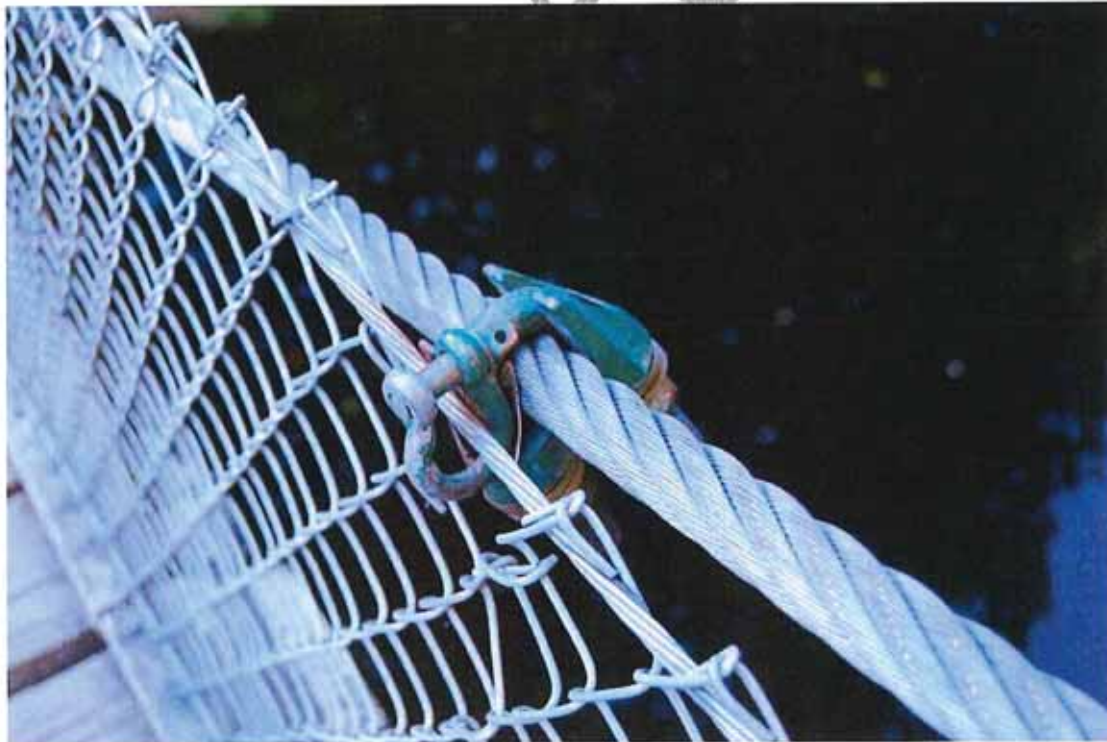
A large number of "makeshift" cable connectors have been used to connect cables together. When used in this fashion, the capacity of these connectors cannot be readily determined and the long term effect of the use of these connectors on the cables is not known.

Figure 19: Makeshift Cable Connectors
