Dam Safety Review and Risk Assessment of Youbou Creek Dam

March 2019

GK-18-020-CVD

Cowichan Valley Regional District
175 Ingram Street
Duncan, BC V9L 1N8

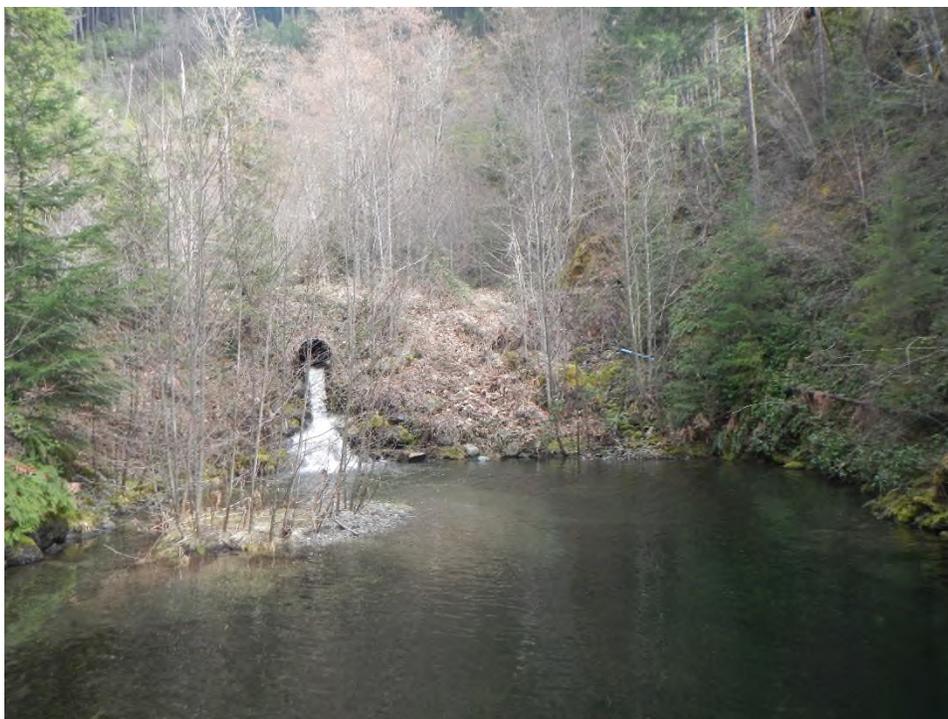
- Five corrugated steel pipe culverts of approximately 1.1 m diameter and up to 6 m length were observed, two beneath the roadway between the stilling basin and the dam and three beneath the roadway downstream of the dam (Photo 3).

Photo 3 Culvert discharging into reservoir upstream of the dam.

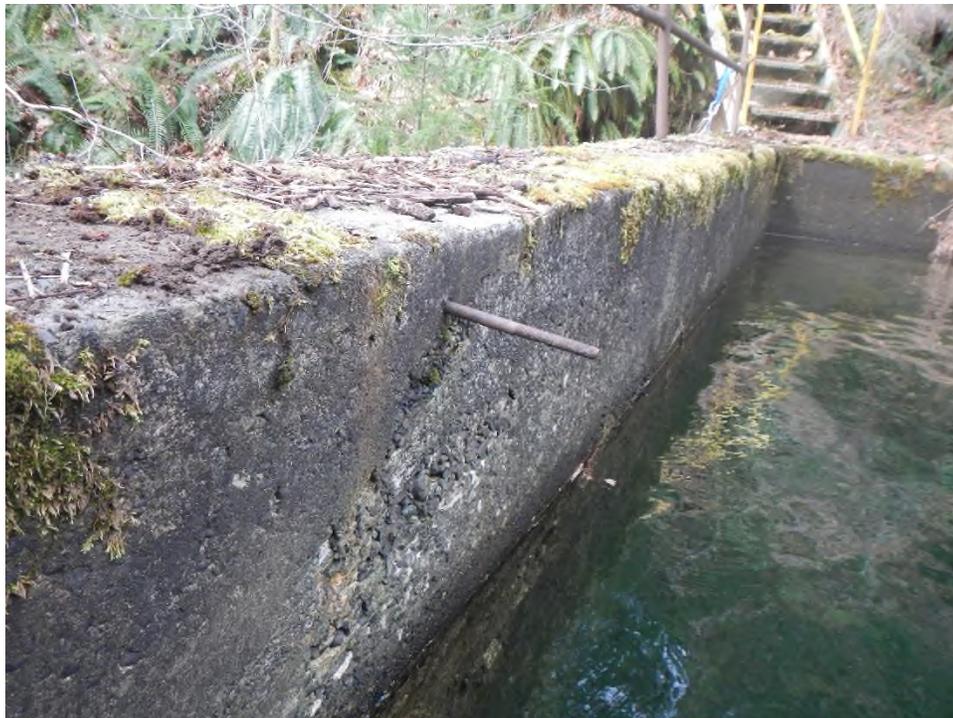
- Signs of moderate weathering, pitting, and erosion of concrete were noted at the waterline (Photo 6).
- Guardrail along crest of dam was noted to be corroded and the stanchion base connections showed signs of movement in some locations (Photo 7).

Photo 6 Upstream face of the dam above waterline.

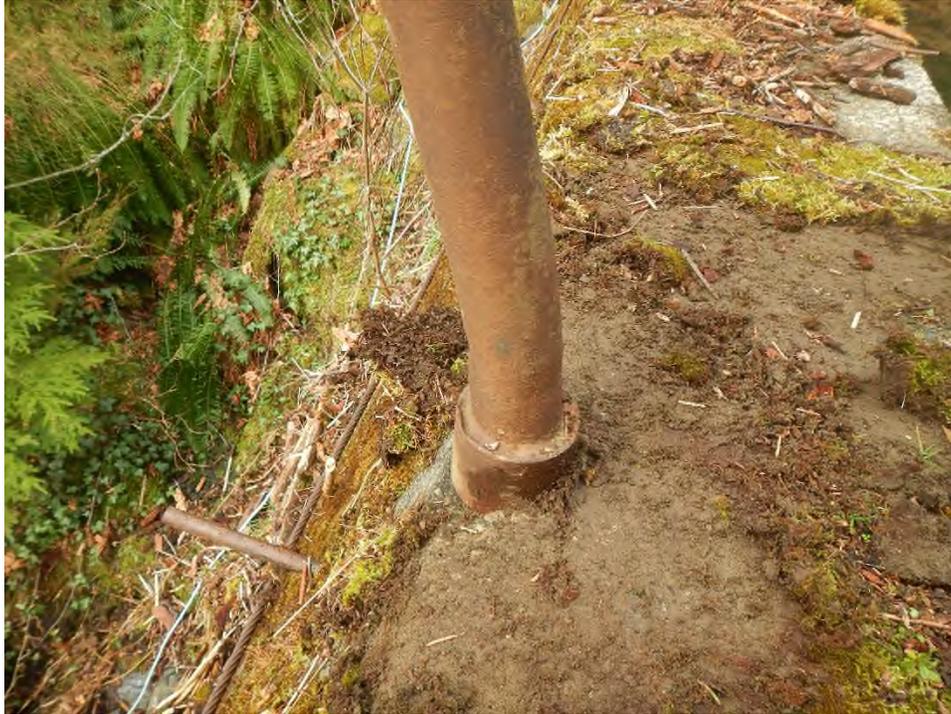
Photo 7 Corroded bent guardrail on the dam crest.

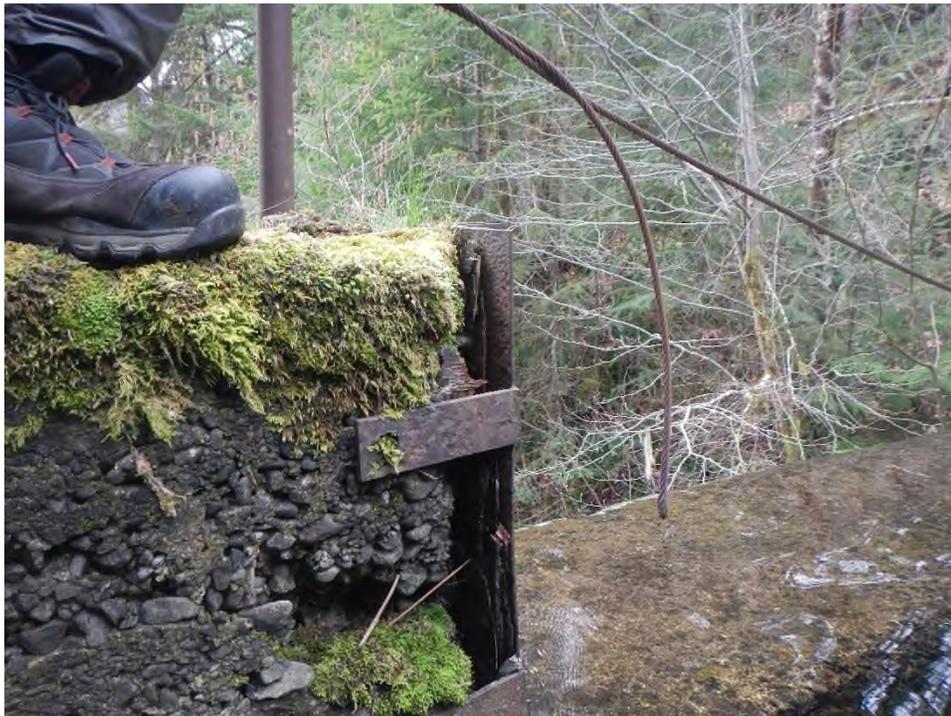
- Erosion was noted behind the east stoplog channel steel plate (fastened to the side face of the spillway) (Photo 8).
- Horizontal cracking and erosion were noted on the west half of the dam face about 1 m down from the crest of the dam. It was determined that cracks extended through the full width of dam, as water was steadily seeping through the cracks (Photo 11).

Photo 8 Weathering of concrete on the left side of the spillway at the stoplog insert.

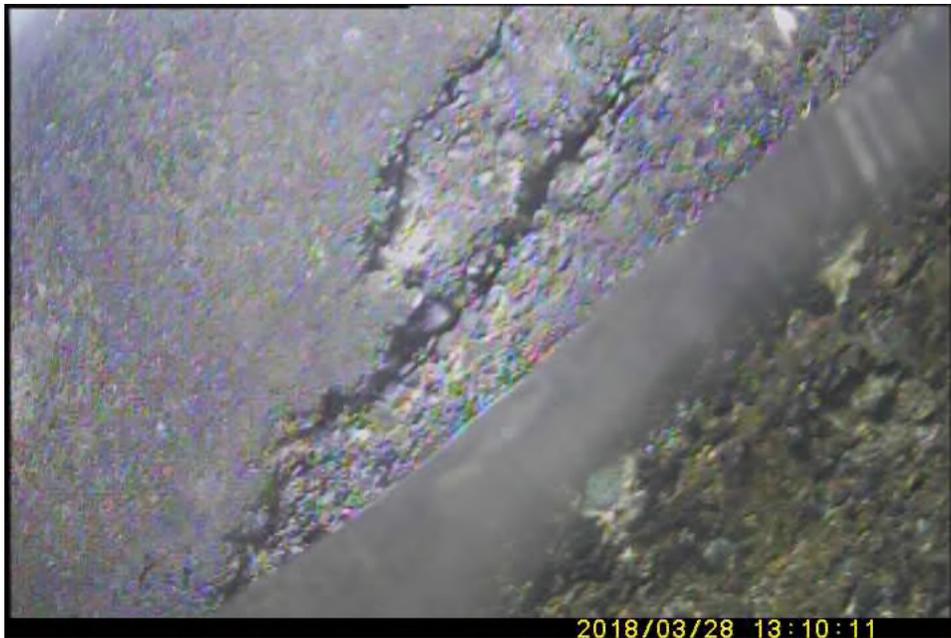
Photo 10 Concrete deterioration above and below water line.

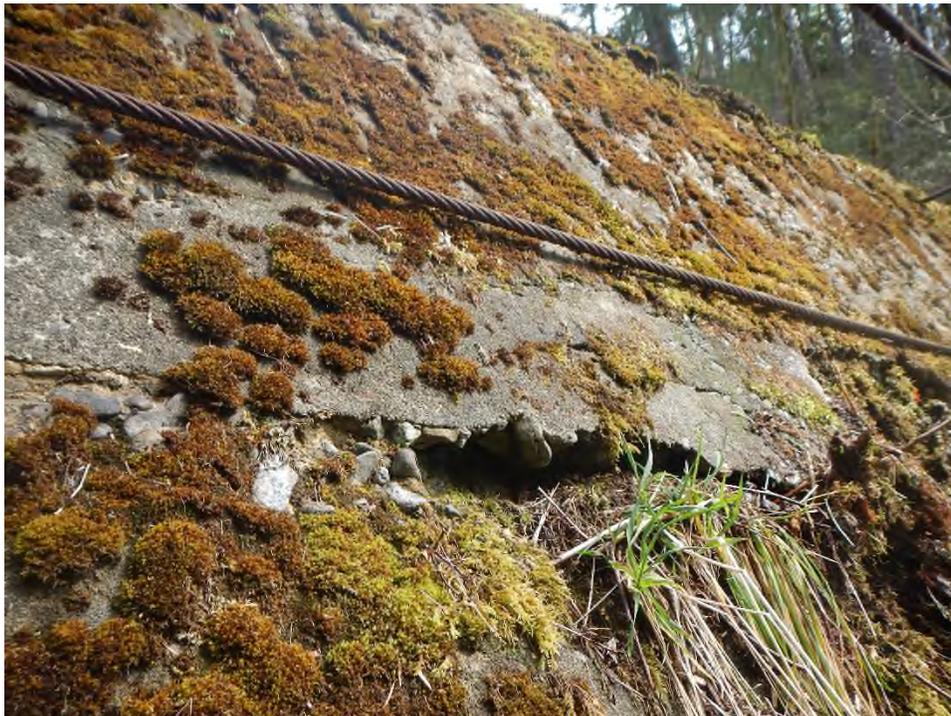
Photo 14 Horizontal cracking and erosion on downstream dam face approximately 1 m below the crest.

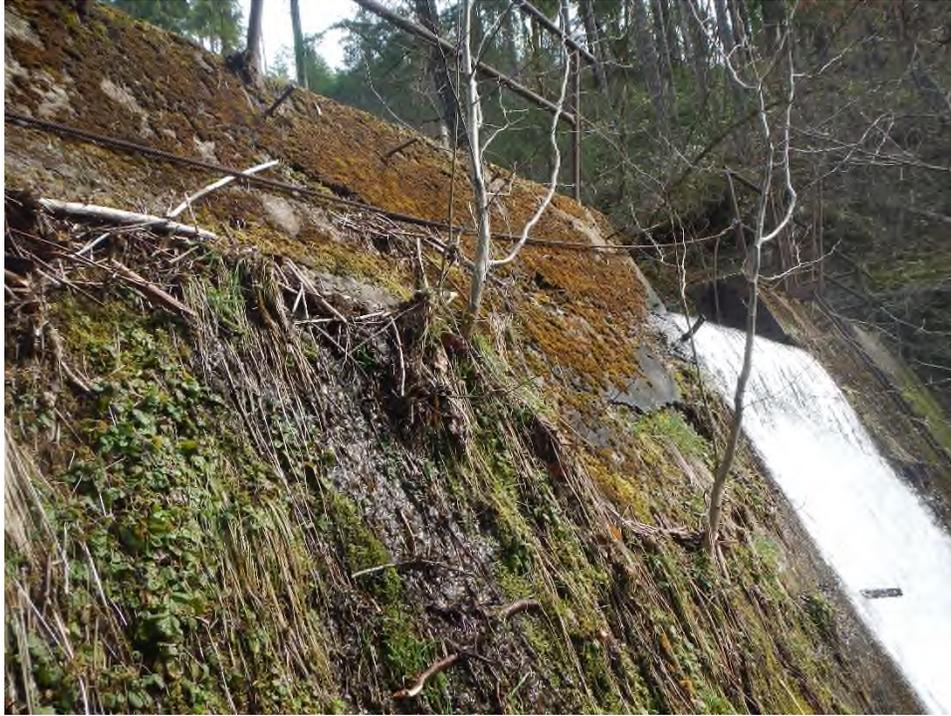
- Extensive vegetation was noted throughout the crest and downstream face of the dam (Photo 15).
- A horizontal groove was noted on the east half of the downstream face at about 1.7 m from the crest of the dam along what may have been a construction concrete pour break (Photo 15).

Photo 15 Vegetation growing on the dam face to the right of the spillway.

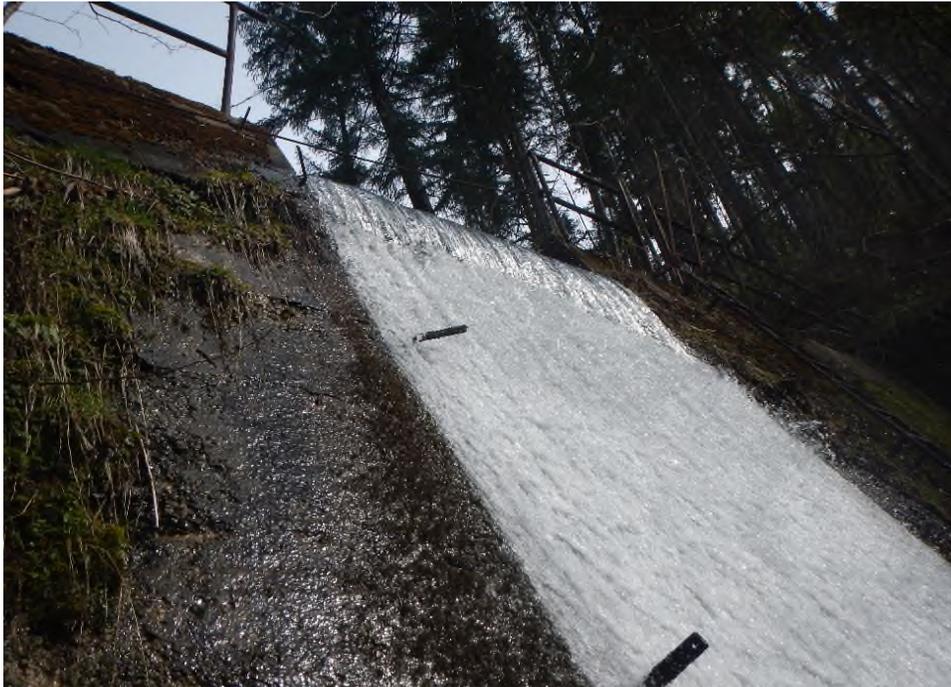
- The downstream face of the dam was heavily eroded/weathered exposing the concrete aggregate throughout (Photo 16).
- Horizontal cracking and erosion were also noted on the east half of the dam face in a similar pattern as the west half, however, no water seepage was noted (Photo 16).

Photo 16 Water flowing over spillway as viewed from below.

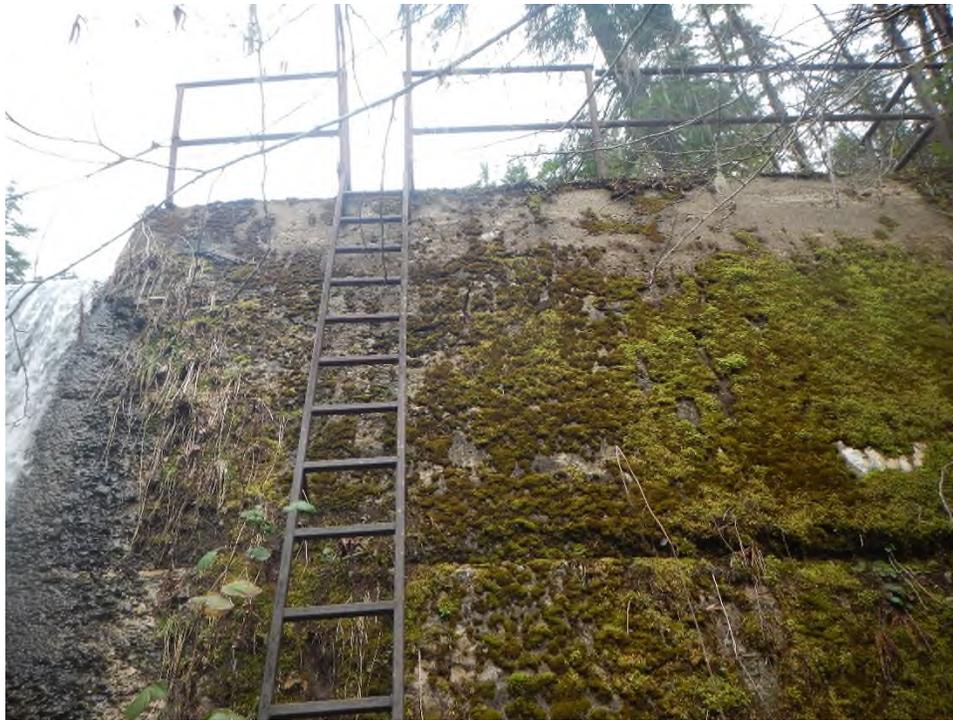
Photo 18 Horizontal groove on the left downstream face approximately 1.7 m below the crest.

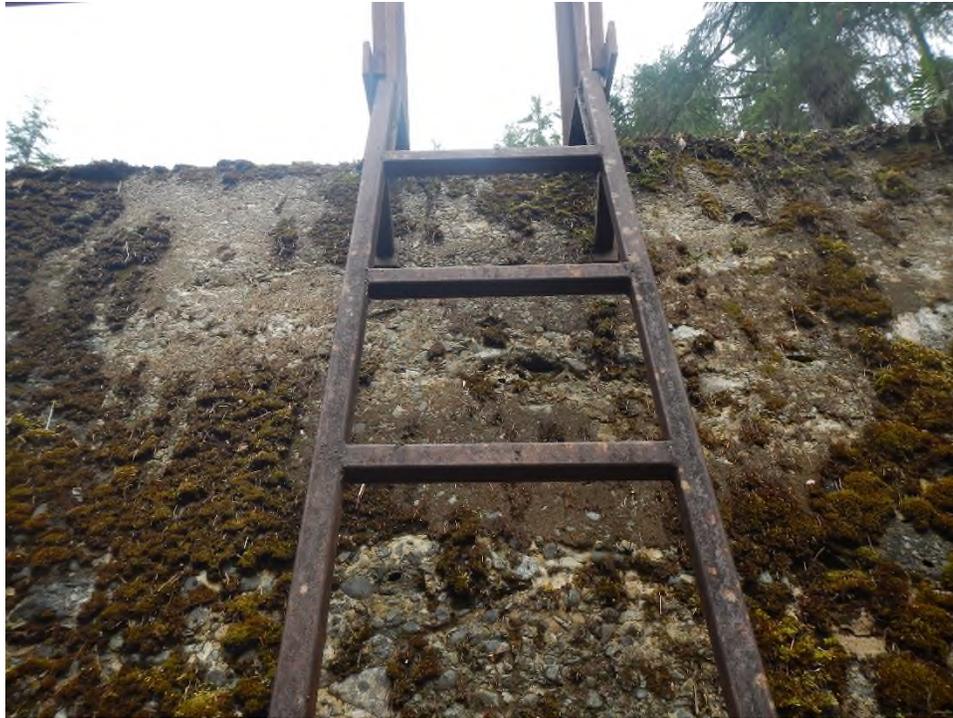
Photo 19 Weathering on the downstream face noted throughout the crest and front face.
