2020 Corporate Strategic Asset Management Plan

Appendix E Condition Assessment Framework Part 2 - Facilities

MH Project No. 5170700.00

**Cowichan Valley Regional District
Facility Condition Assessment and Capital Plan
CVRD Head Office, 175 Ingram Street, Duncan, BC**

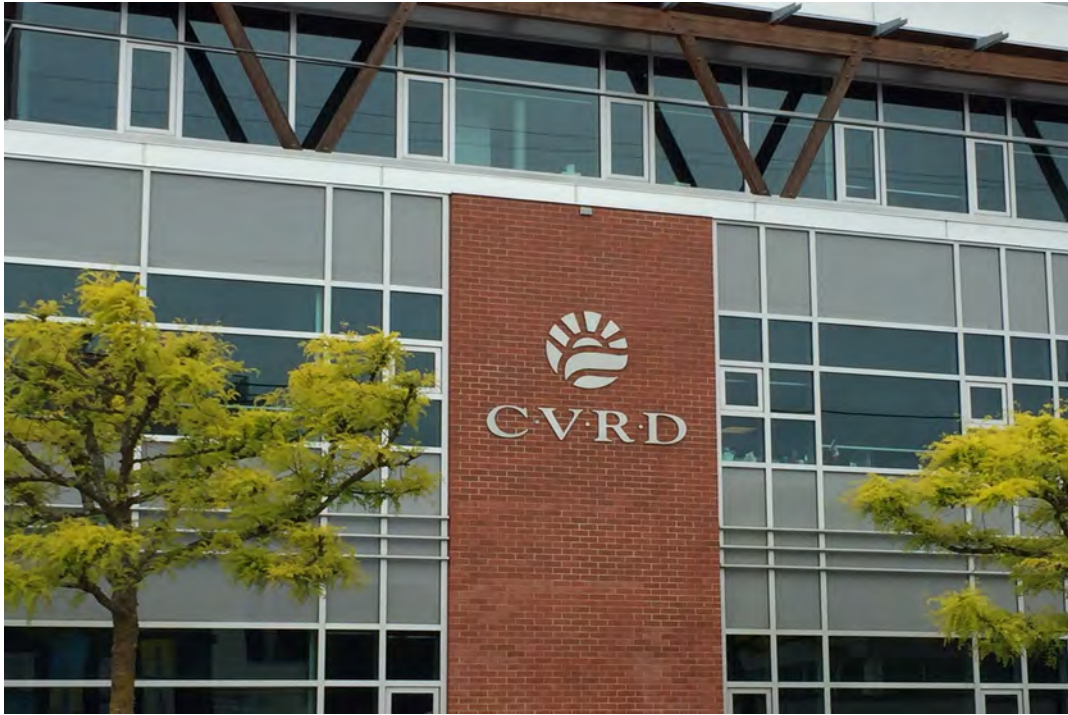
Refer to Photo 01 for a general overview of the exterior of the building.
