**PRELIMINARY ENVIRONMENTAL ASSESSMENT
1355 FISHER ROAD GROUNDWATER WELL SITE
COBBLE HILL, B.C.**

COWICHAN VALLEY REGIONAL DISTRICT

Thurber Engineering Ltd.
Victoria, B.C.

December 5, 2011
File: 17-971-13

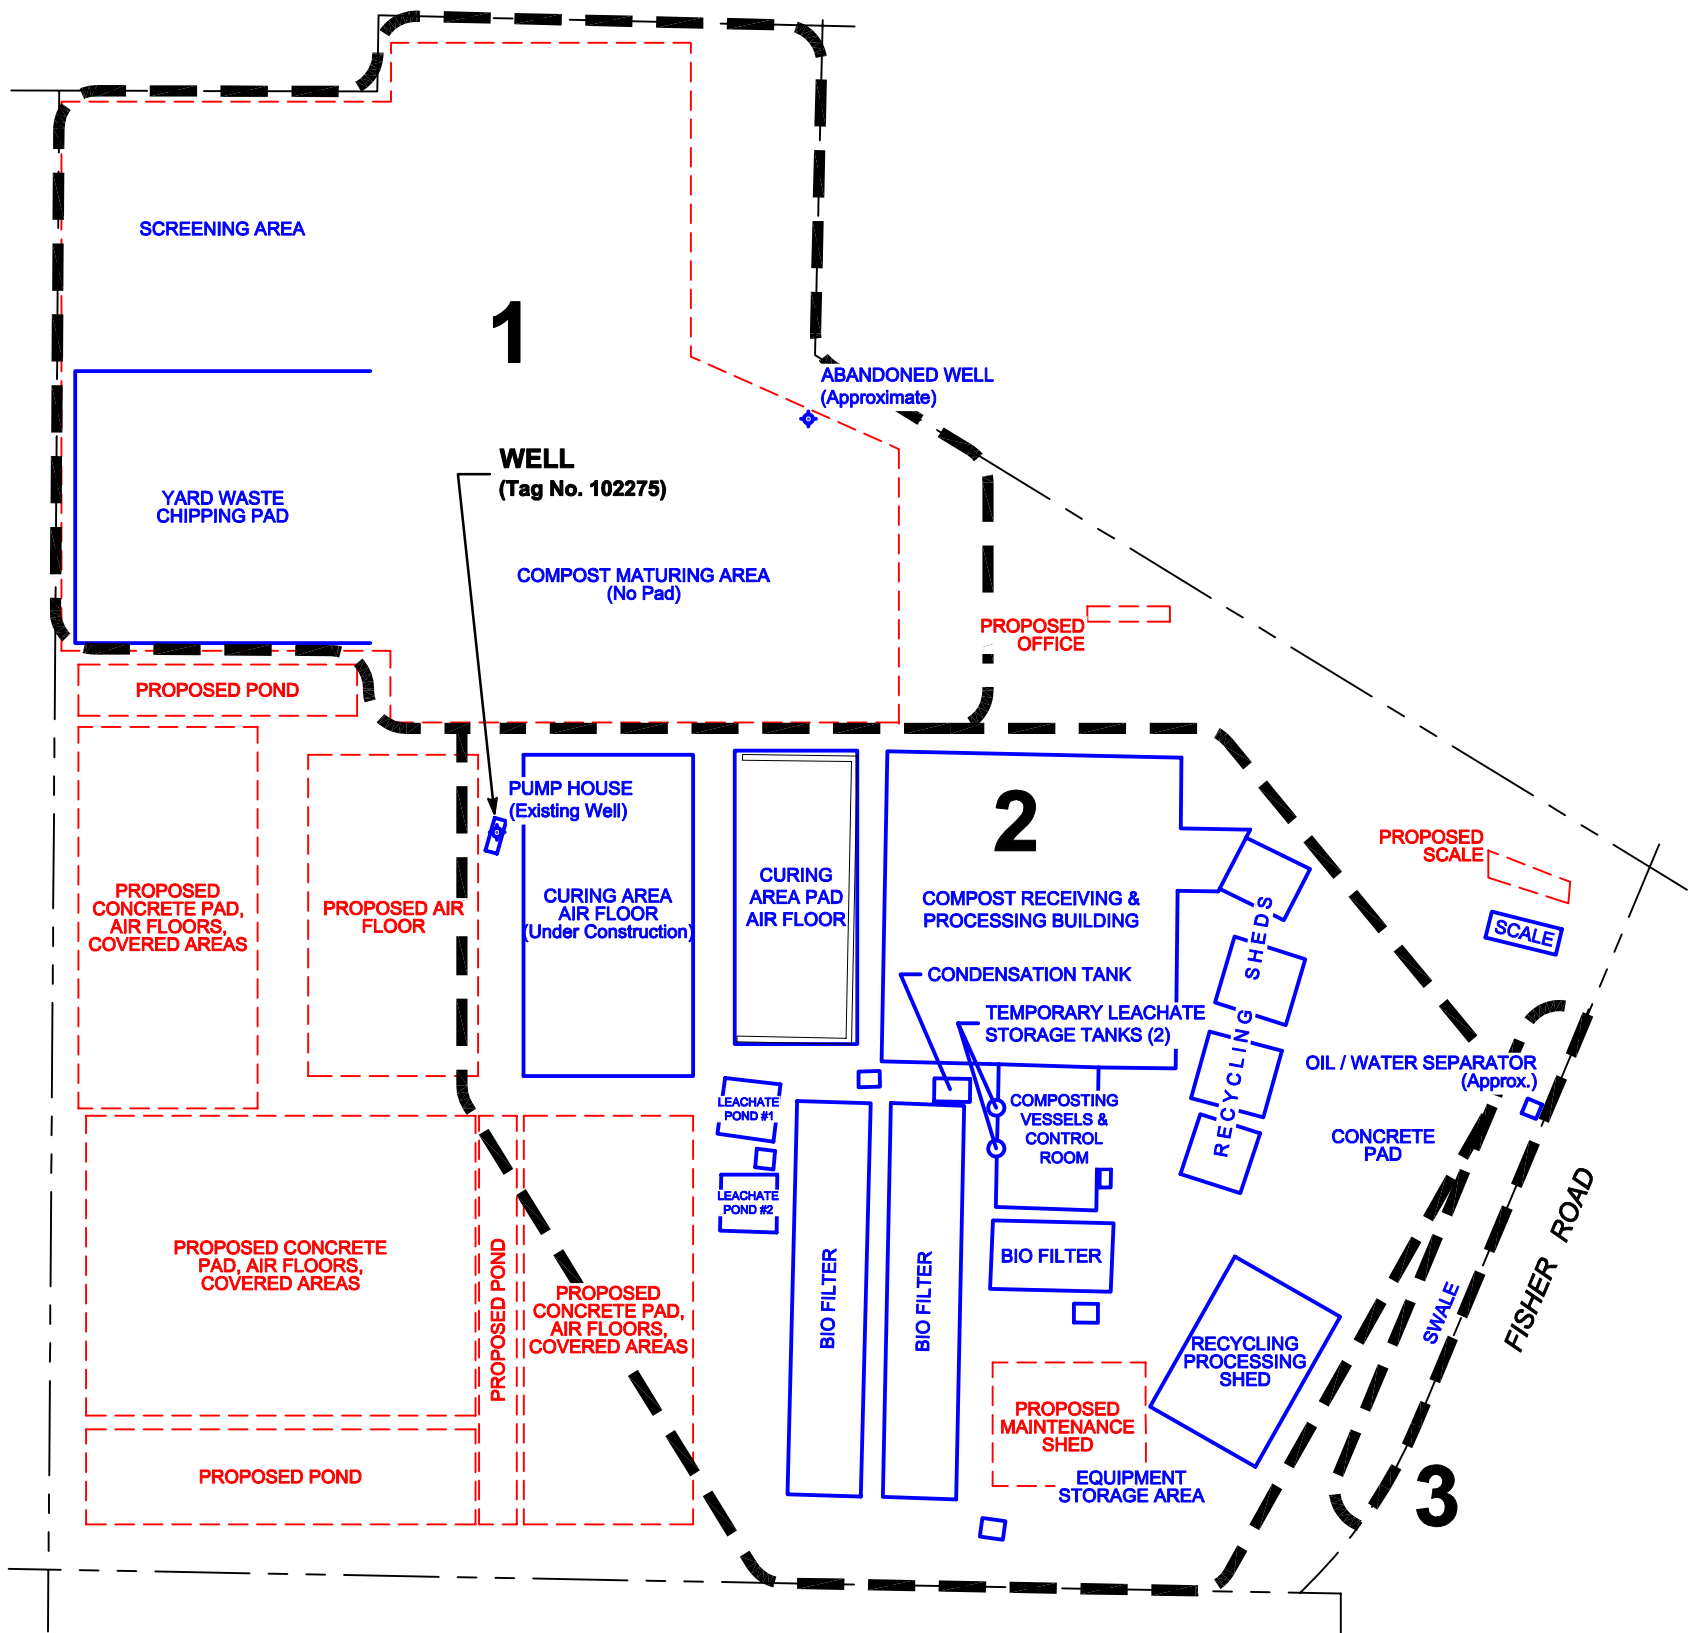
The findings of this report have led to the determination of areas of potential environmental concern (APEC) and primary potential contaminants of concern (PCOC) at 1355 Fisher Road. The PCOC noted are substances identified as potential contaminants under the CSR. The APEC and PCOC for the property at 1355 Fisher Road are summarized below in Table 4, and on Drawing 17-971-13-104 in Appendix A.

1. See report text for additional information.
2. PCOC relate to CSR Controlled Substances.

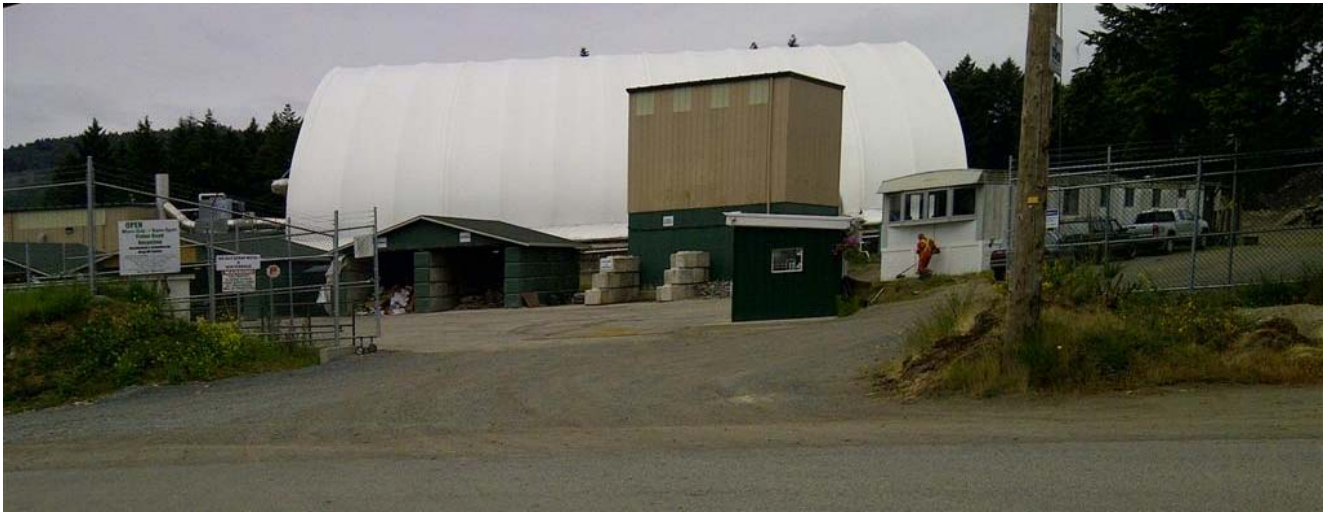
Photo 1: Looking northwest at the entrance from Fisher Road. The large white building is the compost receiving and processing building. The green buildings at left are storage bins for the recycling centre. The scale is in the foreground.

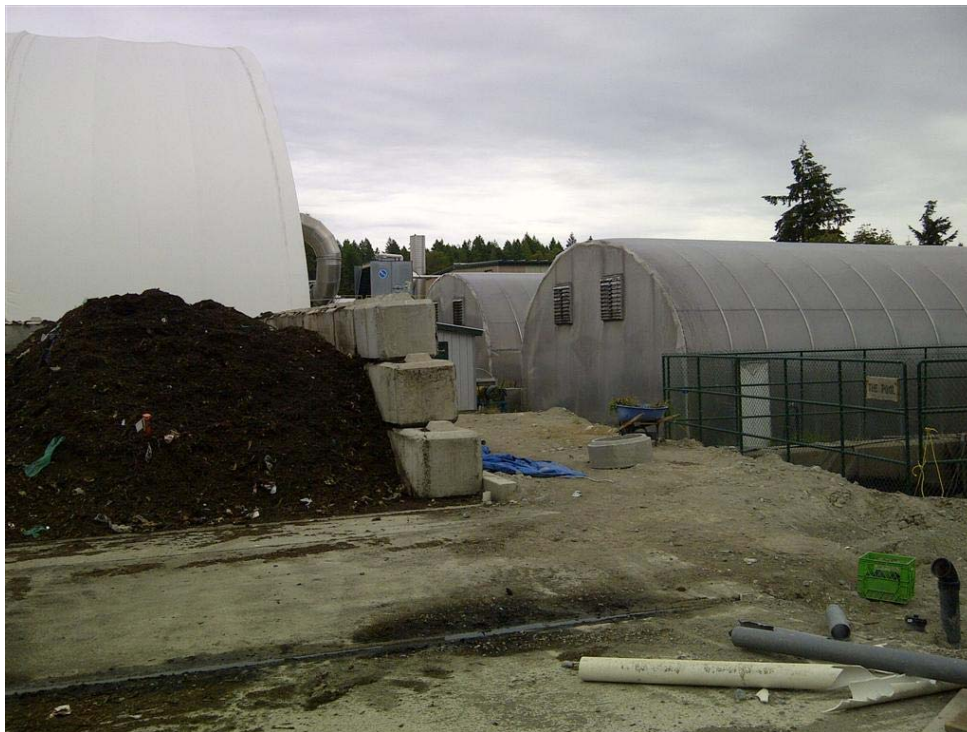
Photo 2: Looking southeast at the north end of two of the PVC covered bio-filter buildings (on right), with a portion of the south end of the outdoor curing pad air floor visible on the left and compost curing building behind. The fence on the right is for a leachate pond.

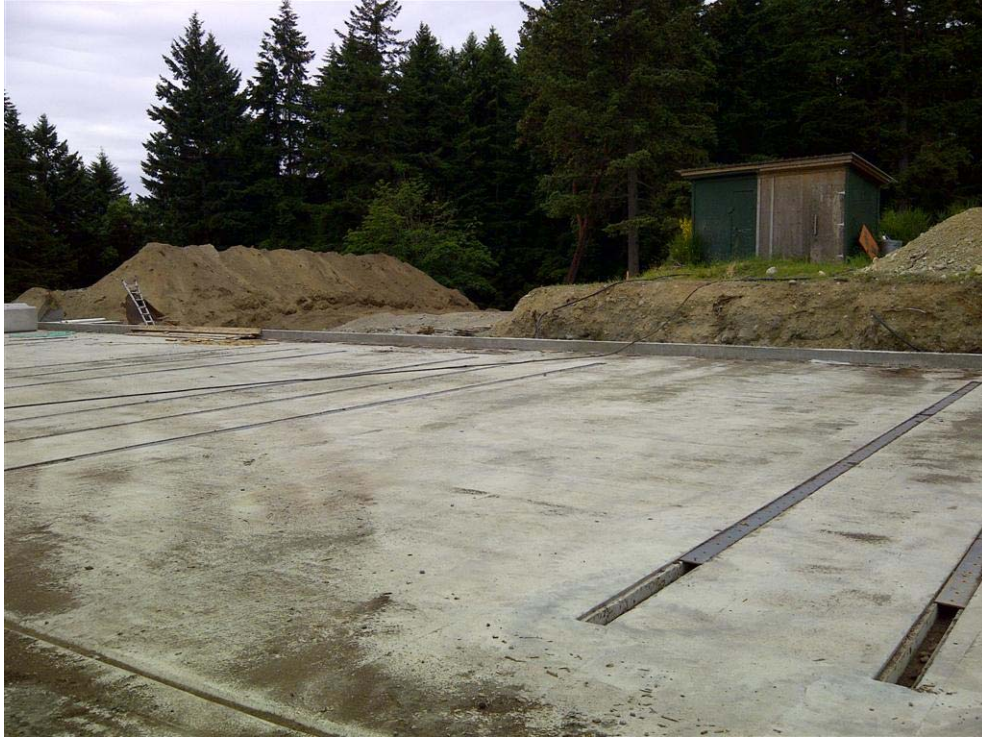
Photo 3: Looking west at the existing well shed (on right) with an air floor curing pad in the foreground.

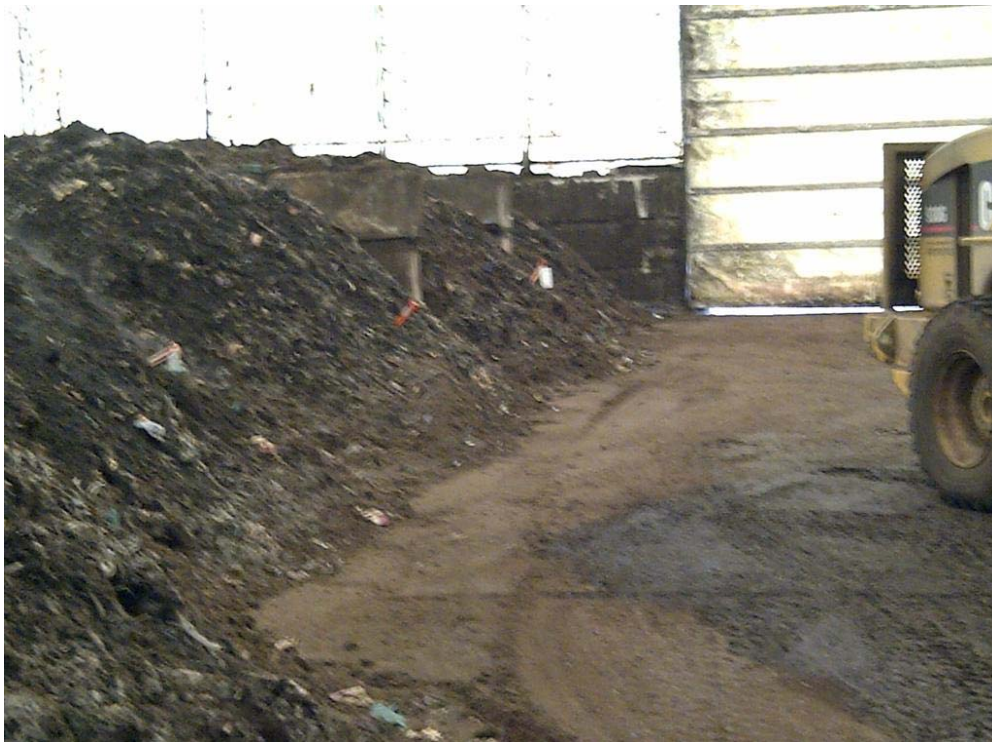
Photo 4: Secondary compost piles located inside the compost receiving and processing building.

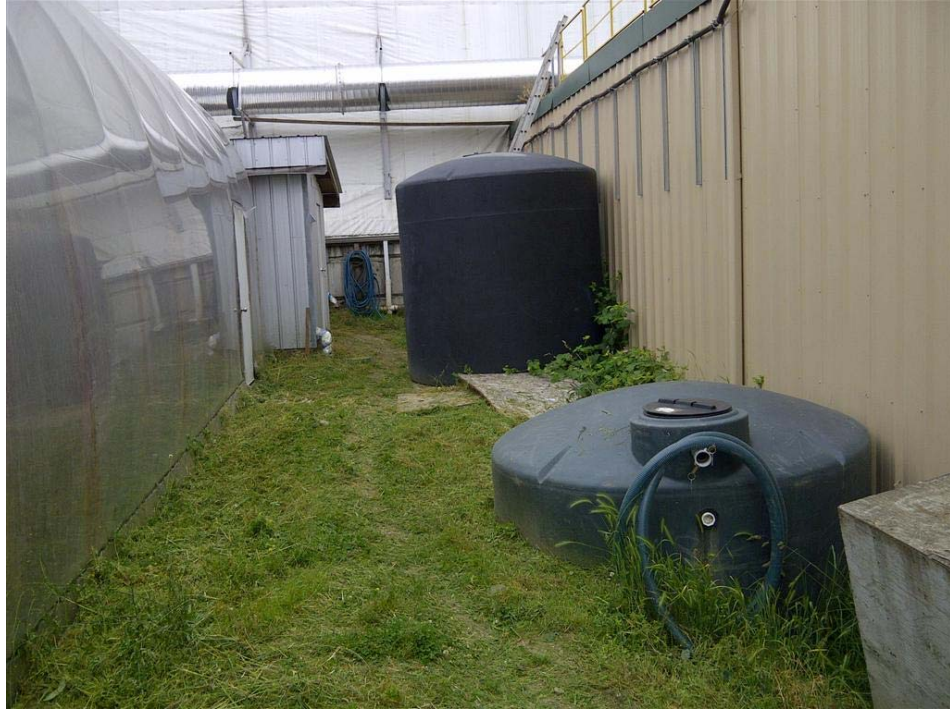
Photo 5: Looking north towards the compost curing (receiving) building with the composting vessels building on the right and bio-filter building on the left. The green tanks are used for temporarily holding any excess leachate generated in the vessels. The small shed (background left) holds a tank used to temporarily store and treat collected condensation water.

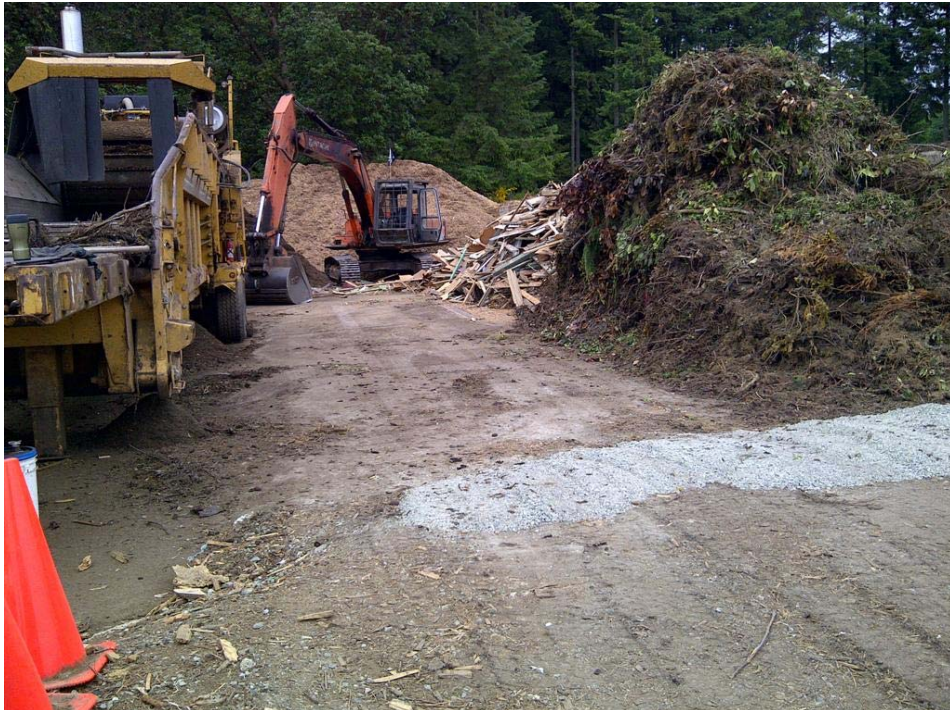
Photo 6: Piles of wood and garden waste in the chipping area. Area has a concrete floor and the storm water is collected.

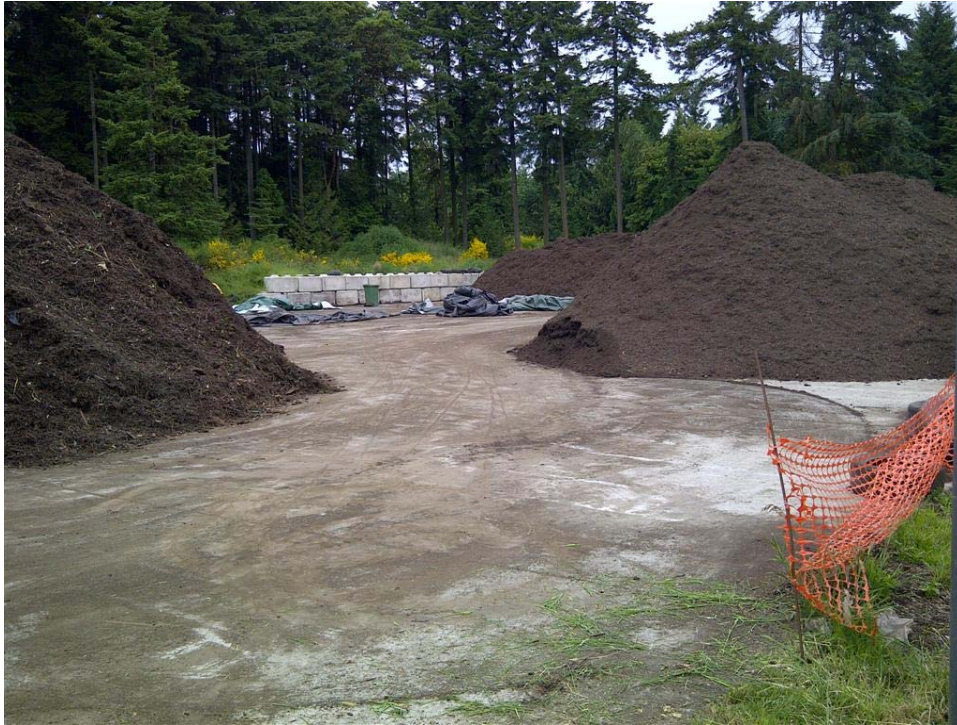
Photo 7: Piles in the screening area at the northwest corner of the site. Note concrete pad.

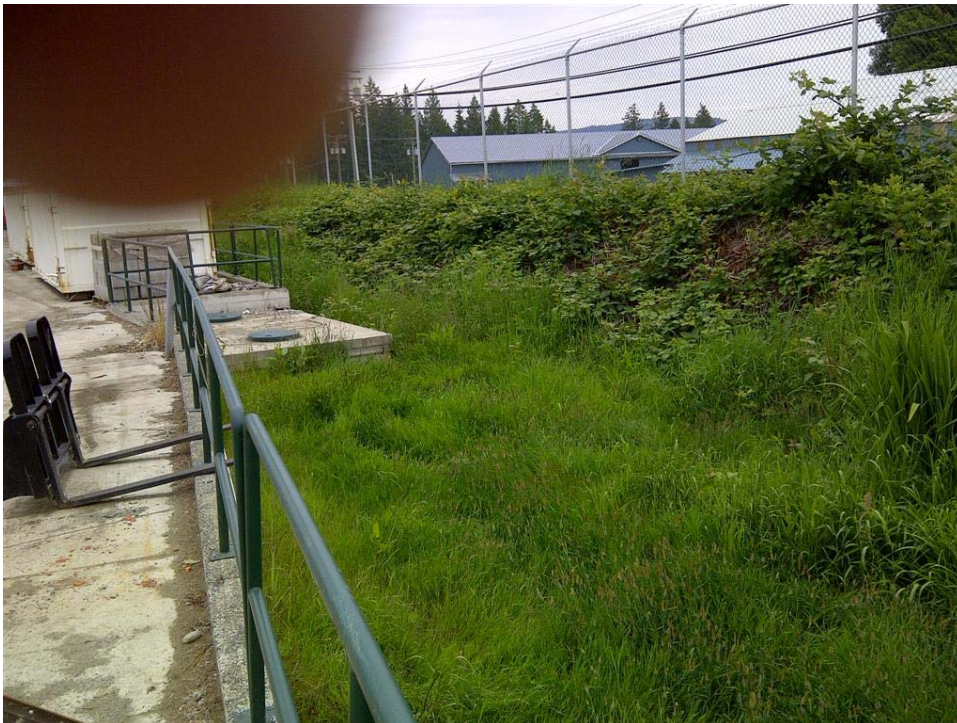
Photo 8: Swale area near the eastern property boundary. The edge of the recycling area pad is visible on the left with the oil/water separators visible at left.

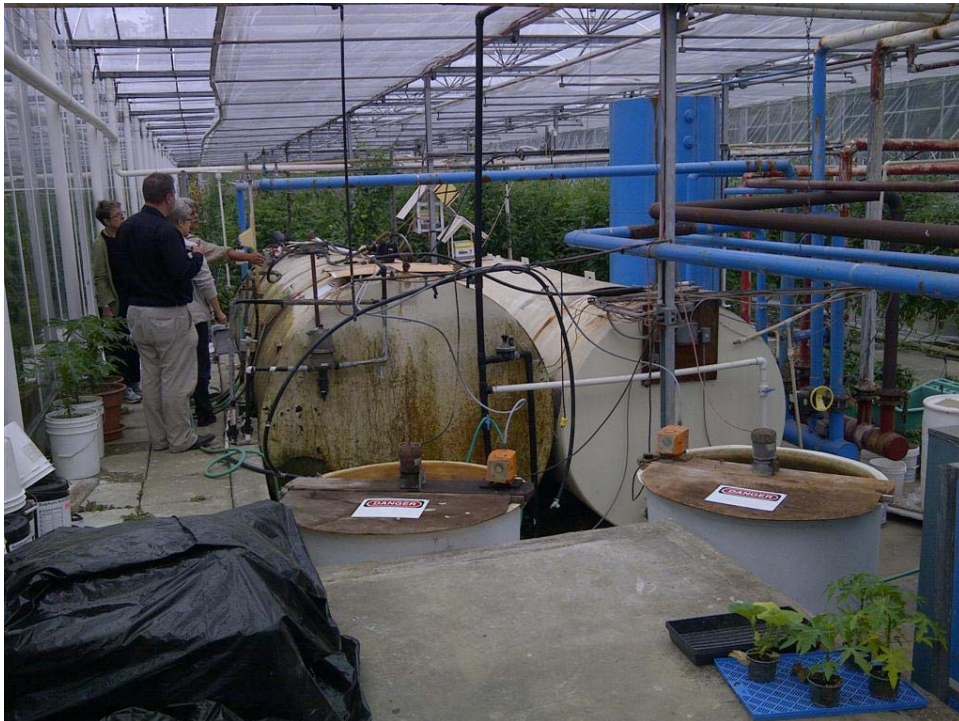
- It was observed that the watering storage tank, fertilizer mixing vessels and fertilizer products were located in the portion of the greenhouse underlain by a concrete slab (Photo 10).

Photo 10: Irrigation water holding tanks and mixing area at 1360 Fisher Road.

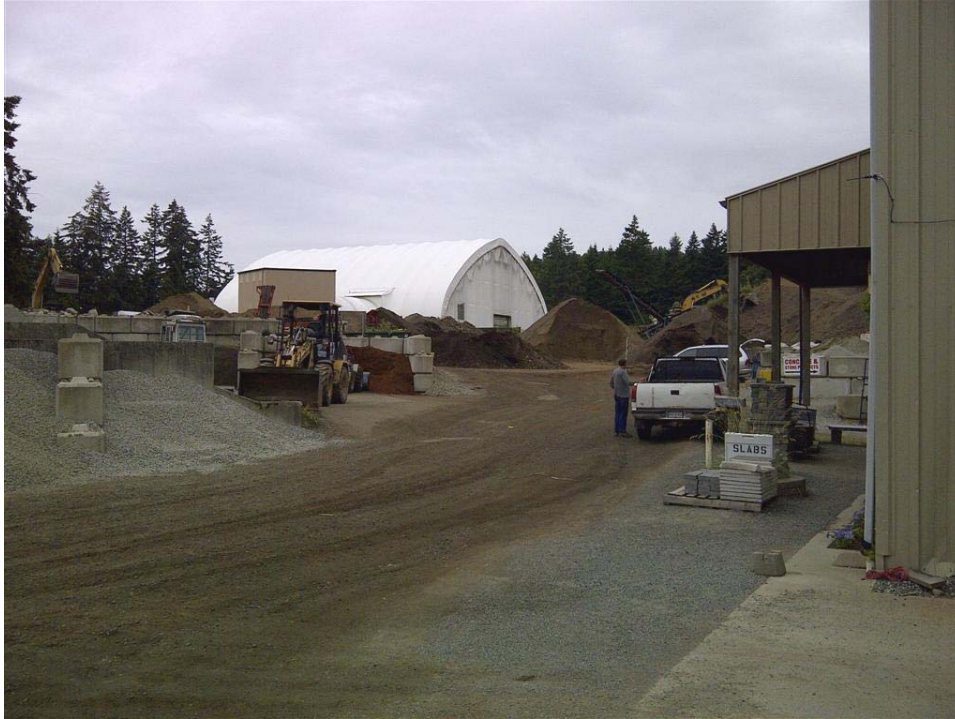
Photo 11: Looking west towards the stockpile holding and processing area at the central and west side of 1345 Fisher Road. The large white building in the distance is the compost receiving building at 1355 Fisher Road.

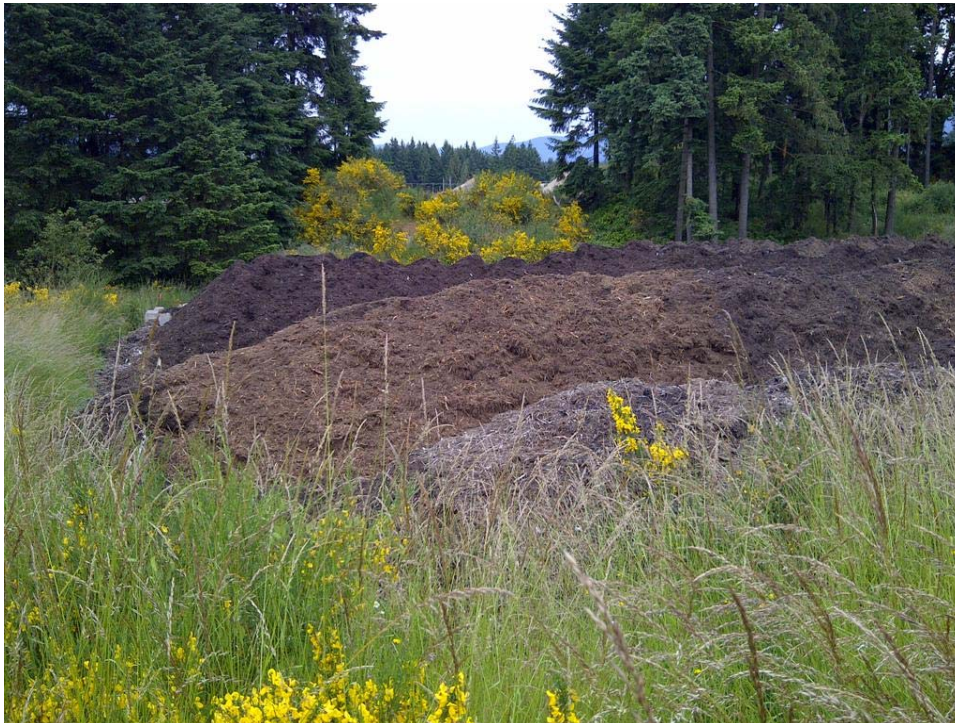
Photo 12: Looking east at maturing compost piles located at the western end of the property at 1345 Fisher Road from near the western property boundary with 1355 Fisher Road.
