Baseline Ecological Assessment Bright Angel Park

November 16, 2012

Dossier 12.0320

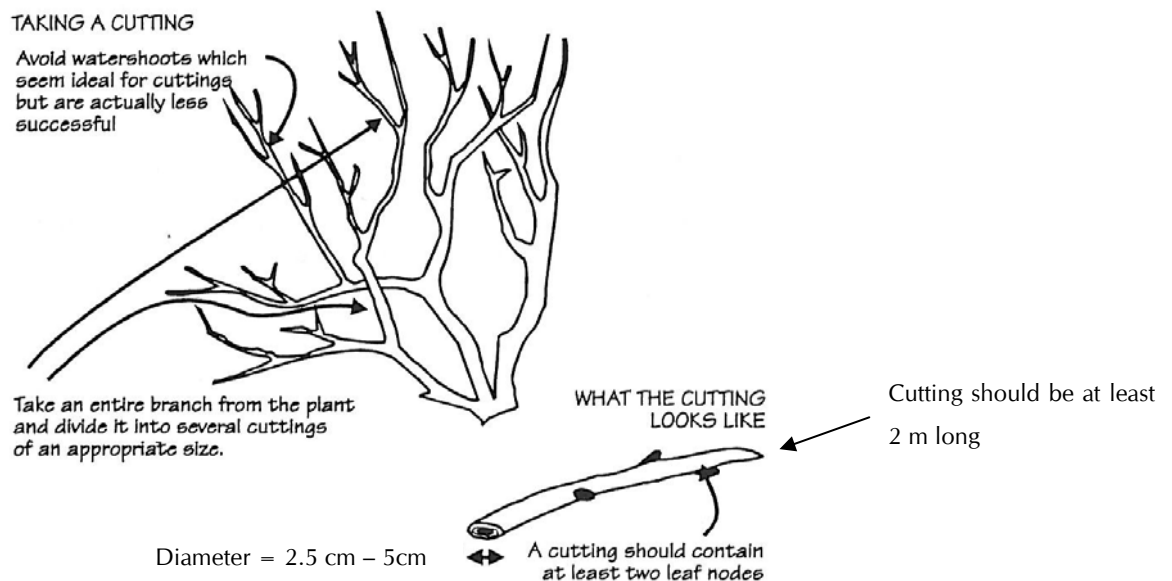
Figure 4. Procedure for taking live stake cuttings from donor plant. (Figure modified from Streamkeepers Handbook, 1995¹).

Live staking uses species such as willow, black cottonwood and red-osier dogwood. When planting cuttings (live stakes), the planting density should be relatively high, with less than 50 cm between each cutting. Live stakes should be at least 2 m long with a diameter of at least 2.5 cm, and all sucker growth must be removed at time of harvest (Figure 4). Areas treated for invasive species removal in Polygon 2 will likely be well suited to the growth of species such as willow and cottonwood, based on the relatively high moisture content of the soil. Red osier dogwood may not be as well suited to this area, as only isolated occurrences were noted in moister depressions.

Stakes should be bundled and soaked in running (oxygenated) water for at least 24 hours prior to being planted. Stakes must be inserted into the ground to a depth of at least 1 m. To help achieve this depth requirement, a hole must first be prepared using a heavy metal bar, into which the stake is inserted. It is of paramount importance that adequate planting depths are achieved, to ensure that the plants become established.

To achieve successful growth, the stakes should ideally be harvested prior to the donor plant breaking dormancy in the spring. Stakes can also be harvested in the fall, after the majority of the leaves have dropped.

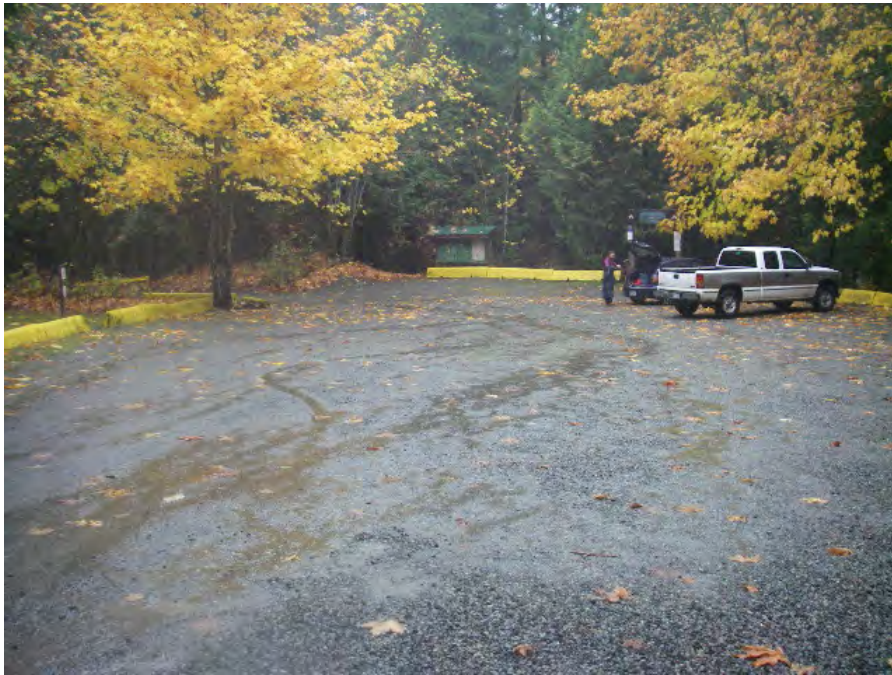
Looking north over the lower parking area at the potential location for the new wash room building.

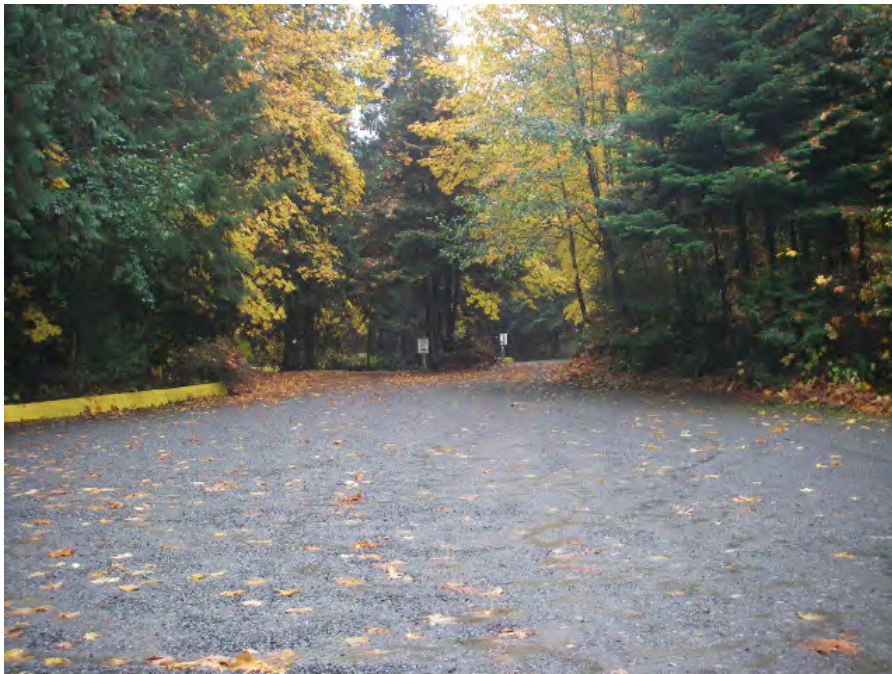
Looking south over the lower parking area at the potential location of the new wash room building.

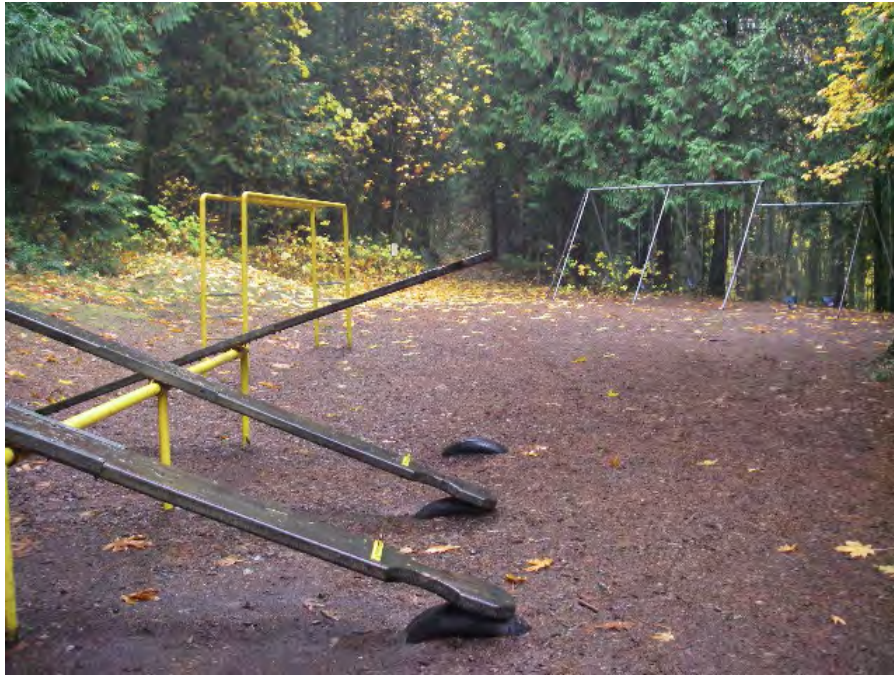
Existing children's playground. Options include placement of a new playground in this area and/or outdoor fitness circuit equipment.

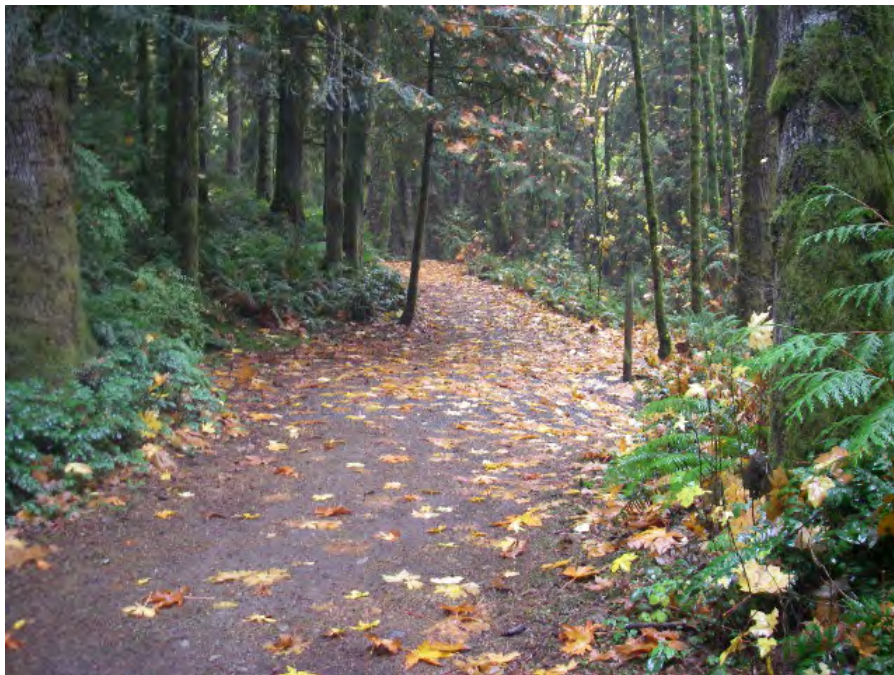
Example of part of the main circular trail to the north west of the lower parking area. The surfaces of these main trails would be upgraded with pea gravel as part of the proposal.

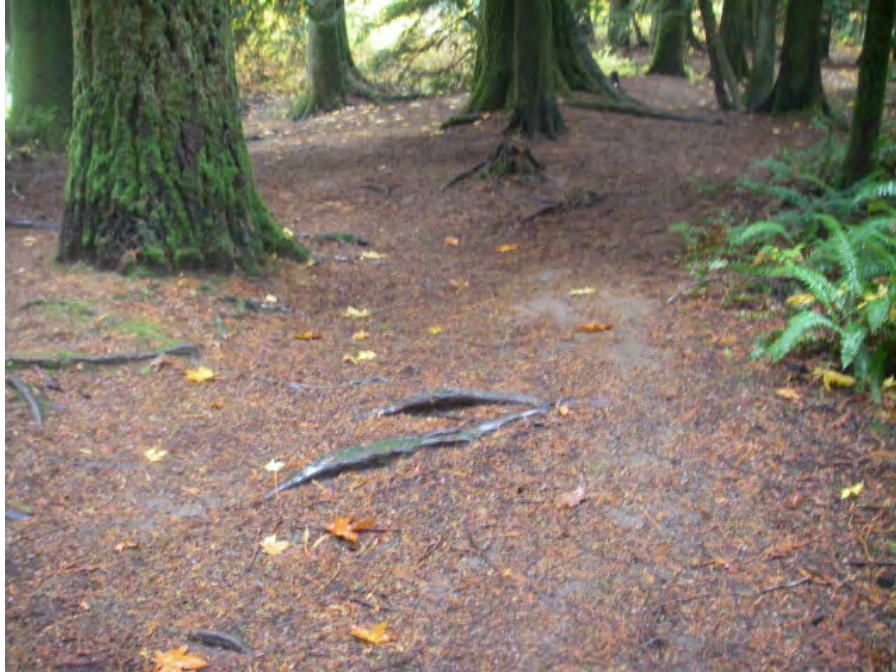
Existing surface of the trail running along the eastern side of the Koksilah River. Note broad area of disturbance from foot traffic and resulting exposed tree roots. The trail should be better defined and re-surfaced, to protect the exposed roots and prevent further degradation.

The gravel surfacing proposal would prevent impacts to tree roots associated with trampling (e.g. root exposure) once the trails are complete. On existing trails, the planned surfacing upgrades will help prevent damage to tree roots, which is currently occurring as a result of foot traffic. Exposed roots, worn down from the action of trampling, were noted along the trail on the eastern side of the river. The addition of a gravel surface will cover these roots, and provide a protective barrier from foot traffic.

The proposed trail upgrades will allow for the existing trail network to be defined, which will help reduce the impact of foot traffic in sensitive areas (e.g. along the eastern side of the Koksilah River). At present, there is no real defined “trail” along the eastern side of the river, and a broad area of disturbance has resulted. For example, trampling has worn down the substrate and exposed tree roots, which are now subject to degradation. Placing a gravel surface in this area will help define the trail, while also helping to cover and protect tree roots that are currently exposed.

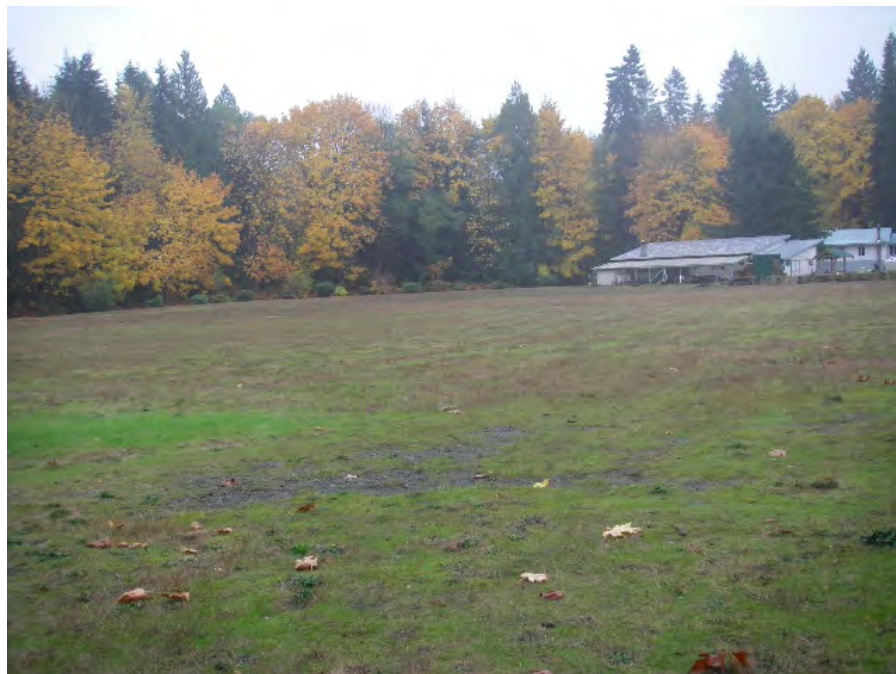
Looking south-east over the open field and the caretaker's residence. Part of the proposed upgrades would involve improving the surface of the field (e.g. leveling).

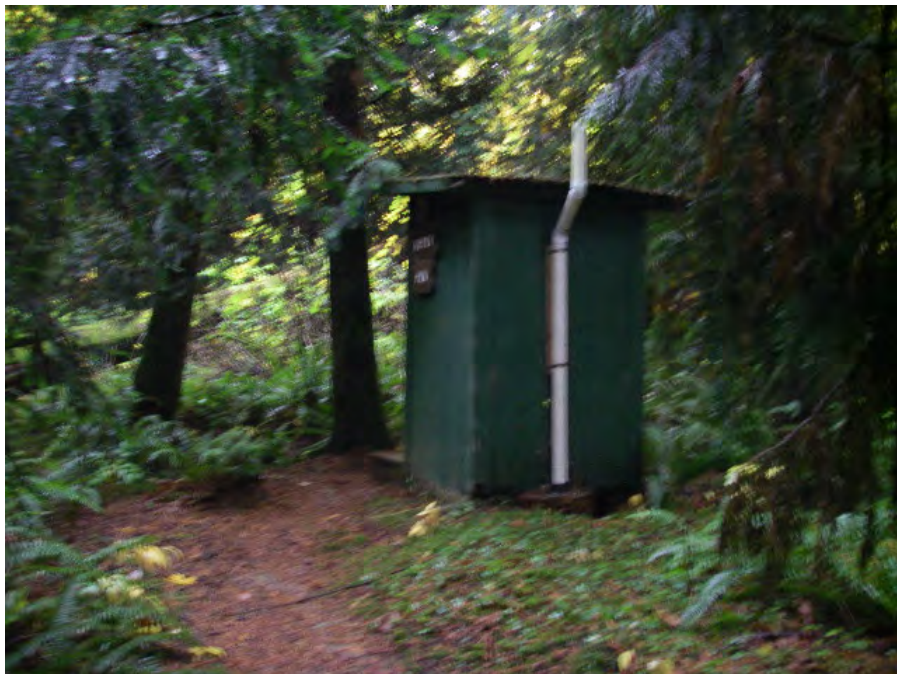
Example of a pit toilet in the park. Part of the planned upgrades would involve the removal of these structures, with replacement facilities provided as part of the new wash room building (including installation of a new septic system).

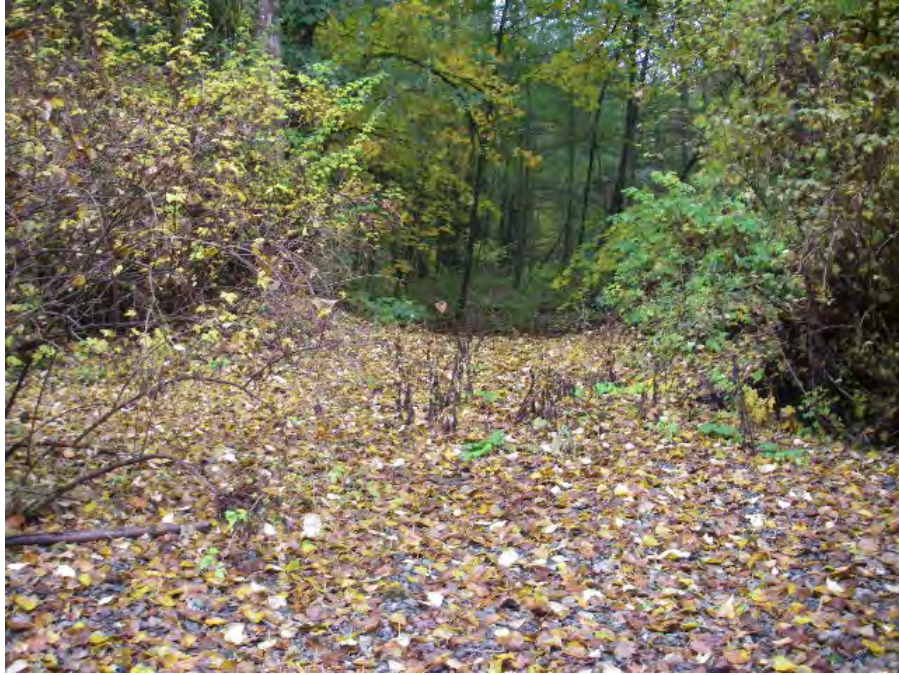
Looking west from the gravel substrate of the Koksilah River towards the opening through the riparian area where the proposed new dog trail would access the river.

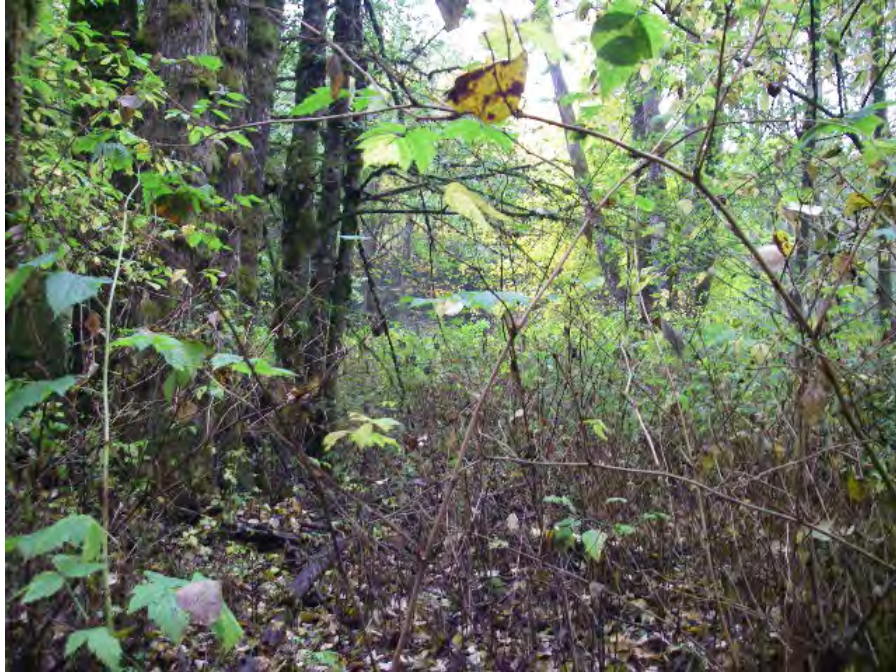
Typical dense shrub vegetation located throughout the southern portion of Polygon 2, where the proposed new dog trail would be constructed.

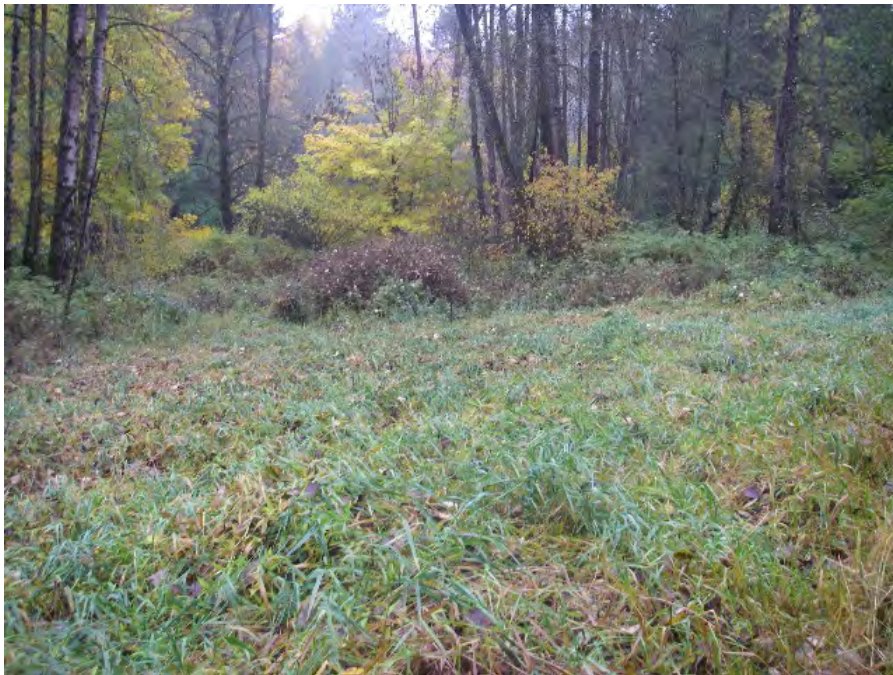
Reed canary grass in open areas throughout the central and northern portions of Polygon 2. The potential phase 2 extension of the dog access trail would be constructed through this area, allowing an alternate route back to the parking area.

Reed canary grass was also noted, although there are differing opinions as to whether this species is considered as an introduced species, or whether it is indigenous to some coastal areas and has extended its range as a result of human influences, such as agriculture (Pojar and MacKinnon 1994). Under Section 2 of the provincial Weed Control Act:

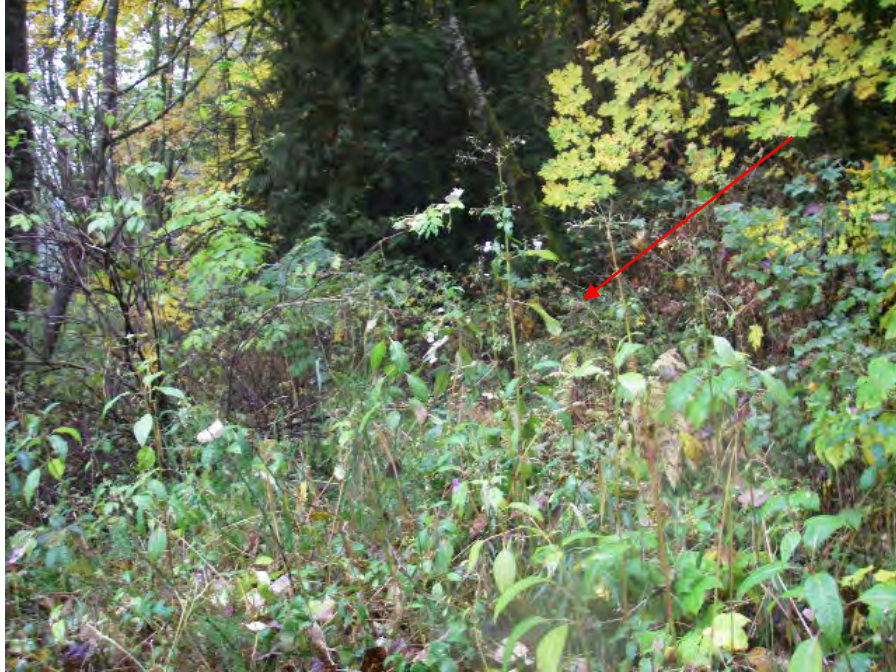
Policeman's helmet (Himalayan balsam) occurred frequently through Polygon 2, especially in the more open areas.

The proposed trail work introduces the potential opportunity to manage invasive plant species. Several introduced/invasive species were noted (especially in open areas in Polygon 2) during the assessment (e.g. Canada thistle, Japanese knotweed, common burdock, perennial pea vine, Himalayan balsam and Himalayan/European blackberry). Of these species, the Japanese knotweed and Canada thistle are considered noxious weeds under Schedule A of the provincial Weed Control Regulation:

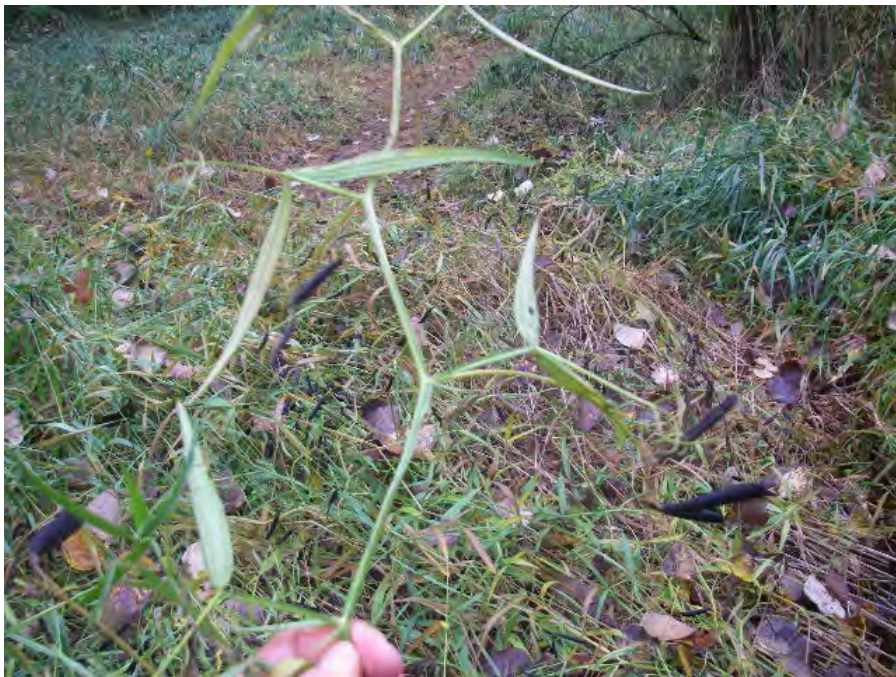
Perennial pea vine found throughout open areas in Polygon 2.

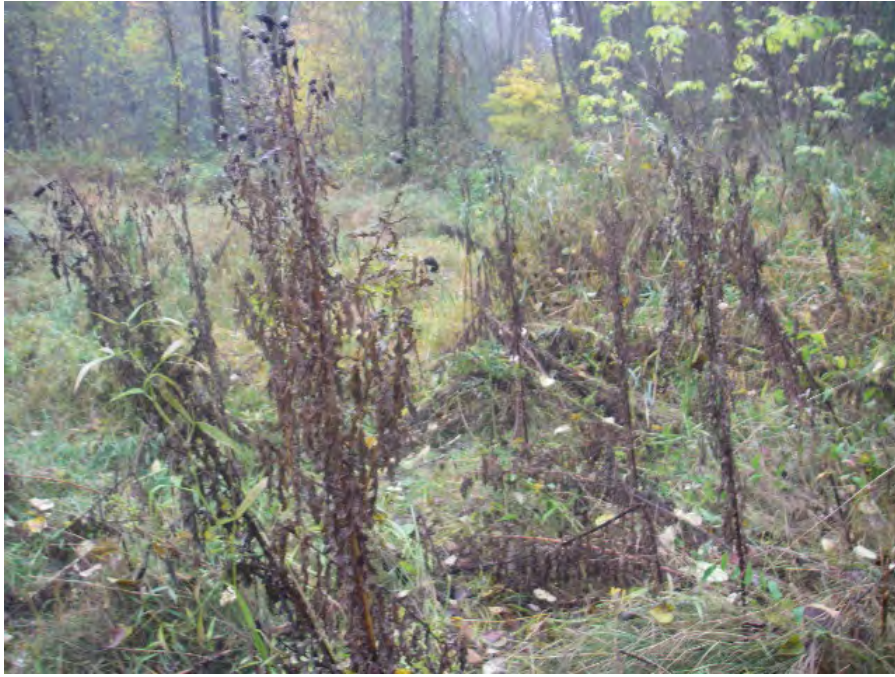
Canada thistle found throughout open areas of Polygon 2.

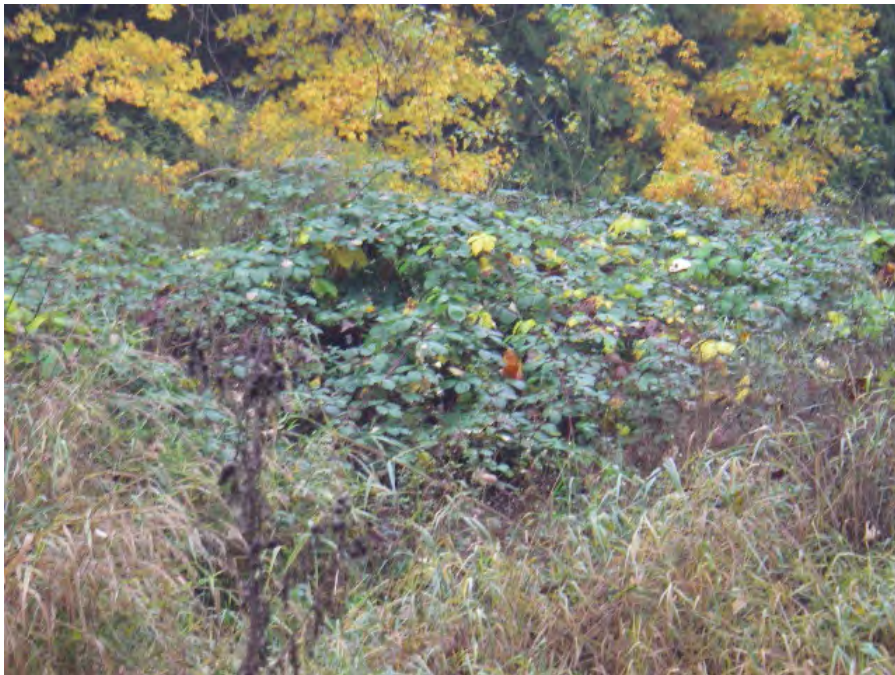
Example of Himalayan blackberry thicket found in Polygon 2.

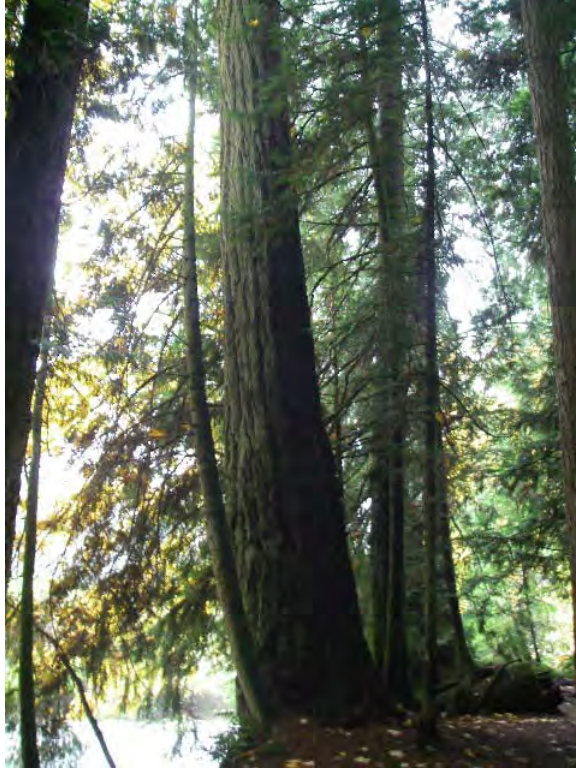
Veteran Douglas-fir in the immediate riparian area of the Koksilah River – Polygon 1 (mature riparian forest).

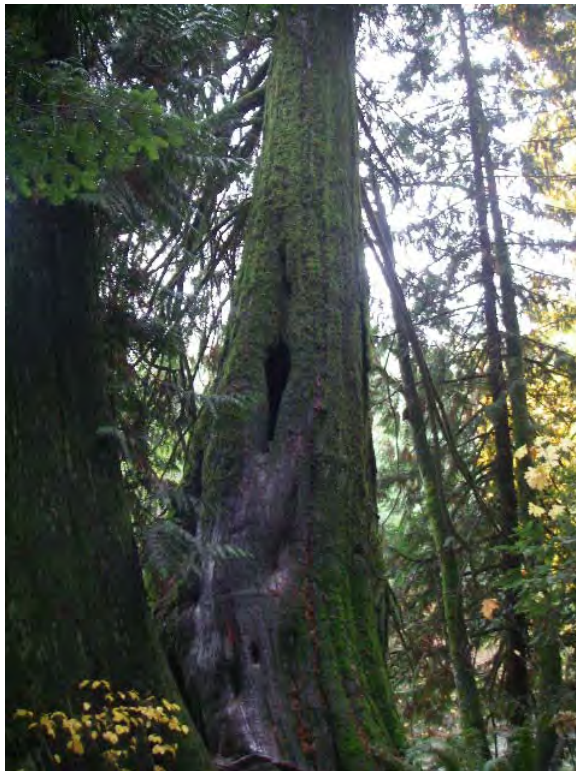
Veteran western redcedar in the immediate riparian area of the Koksilah River – Polygon 1. Note occurrence of natural cavities in the tree, providing nesting opportunities for bird and roosting habitat for bats.

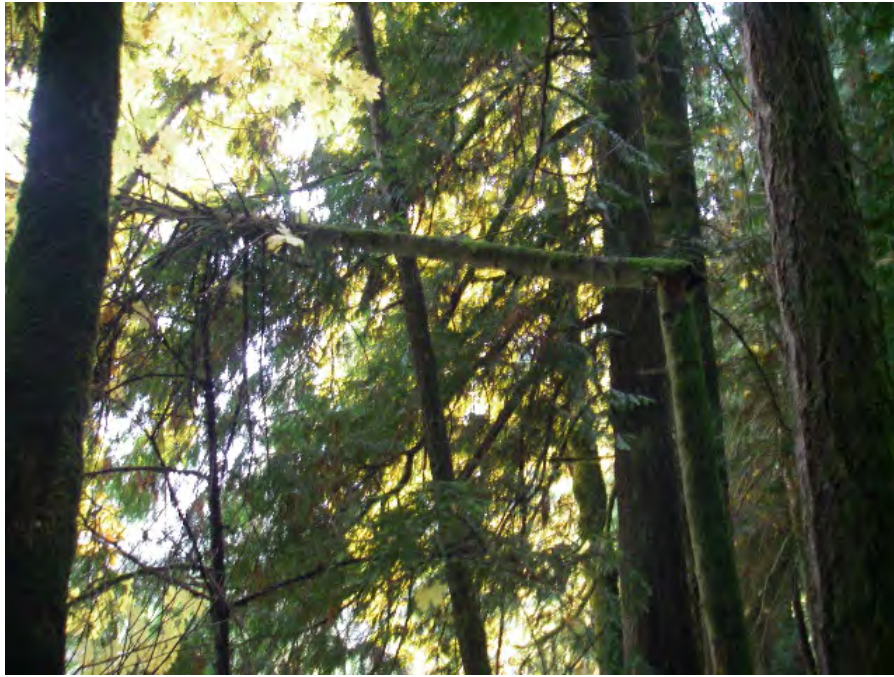
Broken top of small conifer resting on the top of a Pacific yew – immediate riparian area of the Koksilah River (Polygon 1). Removing this top from the yew tree may increase the health and survival chances of the yew.

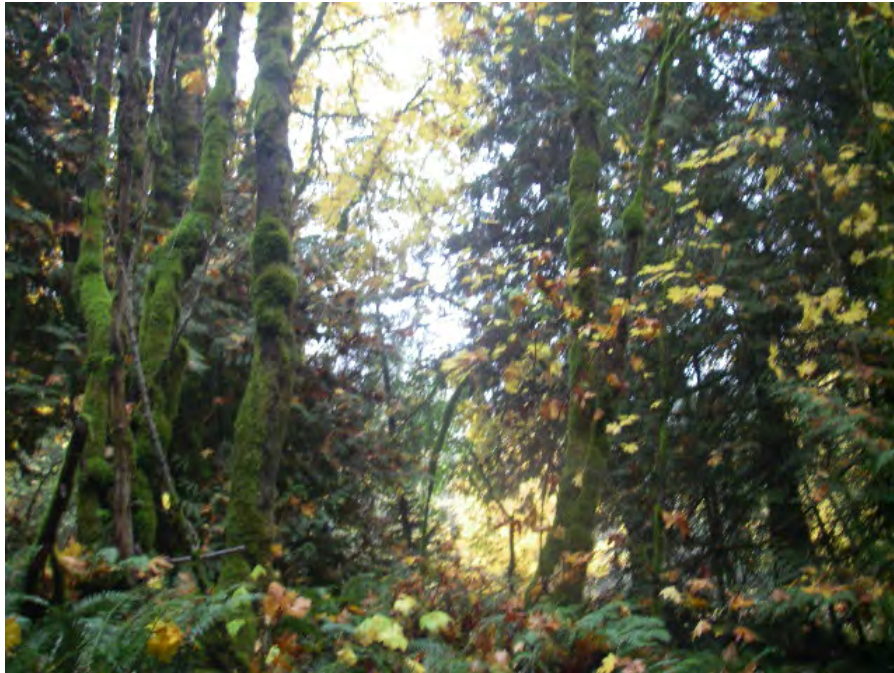
Typical composition of the western redcedar-bigleaf maple forest found throughout the majority of Bright Angel Park (Polygon 3).

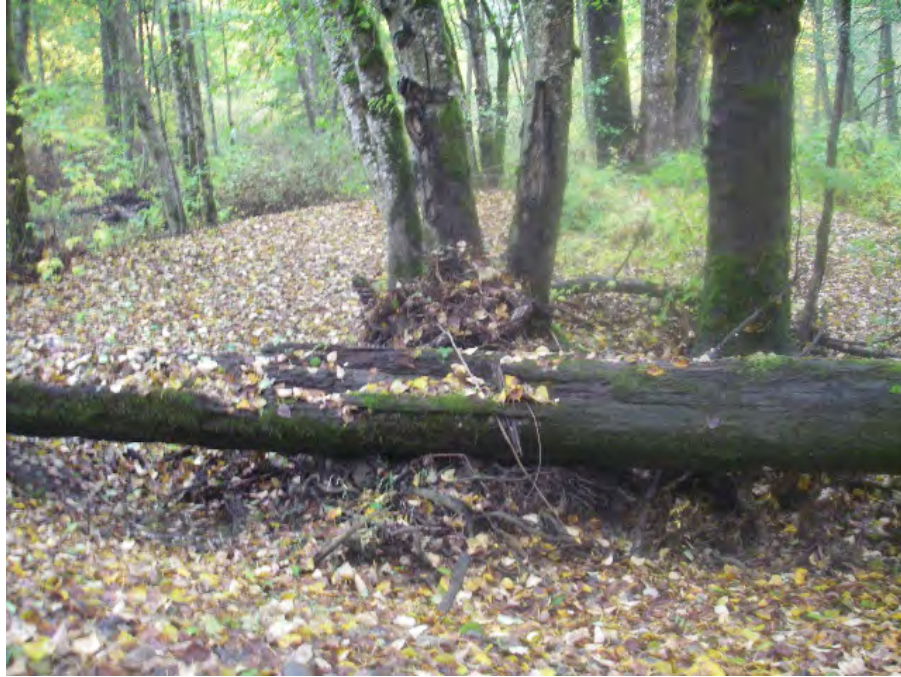
Example of flood rafted debris and seasonally inundated channels throughout the active floodplain found in Polygon 4.

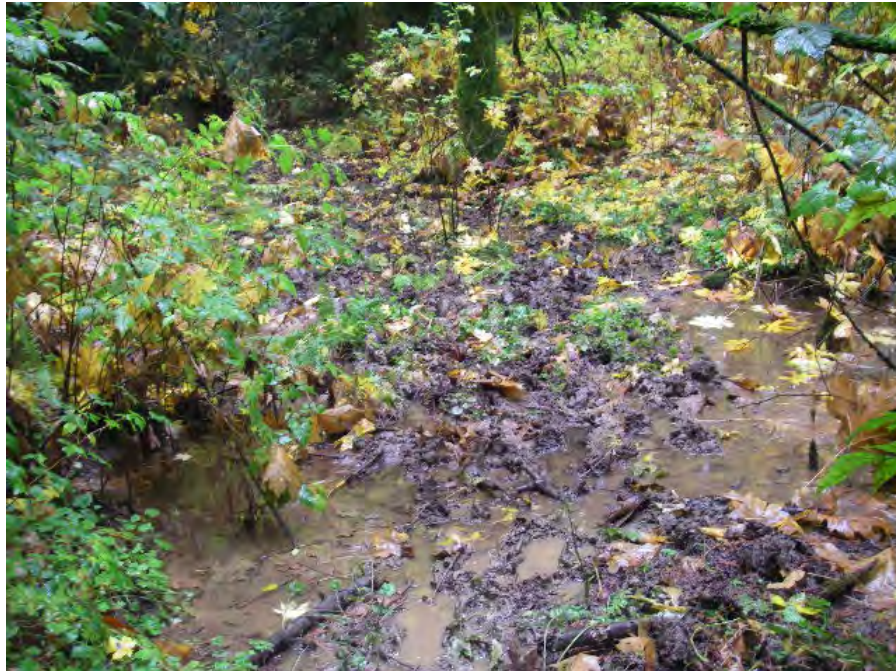
Moist seepage area flowing along the base of the slope in the northern portion of Polygon 1. Note considerable use of this area by ungulates (deer and elk).

Consideration may be needed for appropriate vegetation management techniques if the proposed loop extension is added to the existing trail along the eastern side of the river. As per Figure 3, the trail would cross a very moist seepage area and small stream, if constructed in the proposed location. If an alternate route cannot be identified, a raised boardwalk is recommended to avoid any potential impacts

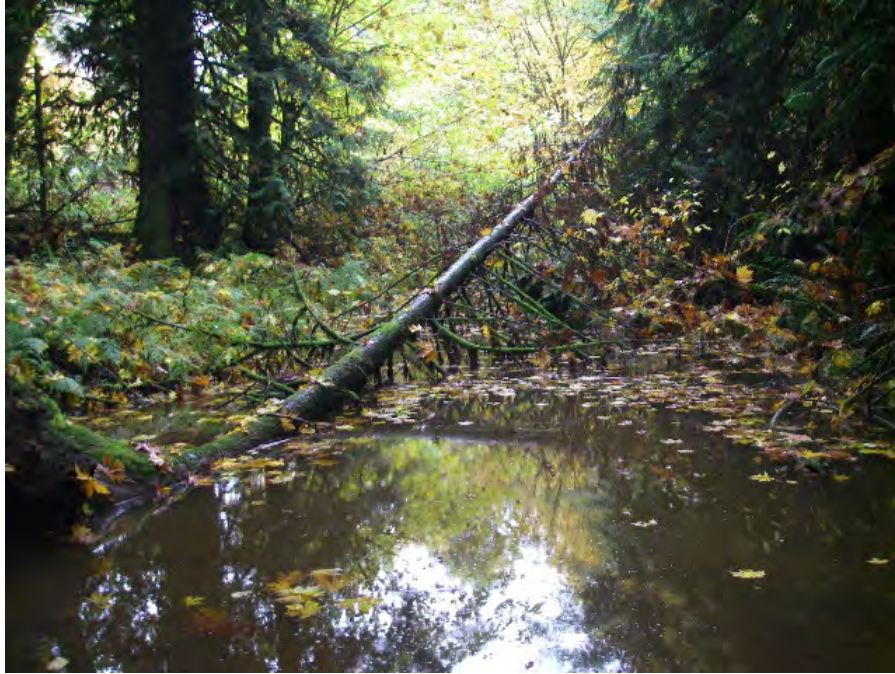
Seasonally-inundated depression located along the seepage area pictured above. Depression such as this will provide potential breeding opportunities for amphibians which are able to complete the metamorphosis from tadpole to adult relatively quickly (e.g. Pacific chorus frogs)

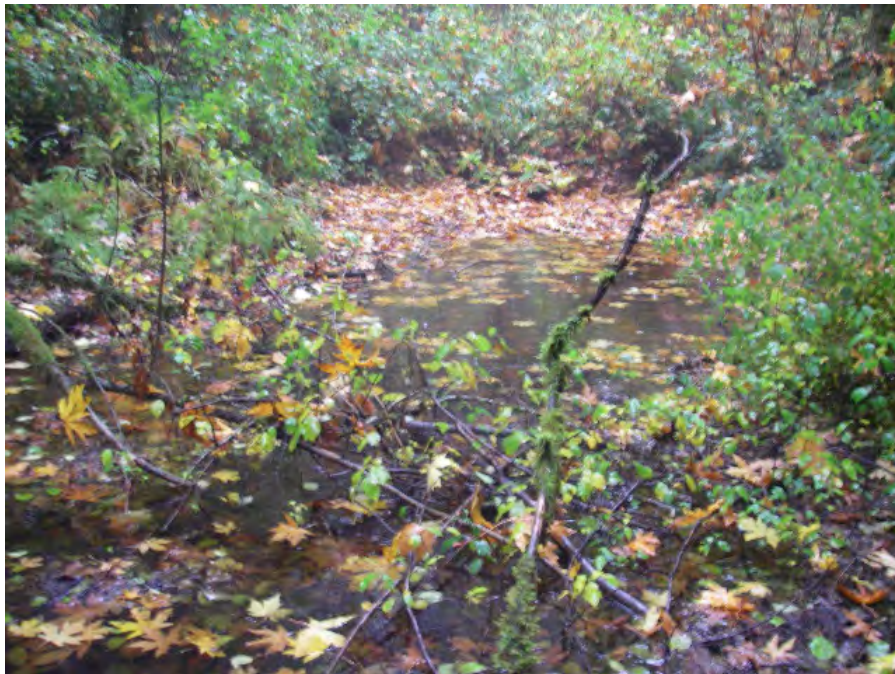
Example of seasonally-inundated depression located in the southern portion of Polygon 3.

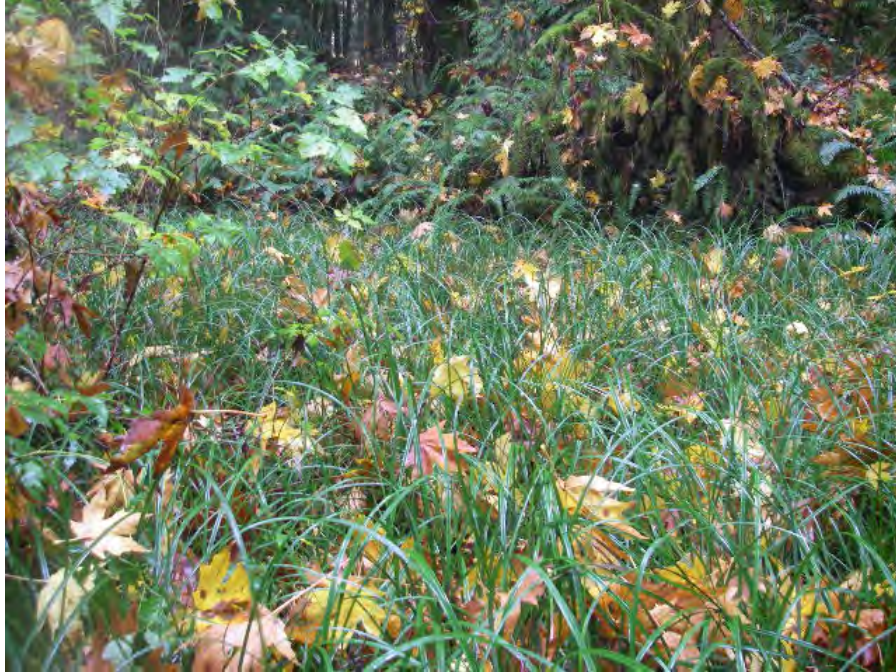
Dense slough sedge growth in the wetland located close to assessment plot 5.

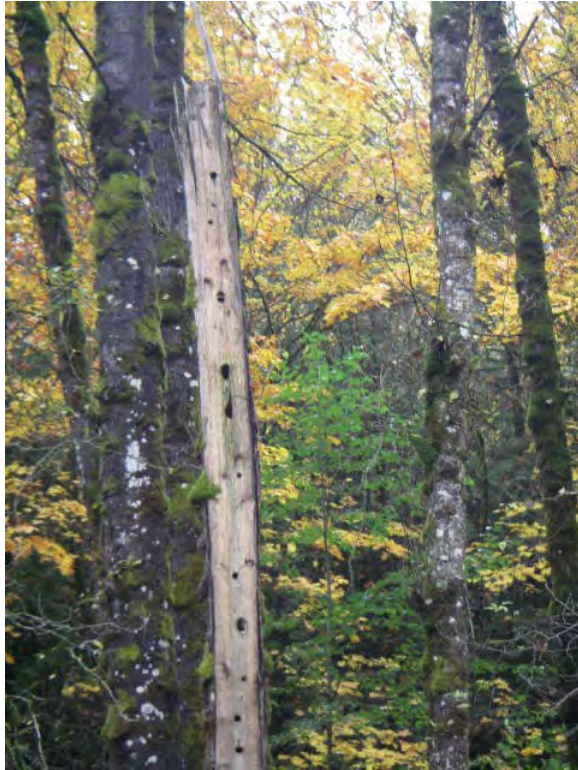
Wildlife tree located in Polygon 2. Note abundance of cavities available for cavity-nesting birds.

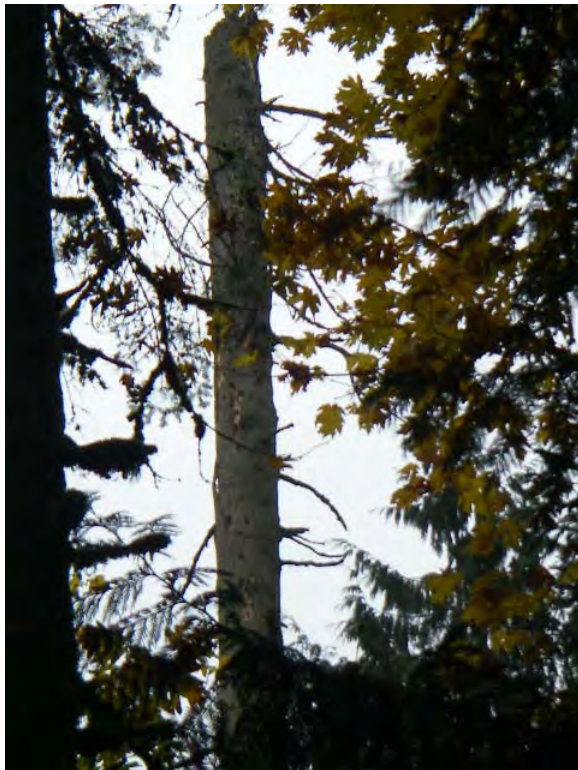
Wildlife tree with evidence of woodpecker feeding activity found near assessment plot 5.

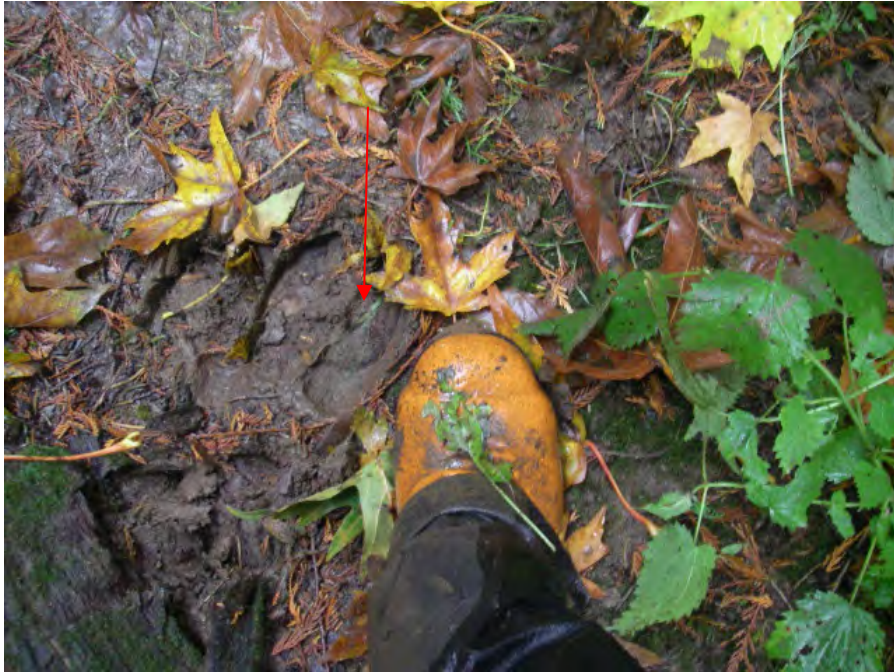
Trails and pellets from Columbian black-tailed Deer (a focal species) were encountered throughout the study area, but most frequently in openings associated with Polygon 2. Defined fresh tracks from another focal species (Roosevelt elk) were observed in and around the moist seepage area located in Polygon 1, likely representing animals from the Dougan lake herd. A Northern red-legged frog (also a focal species) was observed in Polygon 2. An adult western toad (a focal species) was observed by the client in Bright Angel Park during the summer of 2012, further highlighting the value of the study area as forage habitat for native amphibians. Numerous Pacific chorus frogs were heard calling throughout the study area during the assessment. Beaver (*Castor canadensis*) sign in the form of old tooth marks on a bigleaf maple stump was also observed (Polygon 1).

Elk print found close to the moist seepage area in the northern portion of Polygon 1.

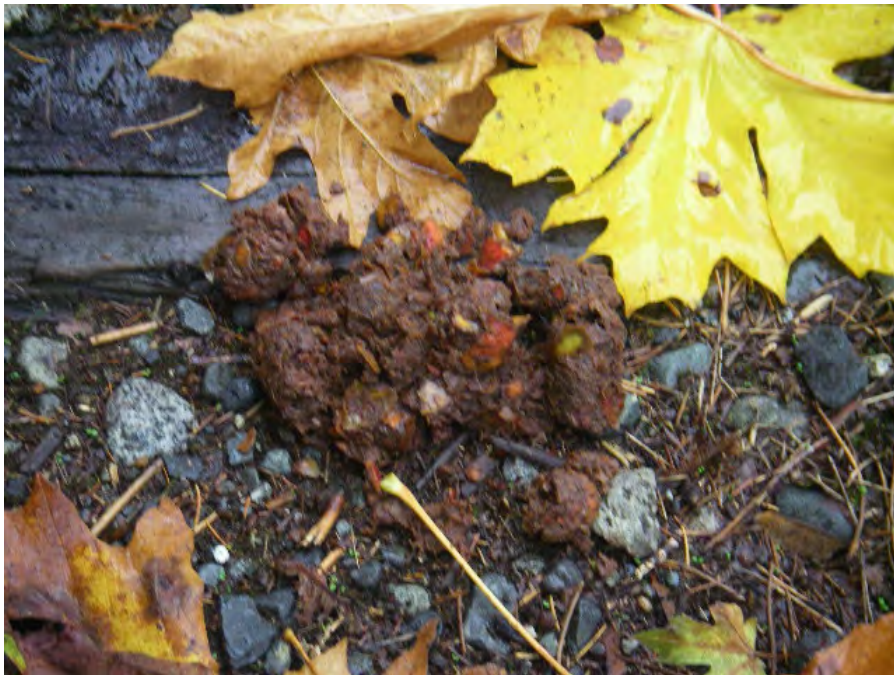
Black bear scat (a focal species) was found along the railway corridor adjacent to the eastern park boundary. The content of the scat was typical for the time of year, consisting mainly of partially digested apples.

Black Bear scat containing apple remains found on the railway tracks adjacent to the eastern boundary of the park.

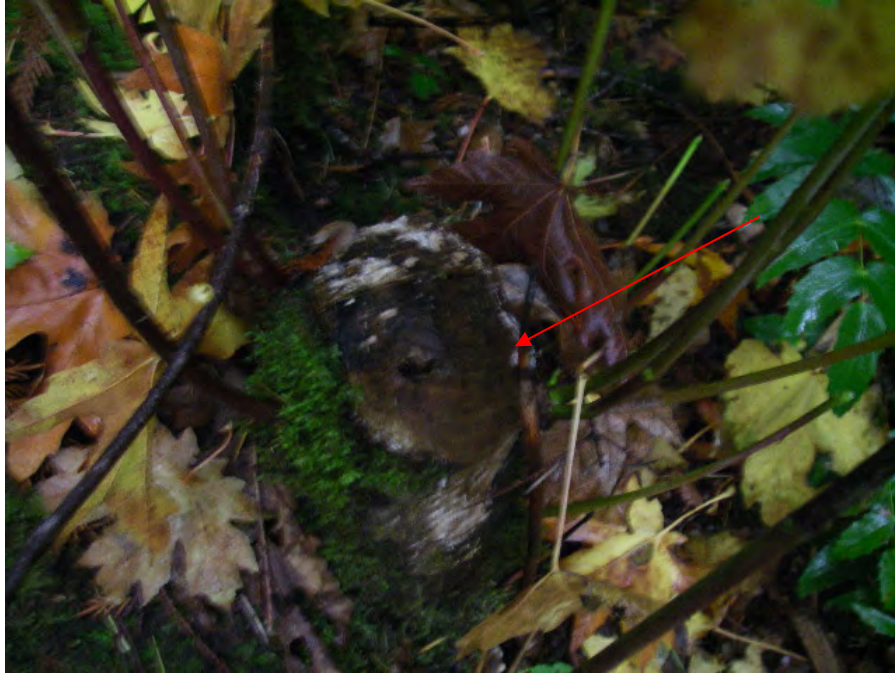
Old beaver tooth marks on a bigleaf maple stump located close to the Koksilah River in Polygon 1.
