Fisher Road Groundwater Investigation Data Review Report

Cobble Hill Aquifer Interagency Task Group

December 18, 2018
Project: 18-052-01

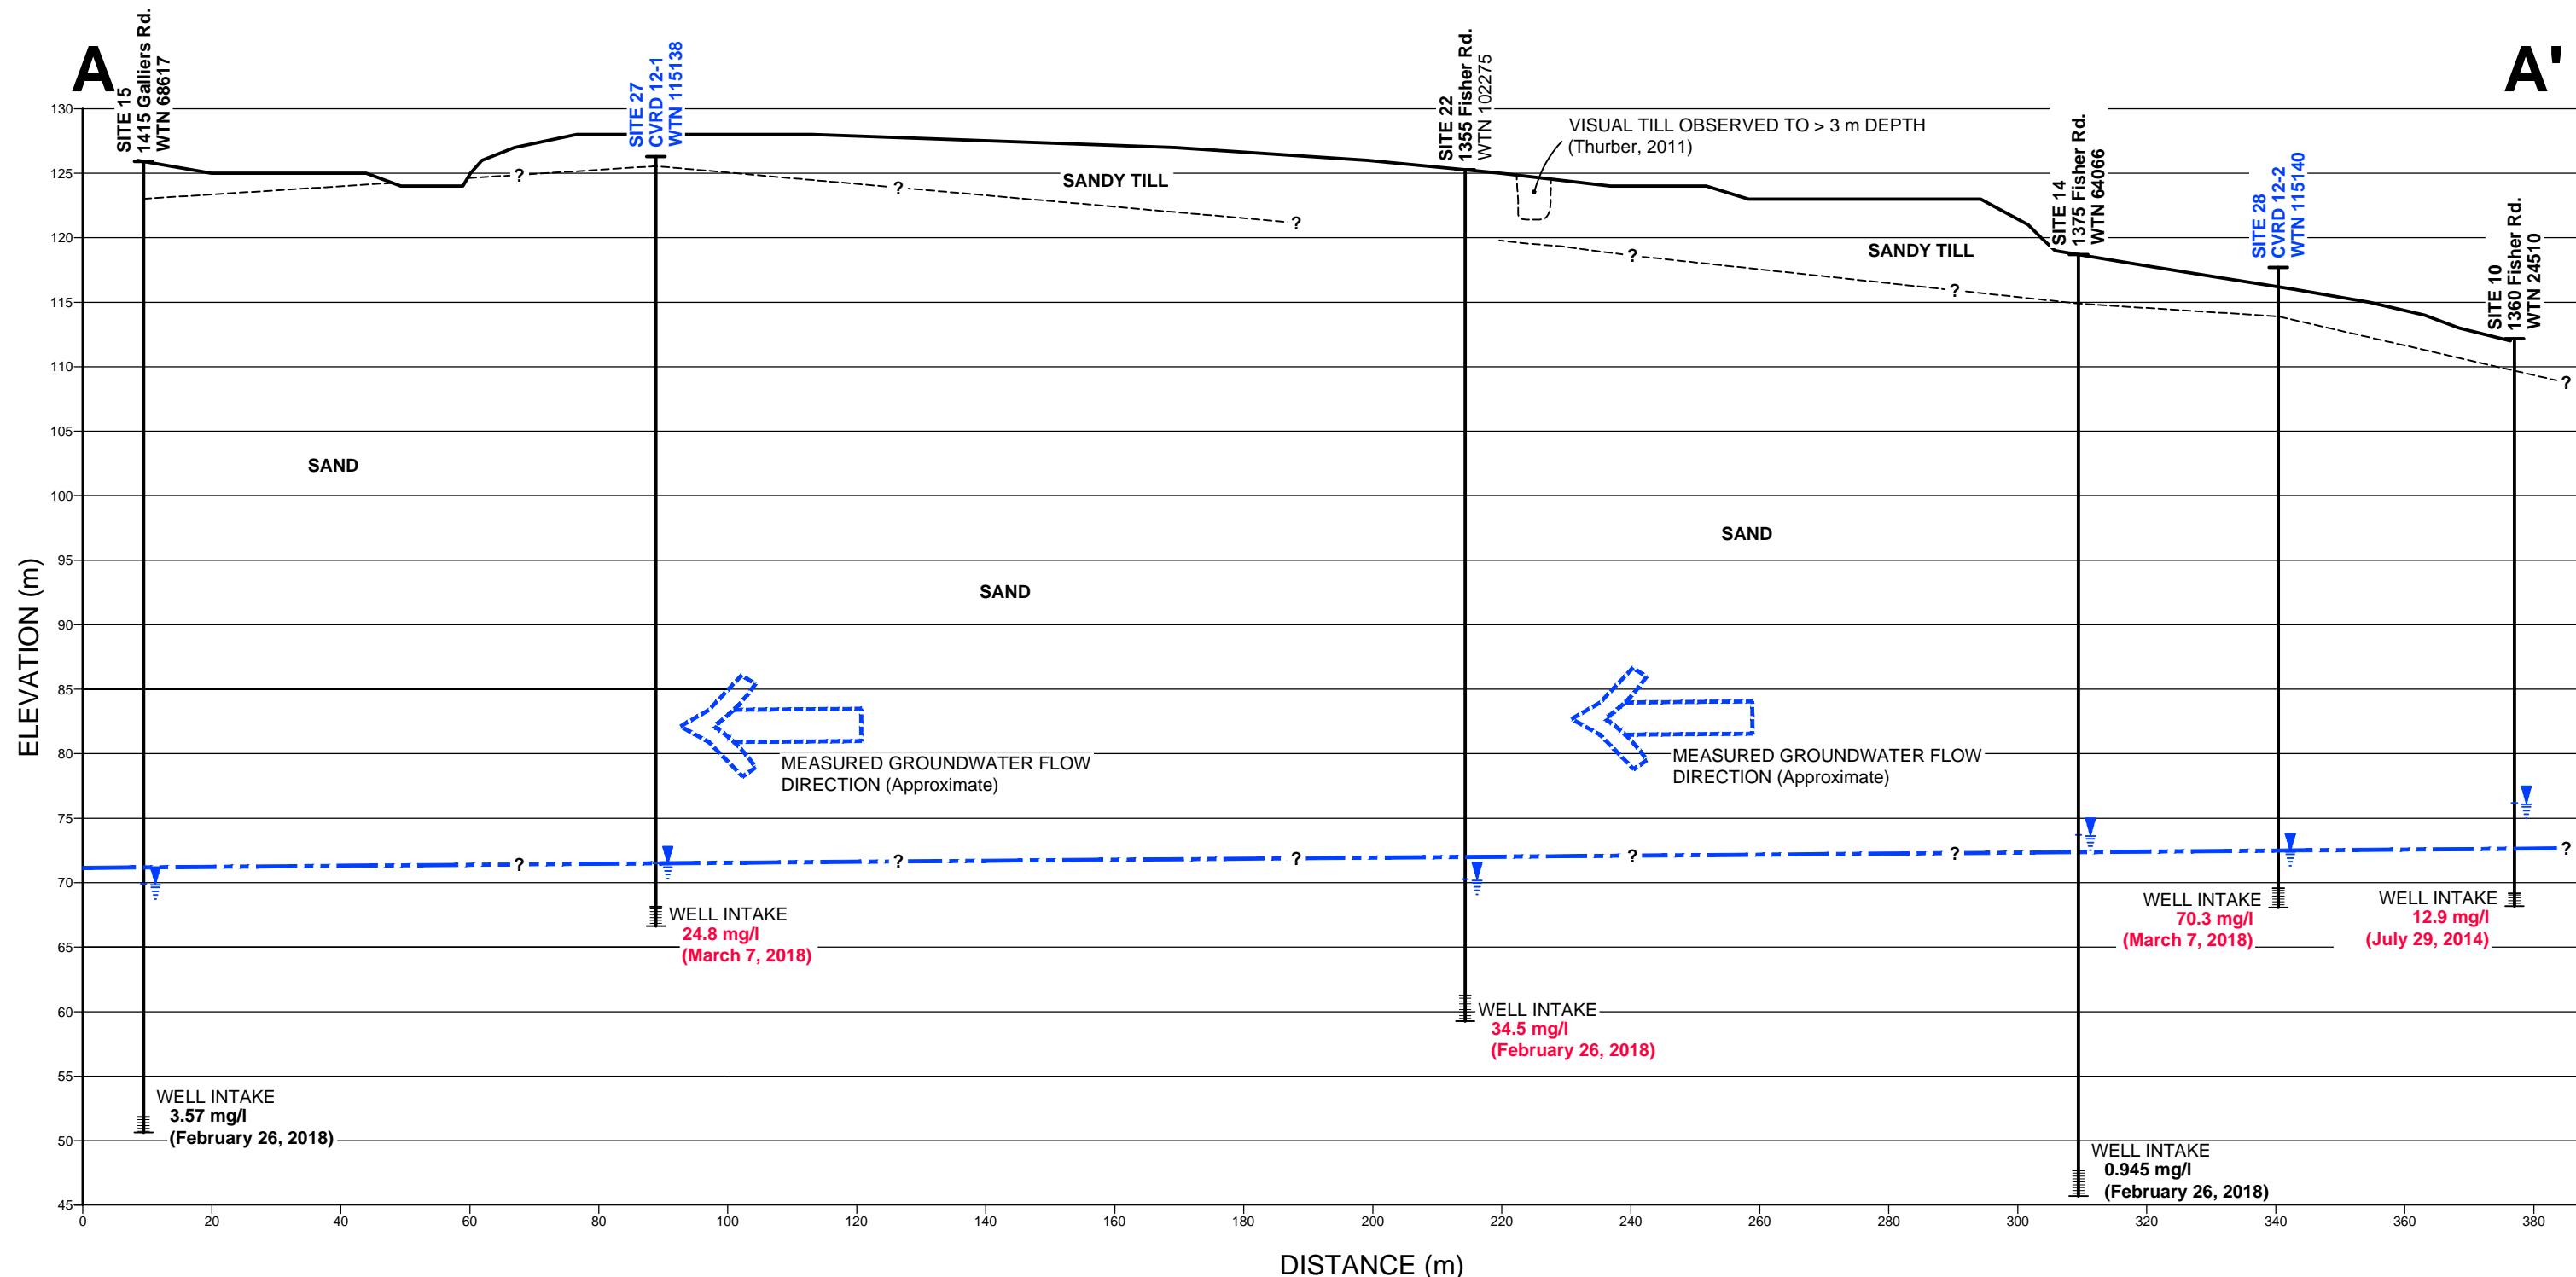
FIGURE 3

FISHER ROAD GROUNDWATER MONITORING
SECTION A - A'
