**RE: 1815 SOOKE LAKE ROAD, SHAWNIGAN LAKE BC
RIPARIAN IMPACT ASSESSMENT & REMEDIATION PLAN**

1.0 INTRODUCTION & BACKGROUND

This report has been prepared to assess the impact of soil deposition/disturbance and vegetation disturbance that has occurred within the Riparian Protection DPA for the unnamed tributary to

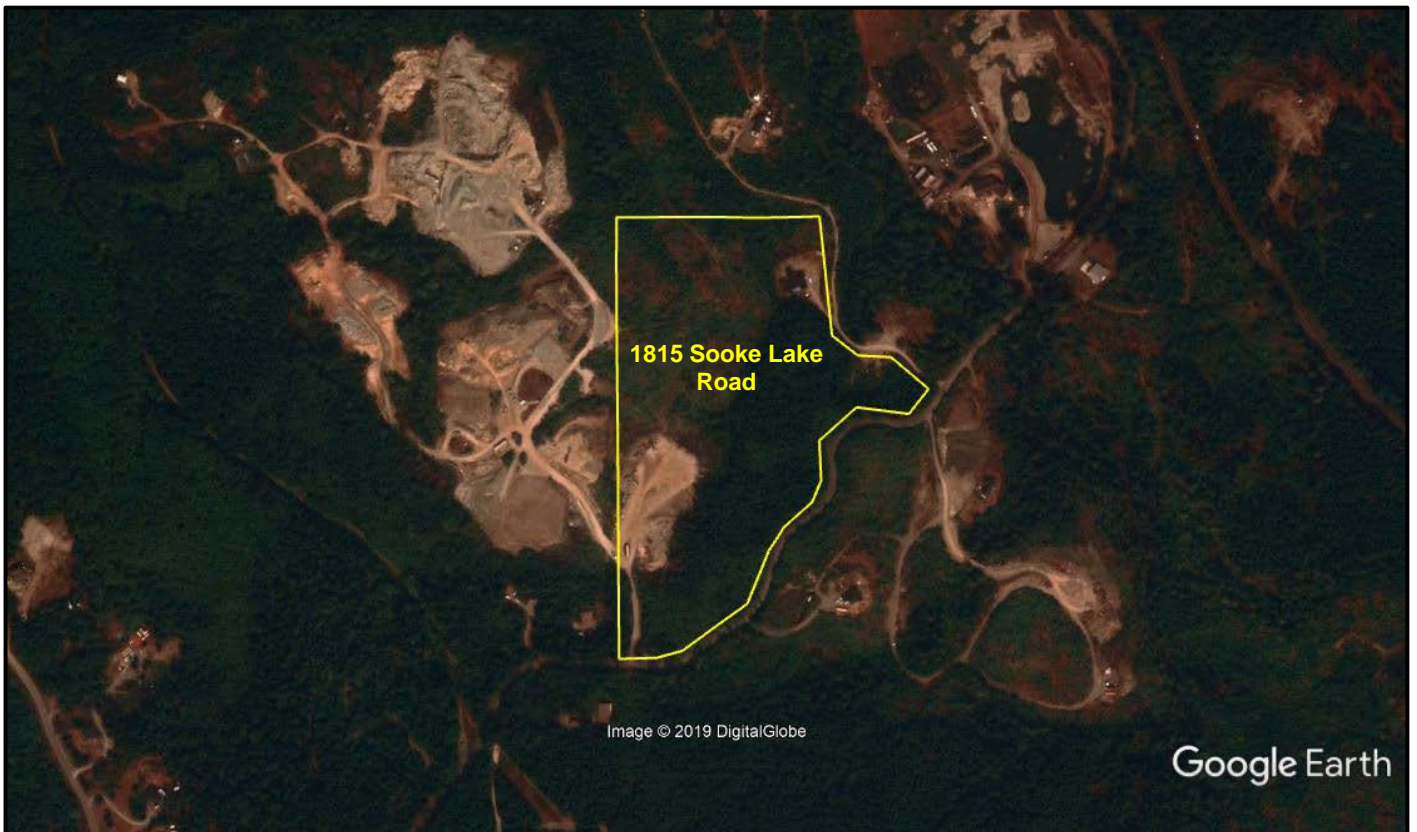
FIGURE 2
DPA BOUNDARIES MAP

**Figure 2. Development Permit Area and Riparian Areas Regulation Site Plan
1815 Sooke Lake Road**

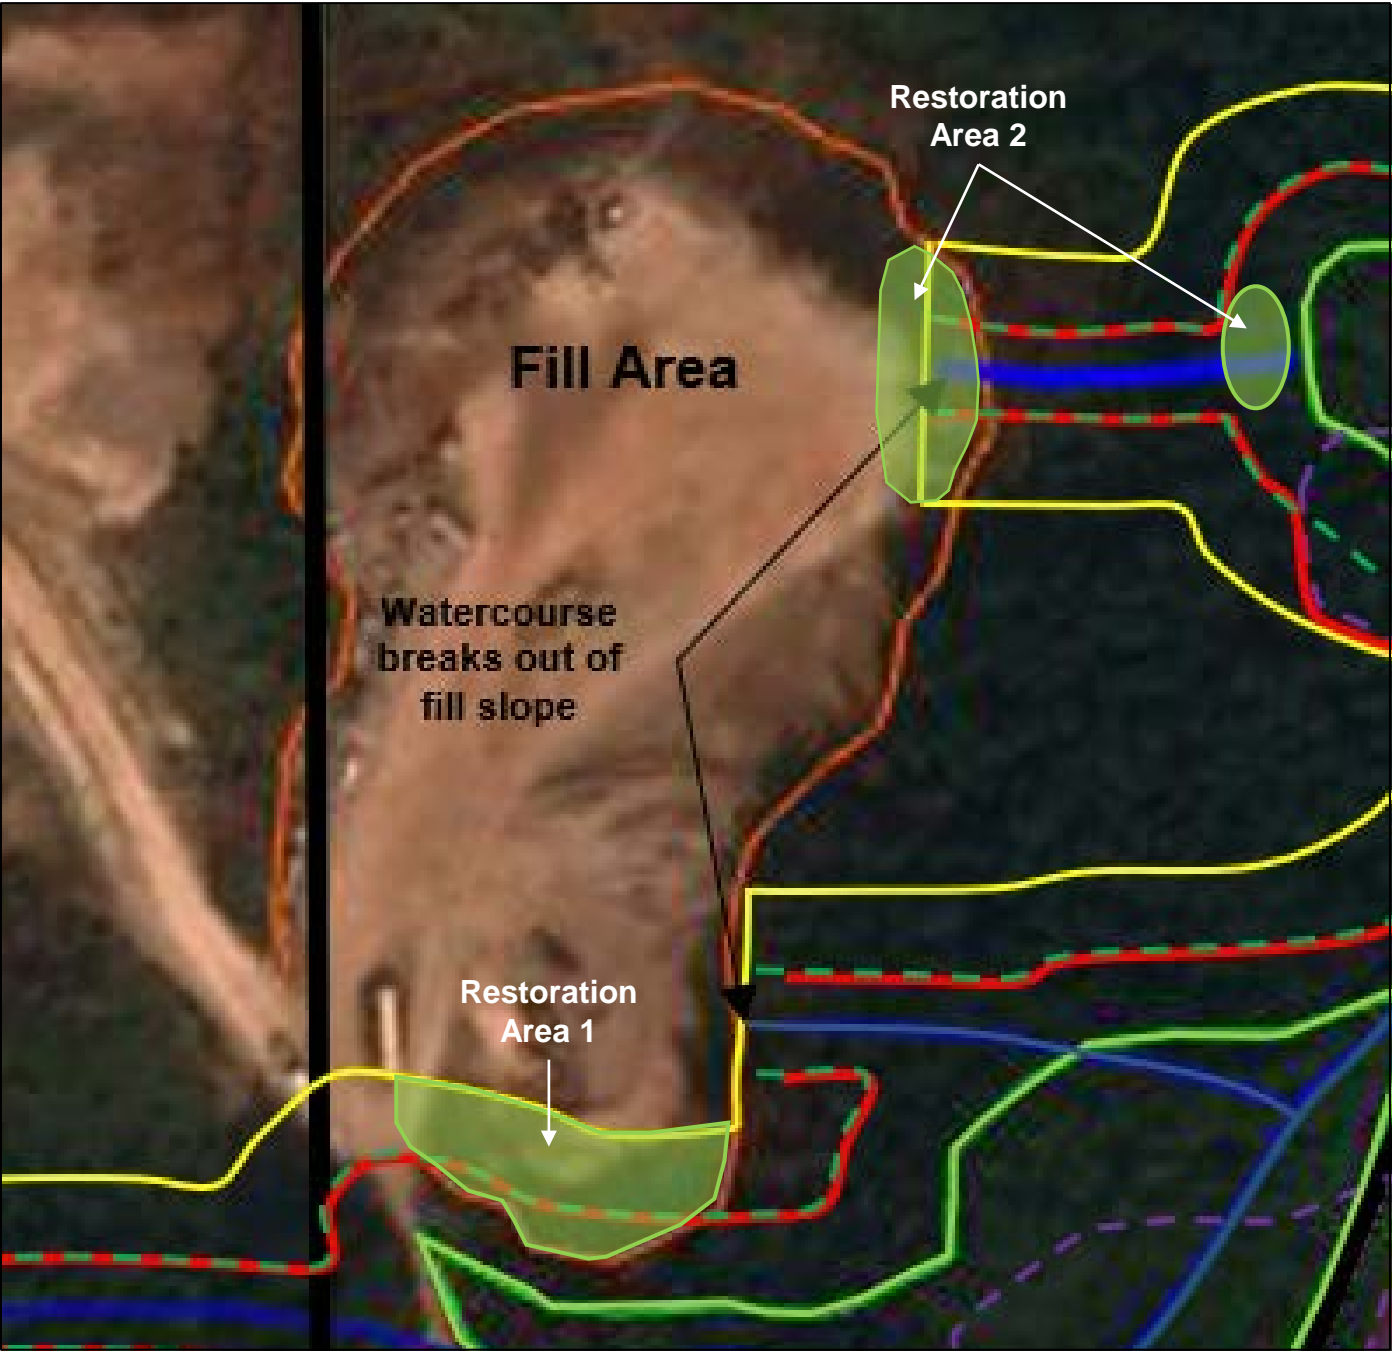
FIGURE 3
PLANTING PLAN

Figure 3. Planting Plan
1815 Sooke Lake Road

Native species selected in this remediation plan were selected based on existing native shrub and tree species present within the property and suitability to the site conditions (see Table 2). Overall planting density to be achieved is a minimum of one tree per 3m² with the goal of 100% cover within 2-3 years. Red alder are expected to seed themselves naturally as evidenced on site on recently disturbed areas. Willow stakes are to be planted in clusters of 3 cuttings and spaced 1m apart. Refer to Figure 3 for a diagram of restoration areas.

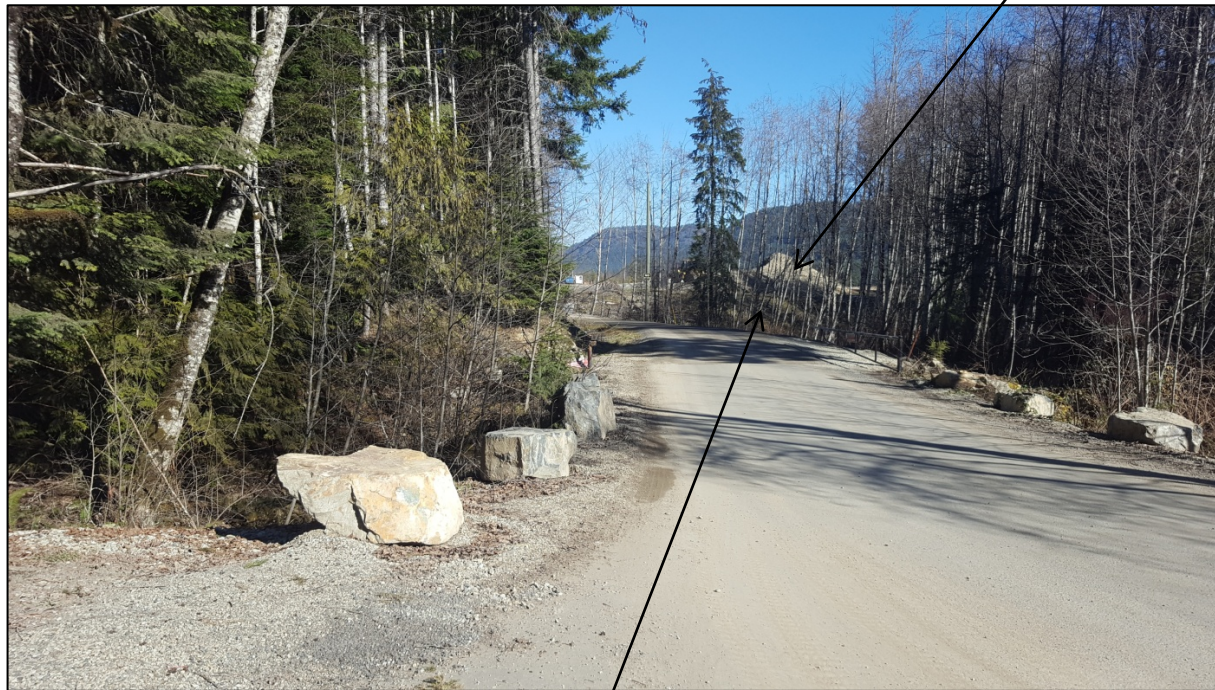
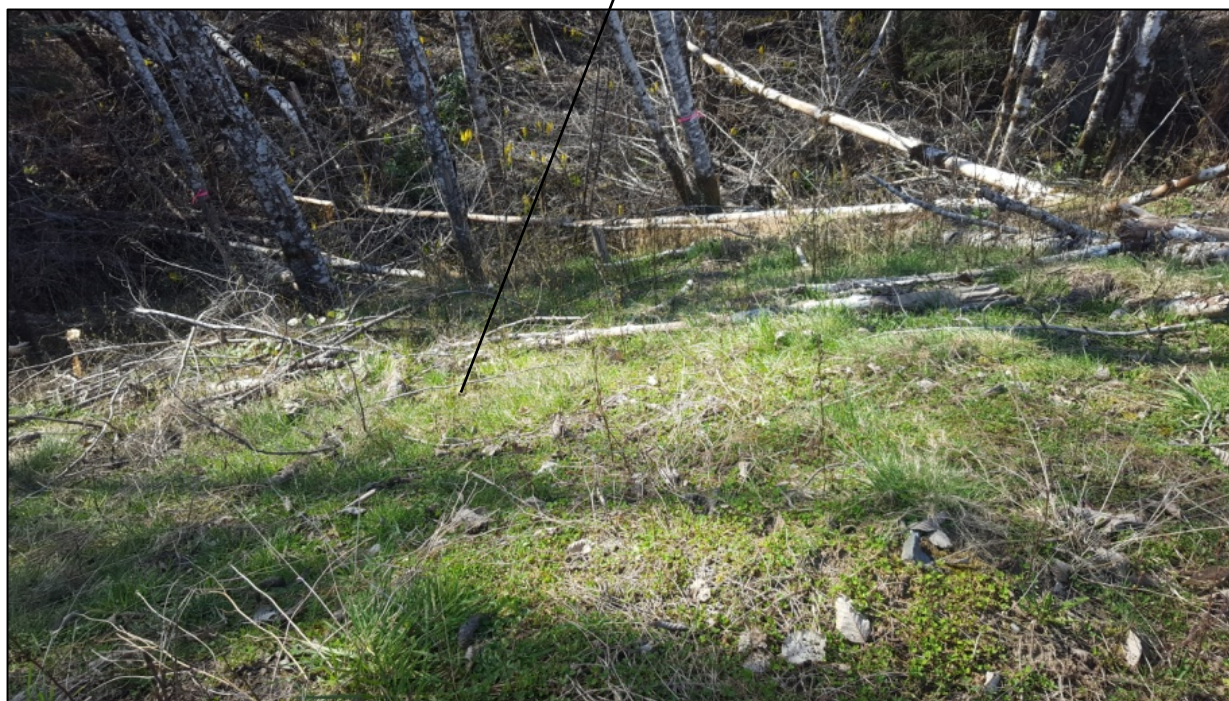
Restoration Area 1: Remove recent fill from Riparian DPA and retain older stable fill with existing alder saplings and other riparian species to re-generate and naturally infill in this area (~1600m²).

Remove new fill

- Survey and flag the 30m riparian setback.
- Improve existing erosion and sediment control measures by installing silt fences or straw bales between the fill slope and the high water mark to prevent sedimentation of watercourse while the site is stabilized.
- In the dry summer period, remove the new fill pile to outside the 30m setback. Apply grass seed and straw mulch over newly exposed soils. Retain the old fill slope as it is stable and has begun to regenerate a large number of red alder seedlings and ground cover species. Allow the existing alder saplings to regenerate and riparian vegetation to naturally infill the impacted area.
- Visually demarcate the 30m setback to prevent future encroachment (i.e. snow fence).

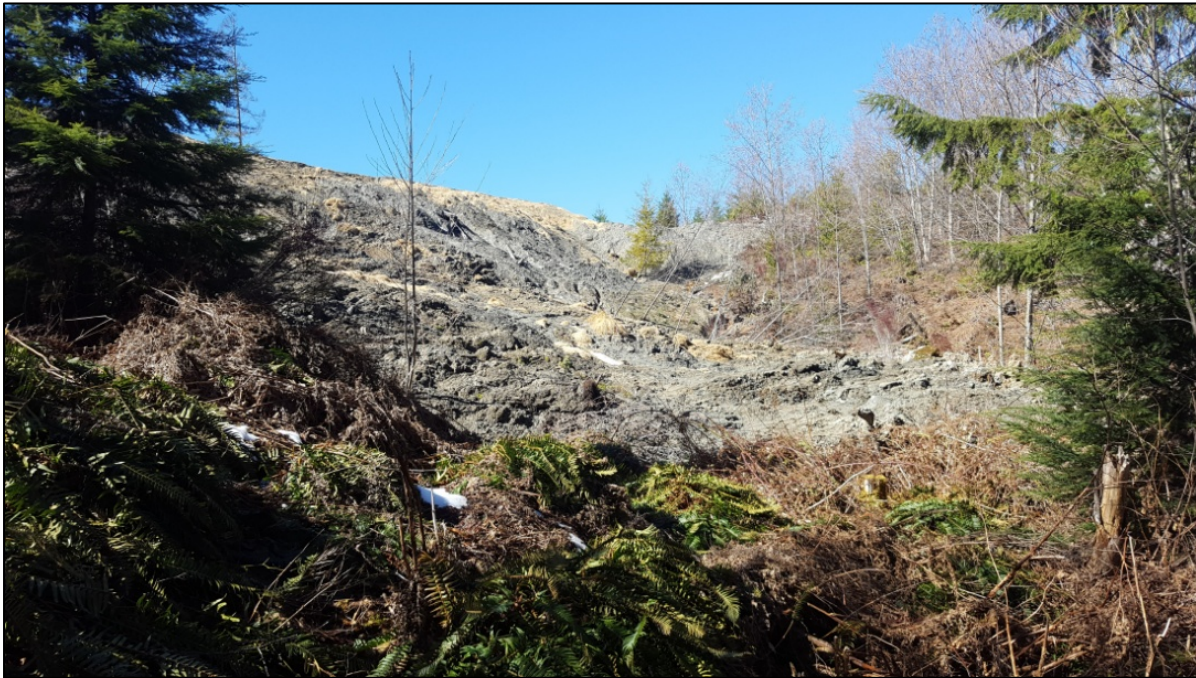
Restoration Area 2: remove fill from Riparian DPA; regrade and reduce fill slope and construct a soil berm at the toe of fill slope; place soil over the newly constructed slope and where the fill was pulled back; seed with grass and spread straw over exposed soils; plant new fill slope area (~400m²) and impacted DPA area (~400m²) with native trees.

- During the dry summer period remove slumped fill material to outside the 30m setback.
- Construct a compacted soil berm at the toe of the fill slope with suitable compactable soils to support the toe of the newly graded slope.

- Re-grade the fill slope to at least 2H:1V (or less) to improve slope stability and prevent future slumping. Install a layer of good soil over the newly graded fill slope. Seed the fill slope and soil berm with grass seed and cover with a layer of straw. Leave the surface of the slope rough to reduce surface erosion. If logs are available, place them randomly over the slope in a horizontal alignment and push them into the slope.

- In the following fall (October), plant the impacted area within the 30m setback and the newly constructed fill slope with native trees to improve sediment and erosion control and to reinstate riparian habitat. Trees should be plugs and spaced at least one every 3m on centre.

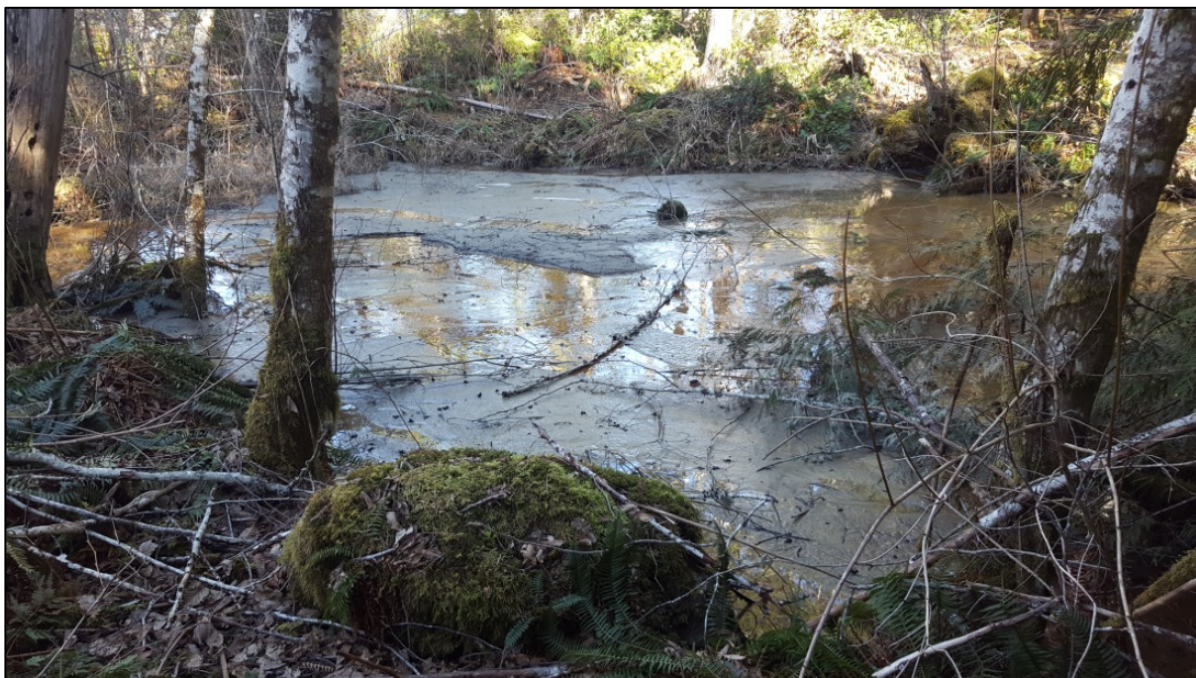
Restoration Area 2 Drainage:

After the ditch that flows from the SLR Quarry fill slope has been redirected and the area where it currently enters the wetland has dried up somewhat, plant live native willow stakes in this area in the fall (~200m²).

- Install clusters of three 1m long willow cuttings (not all are expected to survive) in the upper end of the drainage channel where it is a ponded slurry of clay fines to stabilize this area. Plant clusters approximately 1m apart. The alternative of excavating the slurry would result in more damage than it would be to stabilize it.

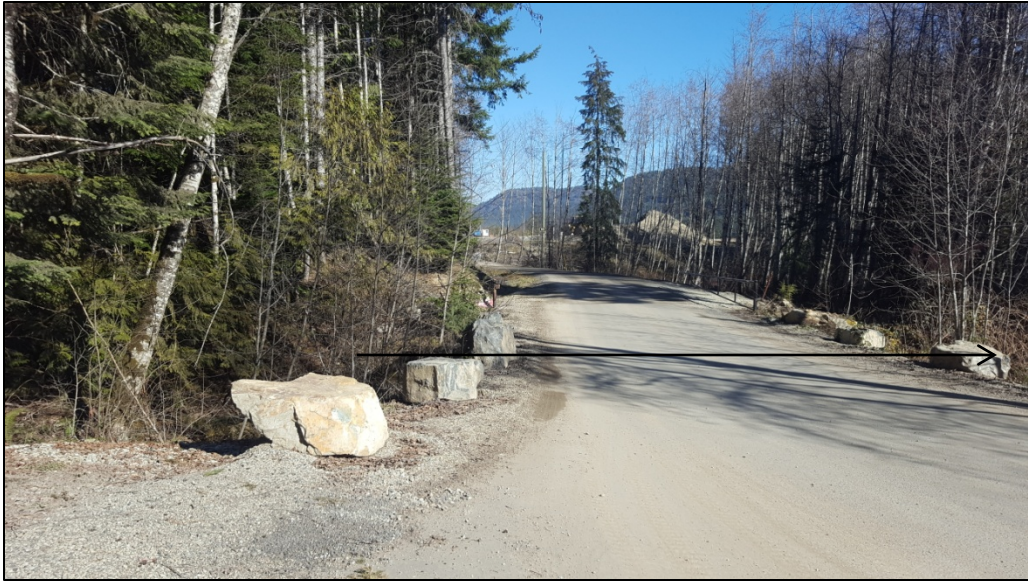
Photo1. Looking into the driveway of 1815 Sooke Lake Road at the culvert crossing of the main tributary.

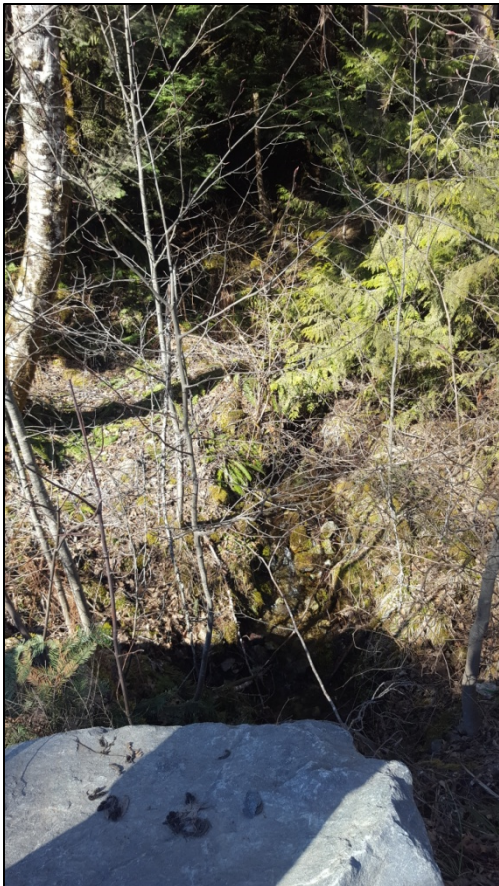
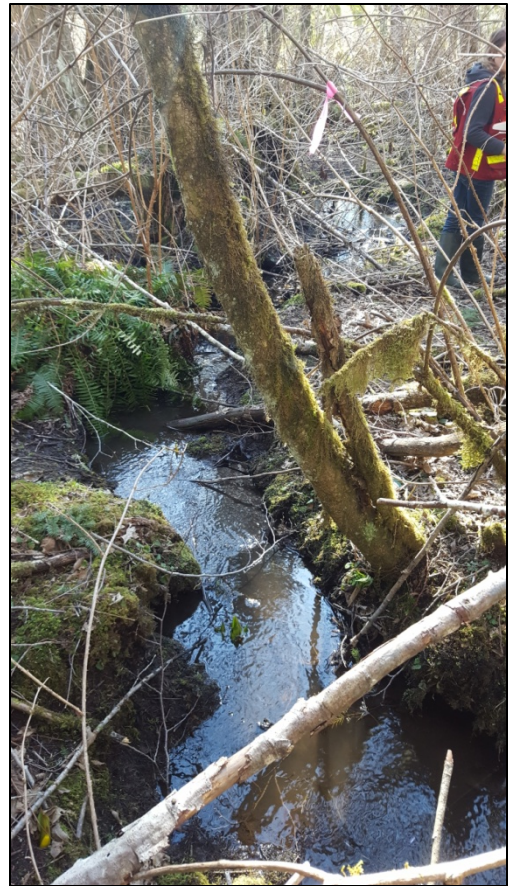
Photo 2&3. Looking upstream and downstream from the driveway crossing the main tributary stream.

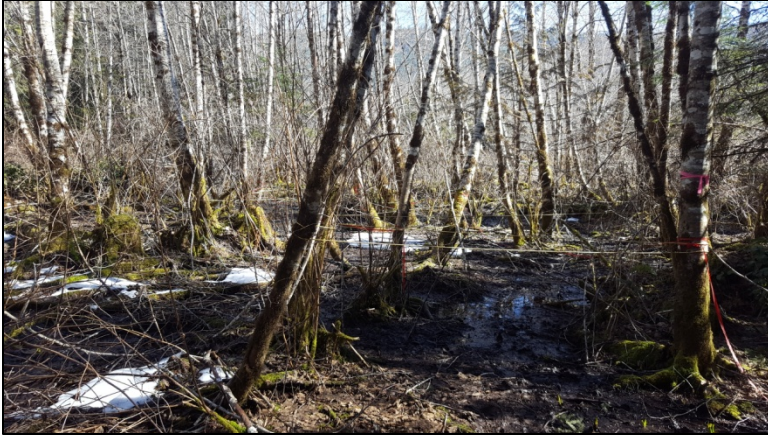
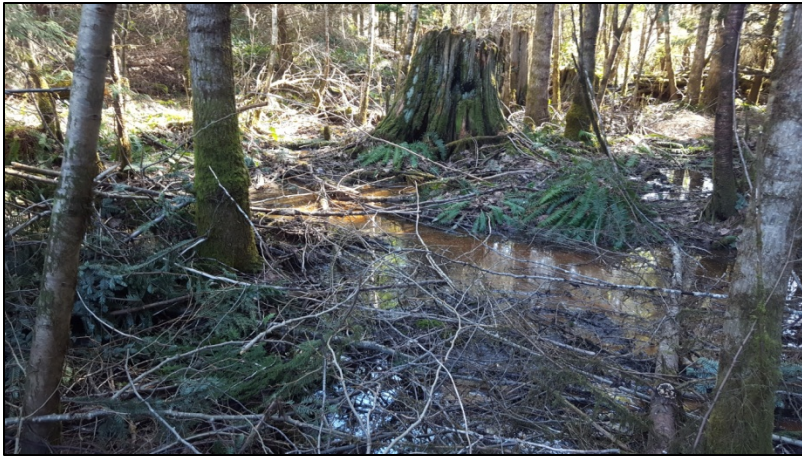
Photo4 & 5 showing the forested swamp wetland (Wetland 1) on the downslope side of the entrance driveway.

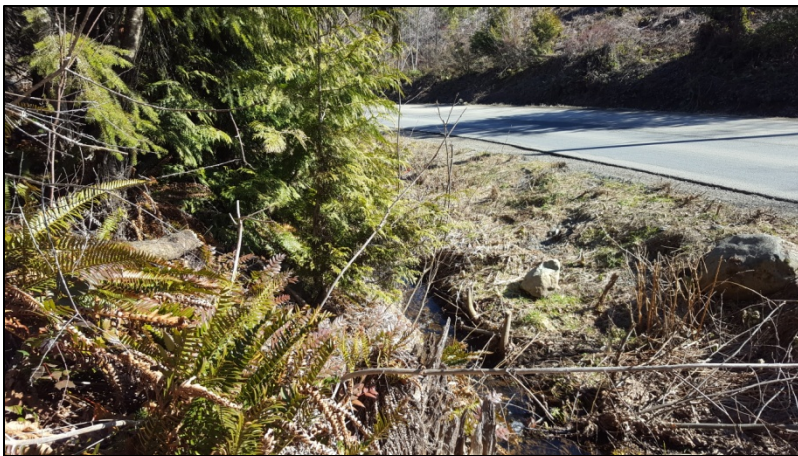
Photo 6. Showing the stream reach beside Sooke Lake Road downstream of Wetland 1.

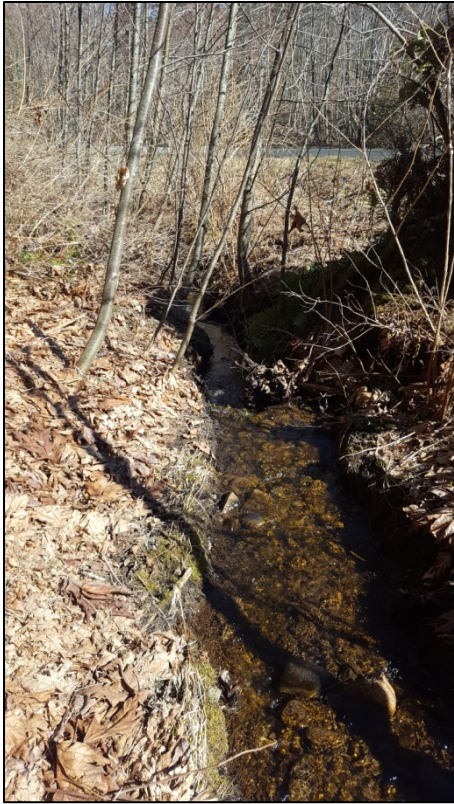
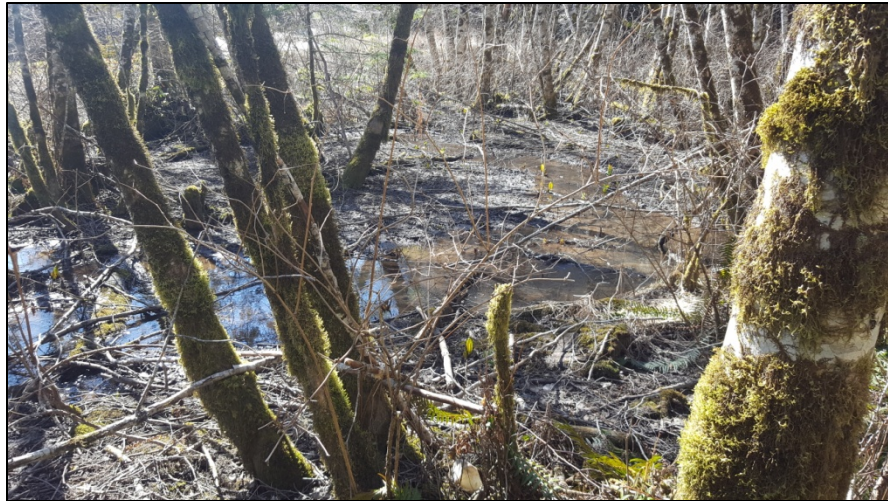
Photo 7 & 8. The tributary continues along the road edge to Wetland 2. Wetland 2 is also fed from the drainage coming from the slope failure area.

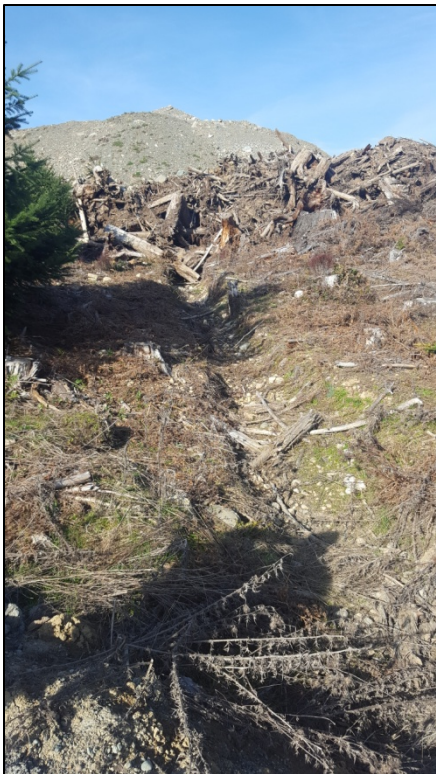
Photo 9. Showing the SLR Quarry ditch directed toward the fill area in 1815 Sooke Lake Road.

- Discuss redirecting the SLR Quarry ditch away from the fill slope (I.e toward the north and let it fan out through the adjacent clear-cut shrub and groundcover vegetation area.

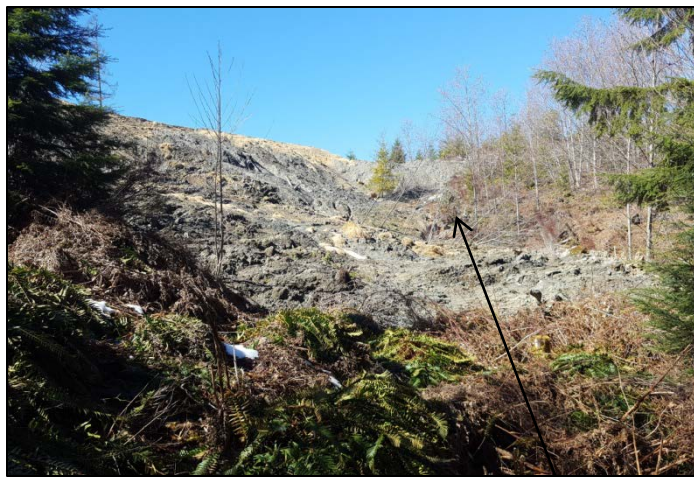
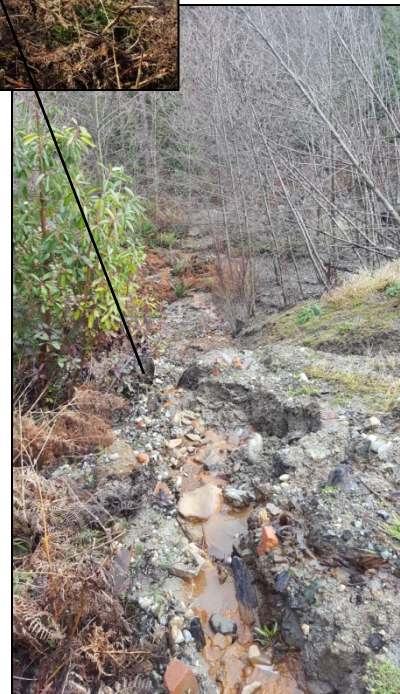
A perimeter ditch along the toe of the SLR Quarry fill drains toward the north end of the subject parcel fill area. Fill material at this end appears to be primarily comprised of clay. Red alder saplings growing in the ditch are approximately 5 years old indicating the drainage path has been in existence for that length of time. The drainage goes subsurface and breaks out of the fill slope below the crest of the slope where bedrock is exposed. The remainder of the slope failure area shows evidence of erosion and rilling from surface and subsurface drainage. The drainage appears to have contributed to a slope failure – a crescent shaped section of the slope slumped and migrated downhill to the tree line. The drainage forms a

watercourse starting a few meters beyond the toe of the failed slope and flows through the forest toward Wetland 2. Sedimentation in the upper section of this watercourse comprised of a clay slurry from the slope failure was evident. The clay slurry had settled out in a relatively flat ponded area. The eastern toe of the slumped fill area encroaches into the 30m DPA setback of this watercourse resulting in an impacted area of approximately 400m².

Photo 10 & 11. Subsurface flows break out of the fill slope at the north edge of the fill and form a drainage at the bottom of the slope.

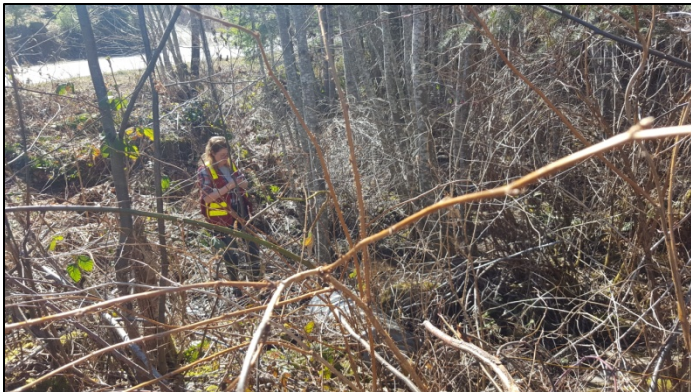
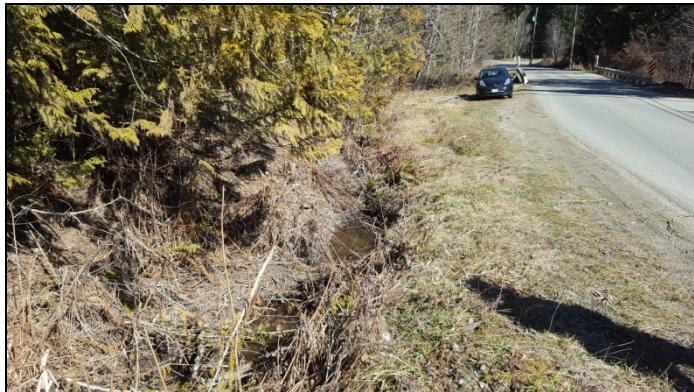
Photo 12 & 13. Showing the driveway crossing culvert at 1815/1805 parcel boundary then the stream follows the road for a while .

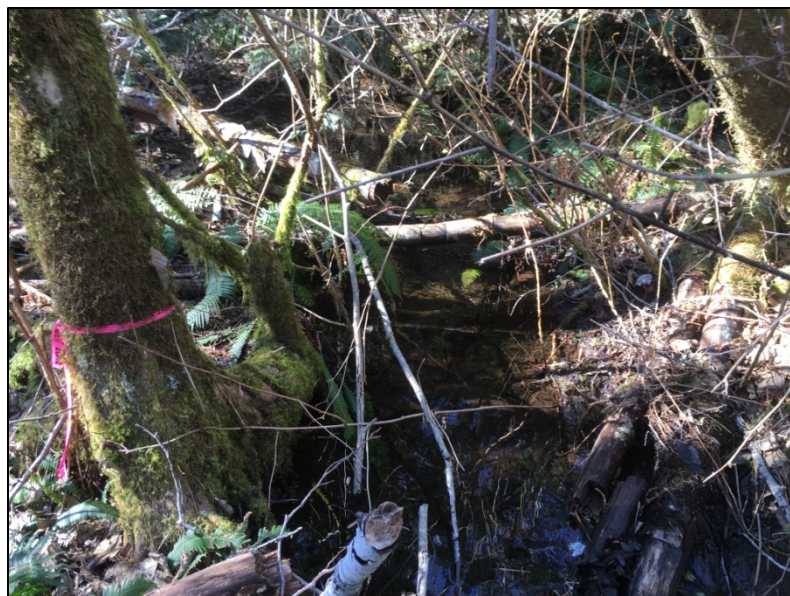
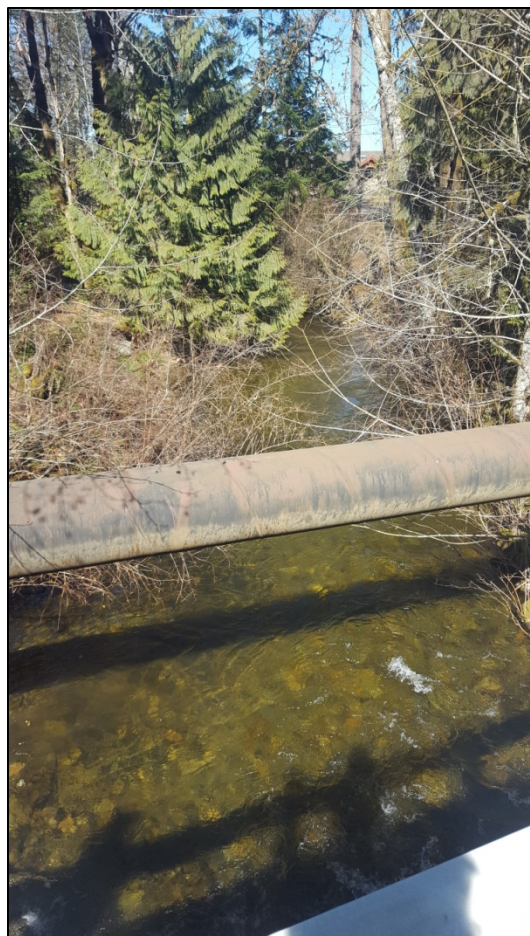
Photo 14 & 15. Showing the tributary bends into the forest for a short distance before discharging into Shawnigan Creek just downstream of the water line crossing beside the bridge shown in Photo 15.
