## 8 Site Monitoring

A site inspection was conducted on May 26, 2020 to review soil depositing environmental practices. Observations from the inspection included:

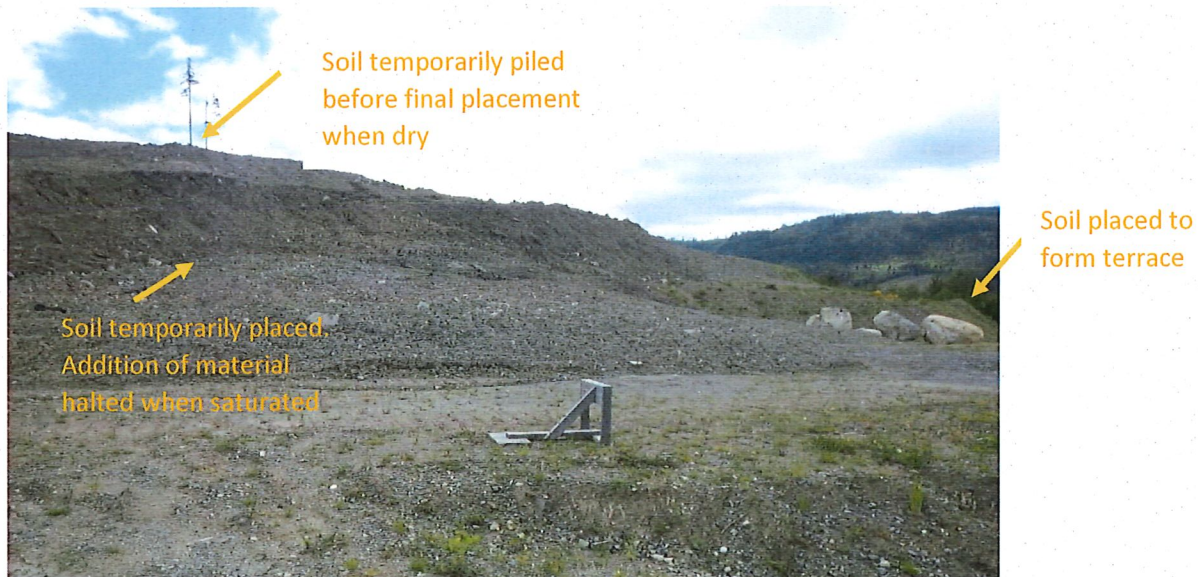
1. Construction of terraces near the base of the slope was halted in the fall 2019 once the fill materials became saturated (see photo below). Soil was being temporary stockpiled away from steeply sloped areas until the ground conditions dry out to allow final soil placement and terracing to safely recommence.

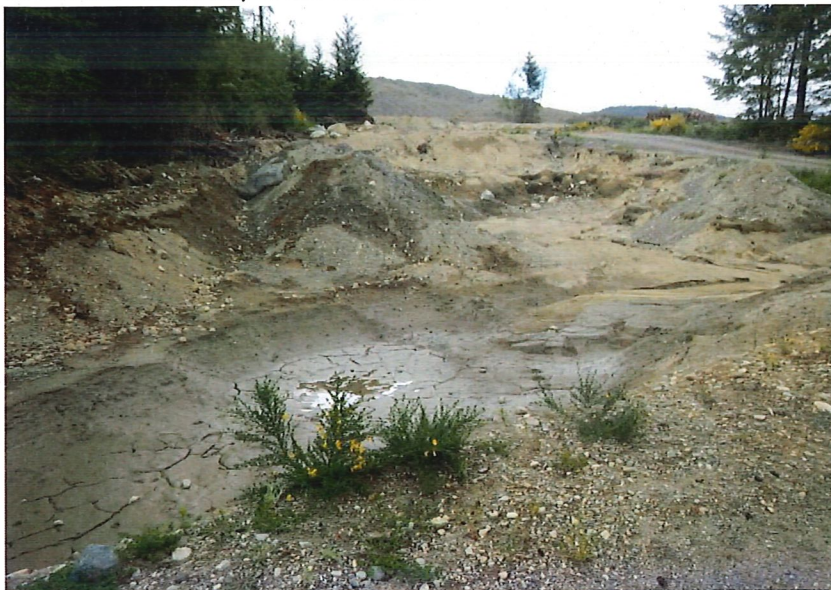
2. Runoff managed by directing to settling/detention areas (see photo below). All watercourses were clear on the day of the site visit.
