ELECTORAL AREA SERVICES COMMITTEE MEETING AGENDA

SUBJECT: Saltair Community Centre Facility Condition Assessment

FACILITY CONDITION ASSESSMENT SALTAIR COMMUNITY CENTRE

**3850 South Oyster Road, Ladysmith
British Columbia**

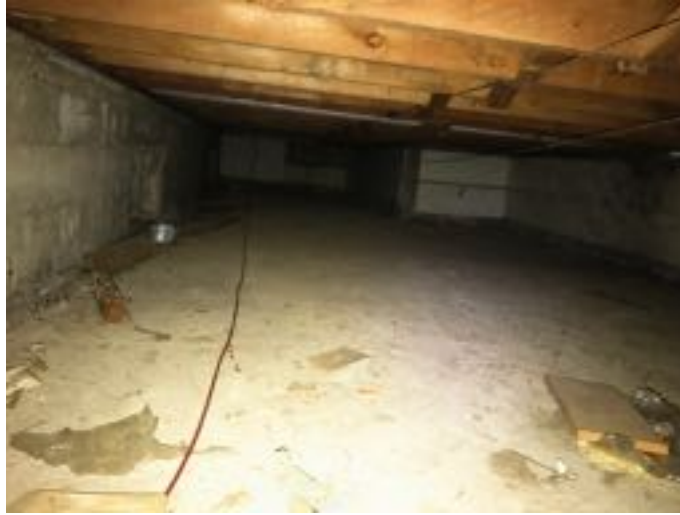
Photo 1 – General view of foundation crawlspace	Photo 2 – A crack in foundation wall
B10 – Superstructure	Wood Framing

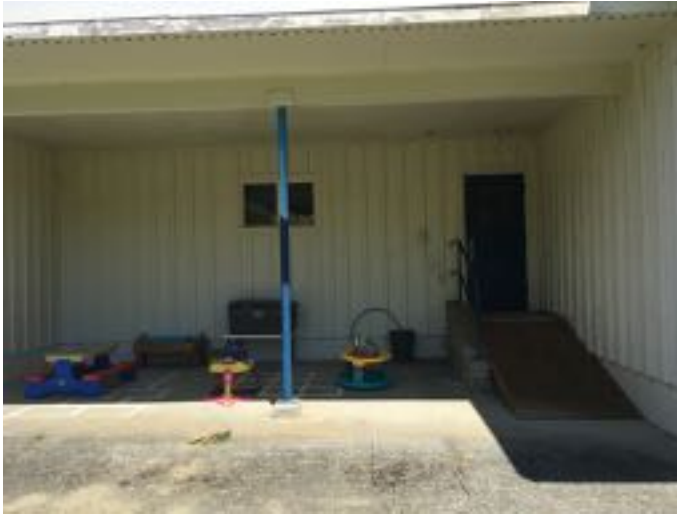
Photo 5 – Painted wood siding on north elevation	Photo 6 – Painted wood siding on southwest elevation	Photo 7 – Poor painted wood siding wall-to-brick chimney interface detail
B2010 – Exterior Walls	Painted Wood Soffit with Vent Strip

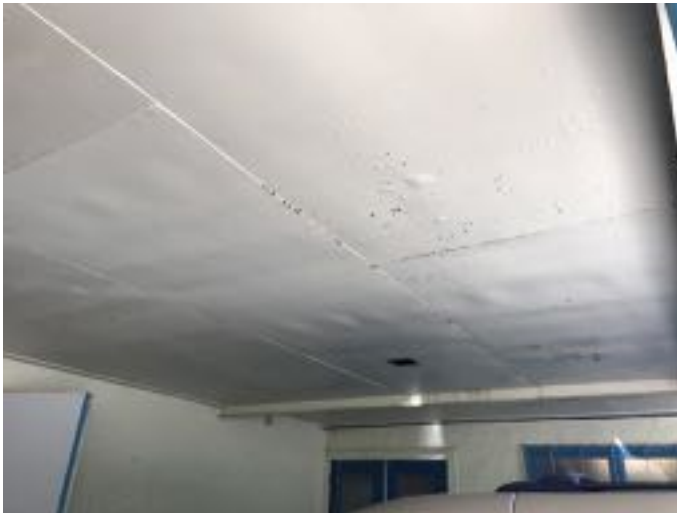
Photo 8 – Typical painted wood soffit with perimeter vent strips	Photo 9 – Painted wood soffit with blistering and microbial growth	Photo 10 – Moisture and microbial growth on painted wood soffit

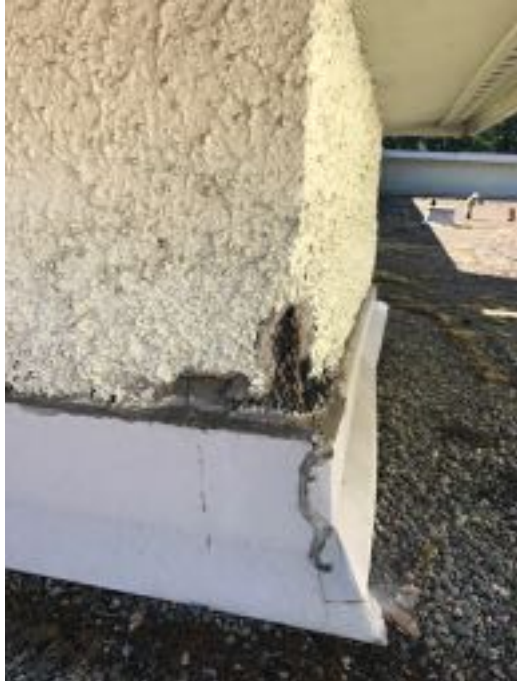
Photo 17 – Delaminating stucco cladding at a corner	Photo 18 – Poor stucco wall-to-brick chimney interface detail	Photo 19 – Hairline crack, stains, and deteriorating stucco coating
		Photo 20 – Typical painted above-grade foundation wall	Photo 21 – Deteriorating coating at base of wall	Photo 22 – Hairline cracks in foundation wall and coating

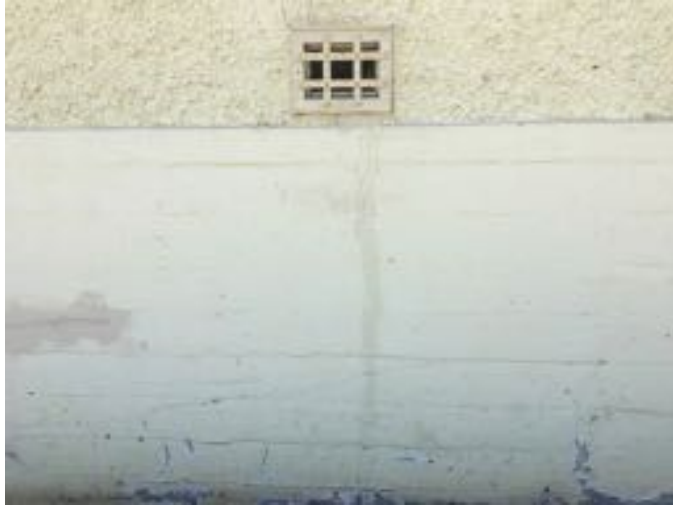
<p>Photo 23 – Cracks in concrete wall and deteriorating coating</p>		
B2020 – Exterior Windows	Wood Framed, Single Glazed Windows

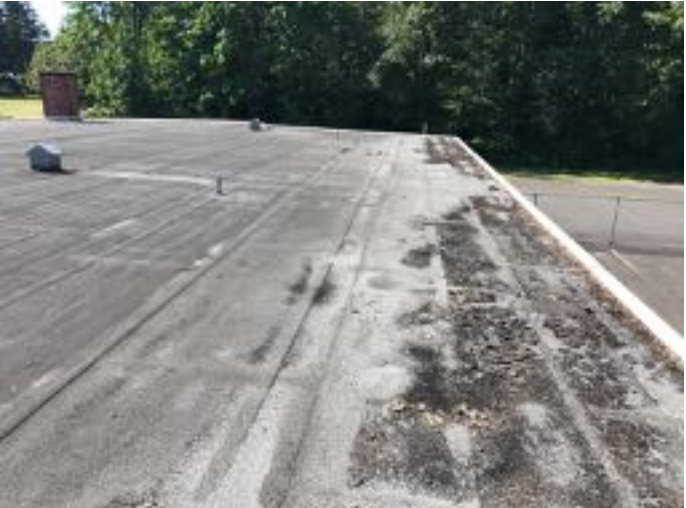
Photo 43 – General view of SBS roofing	Photo 44 – Typical drain	Photo 45 – Staining and collection of debris on roof surface

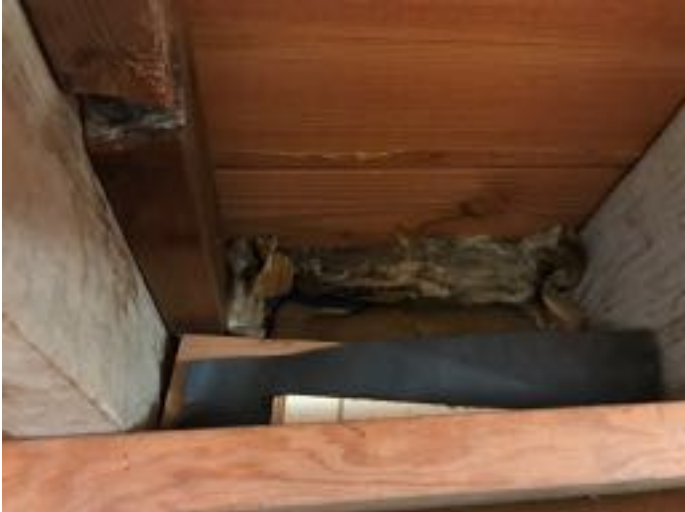
<p>Photo 60 – Water stains and microbial growth on wood members within gymnasium roofing assembly</p>	<p>Photo 61 – A nail penetrating through the wood decking at gymnasium roofing assembly</p>	<p>Photo 62 – A disconnected rainwater leader; different rainwater leader materials</p>

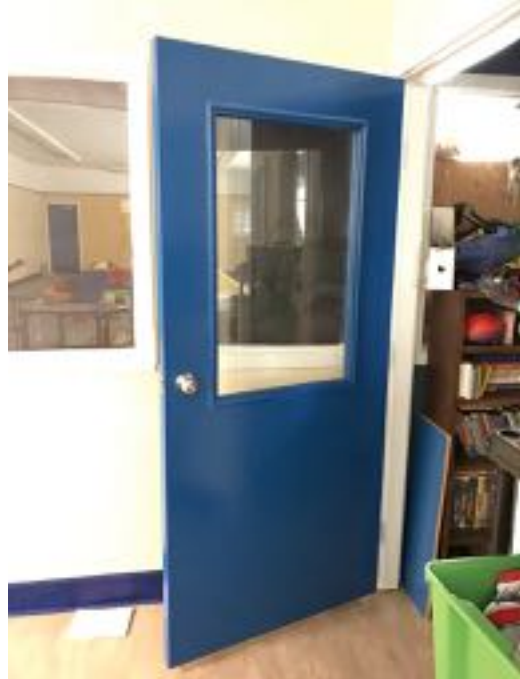
Photo 71 – Typical classroom door with a glazing insert	Photo 72 – Typical painted wood swing door	Photo 73 – Metal swing doors with glazing inserts near main entrance

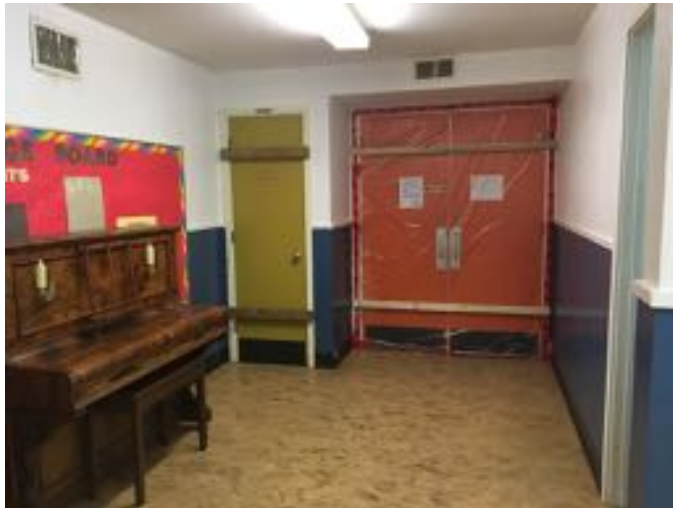
Photo 74 – Doors to gymnasium sealed and blocked to limit access

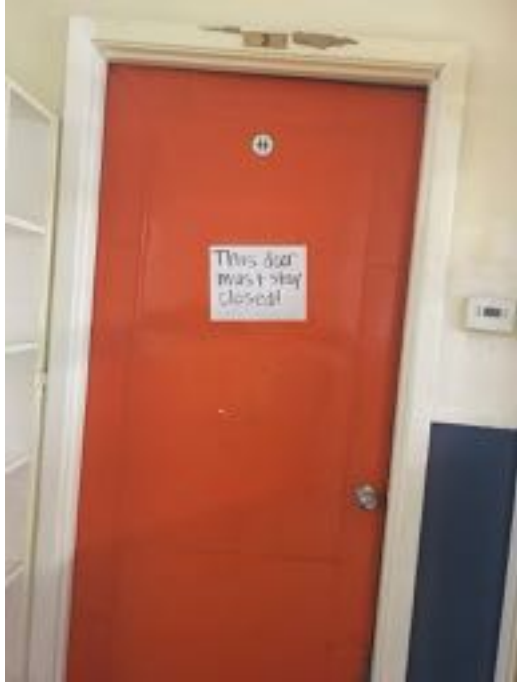
Photo 75 – Metal door to the electrical/mechanical service room	Photo 76 – Unfinished finishes around hallway swing doors	Photo 77 – Hallway double swing doors with glazing inserts
C20 – Stairs	Interior Stairs

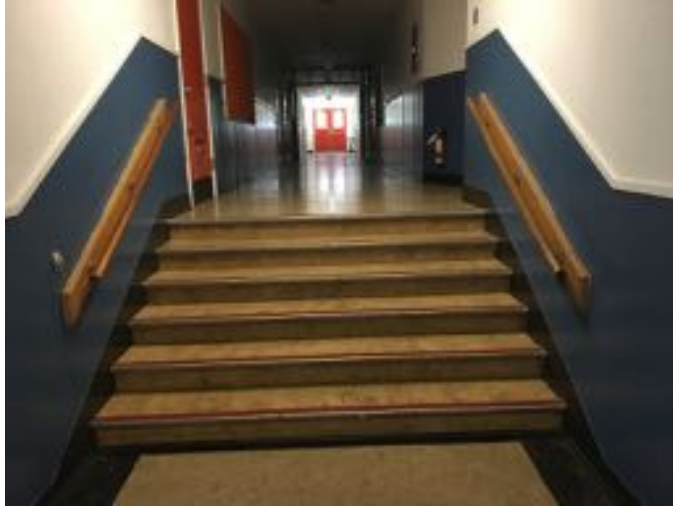
Photo 78 – View of interior stairs

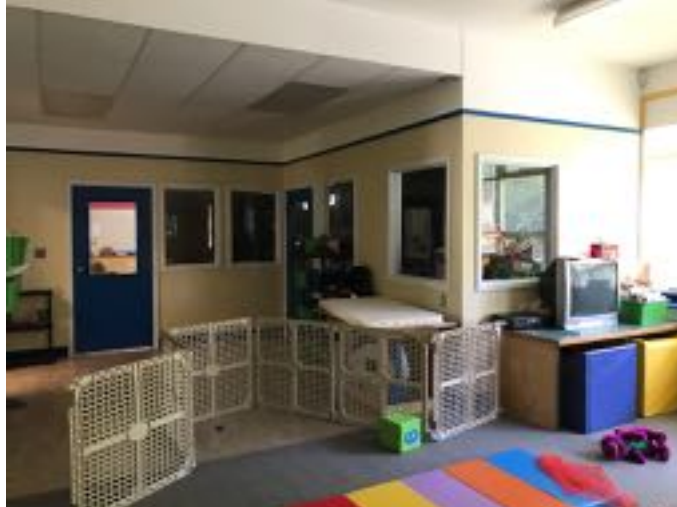
Photo 79 – Interior windows between Classroom 6 & 7	Photo 80 – Interior windows at Office 4	
C3010 – Wall Finishes	Painted Drywall

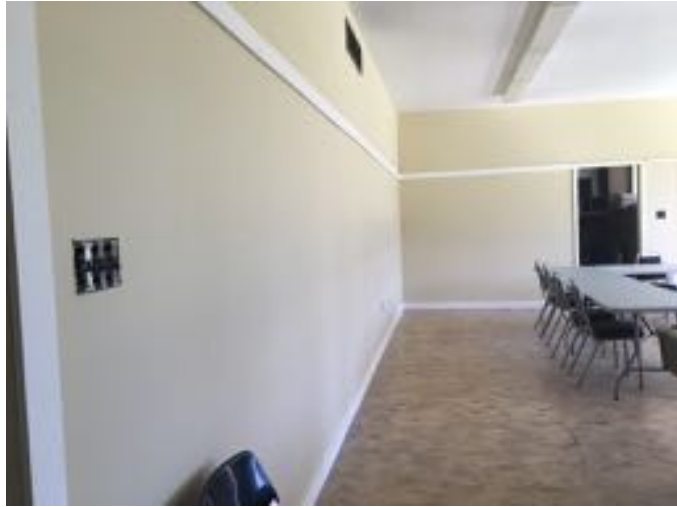
Photo 81 – Typical painted wall	Photo 82 – Painted hallway wall	Photo 83 – Gymnasium wall with ghosting of studs

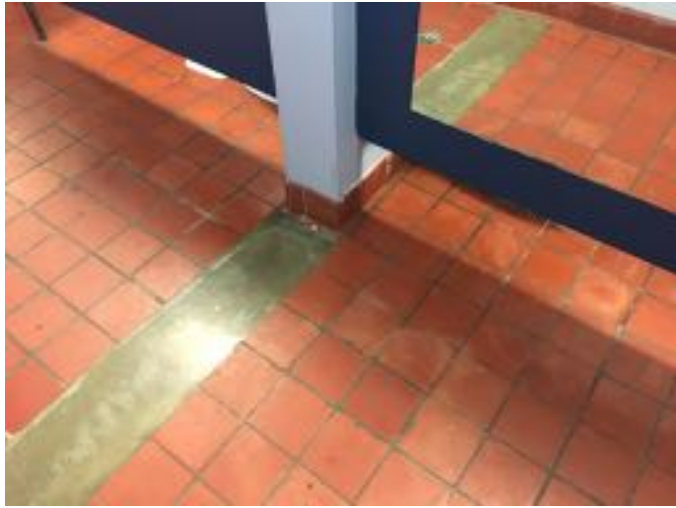
Photo 88 – Tiled flooring in Boys Lav 13 & Girls Lav 15	Photo 89 – Tiled flooring in Lav 10	
C3020 – Floor Finishes	Laminate Wood Flooring

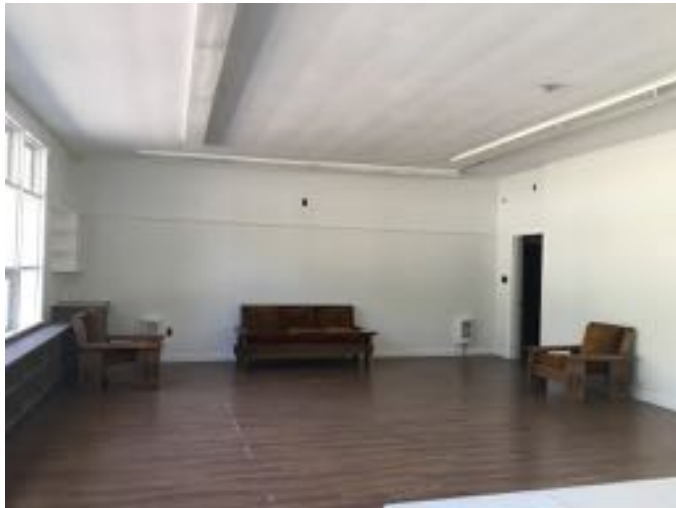
Photo 90 – Laminate wood flooring in Classroom 18

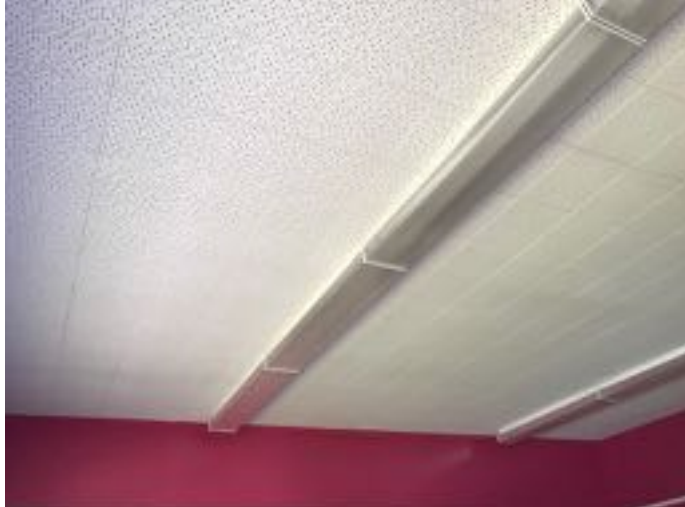
Photo 93 – Acoustic ceiling tiles at Library 6		
C3030 – Ceiling Finishes	Fibreboard Ceiling Tile at Gymnasium

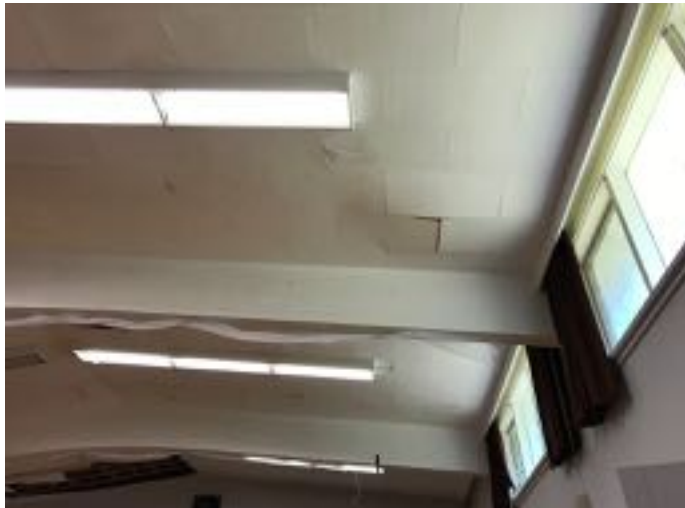
Photo 94 – Bulging and sagging tiles throughout gymnasium	Photo 95 – West gymnasium ceiling where multiple ceiling tiles have fallen off	Photo 96 – Microbial growth on the backside of ceiling tile

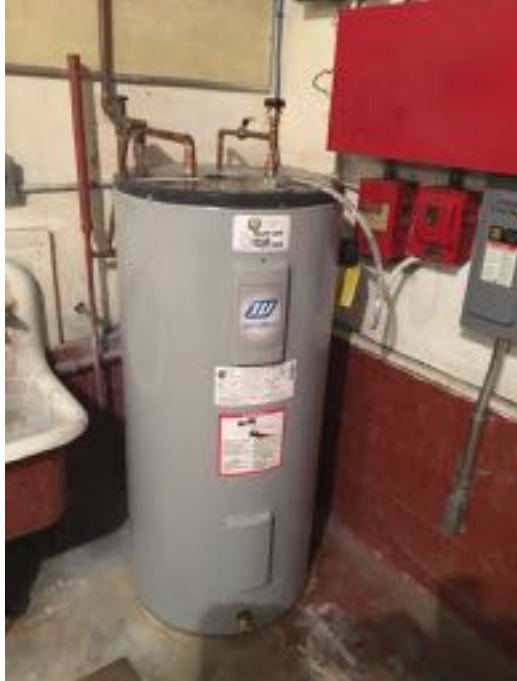
Photo 109 – Hot water storage and heating tank		
D3012 – Gas Supply System	Gas Distribution System

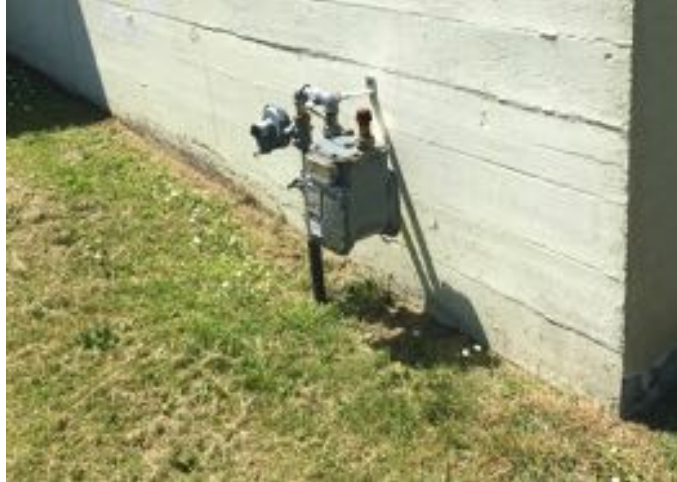
Photo 110 – Gas meter found at northeast corner of the building

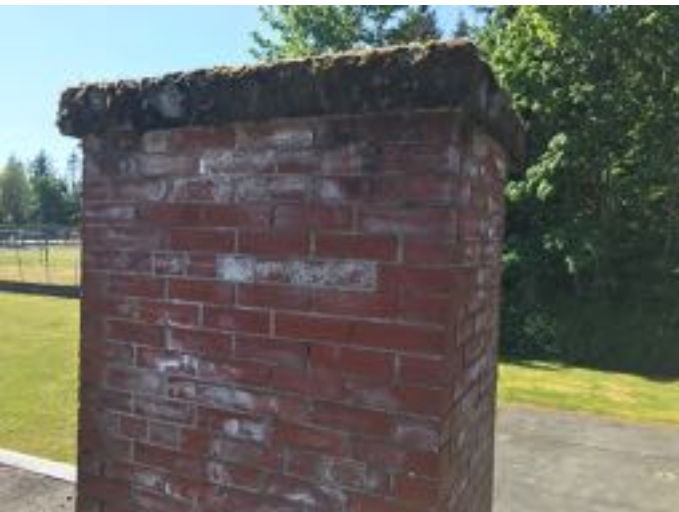
Photo 119 – Chimney found in the middle of the roofs	Photo 120 – Chimney found at the southeast corner of the building	Photo 121 – Moss growth, deteriorating brick and mortar, and efflorescence found on chimney

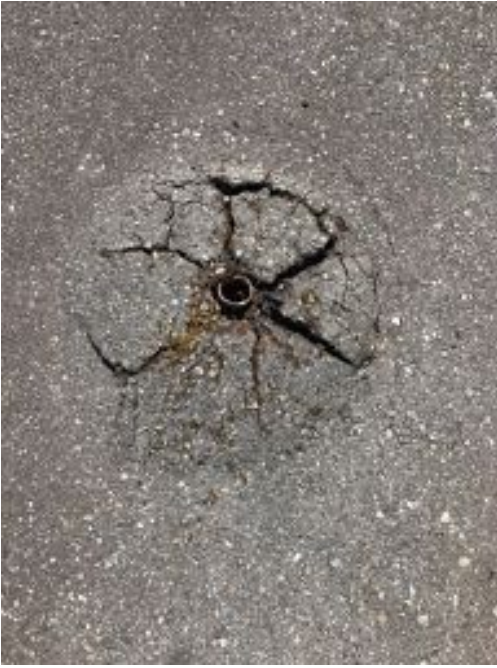
Photo 138 – View of asphalt paved fenced play area	Photo 139 – A potential trip hazard near fenced play area	Photo 140 – Close up of the trip hazard

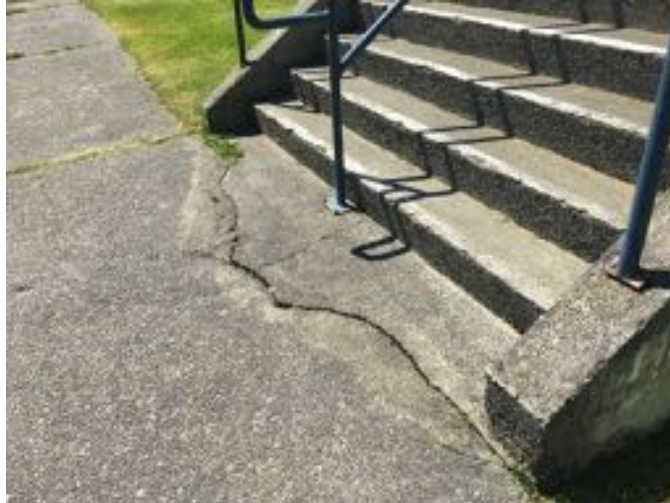
<p>Photo 145 – A sizeable crack at walkway and exterior stairs transition at east elevation</p>		
G2030 – Pedestrian Paving	Concrete Stairs & Ramps	 	 	 
		<p>Photo 146 – Stairs and ramp at south exit</p>	<p>Photo 147 – Stairs at east exit</p>	<p>Photo 148 – Stairs from street on north elevation</p>

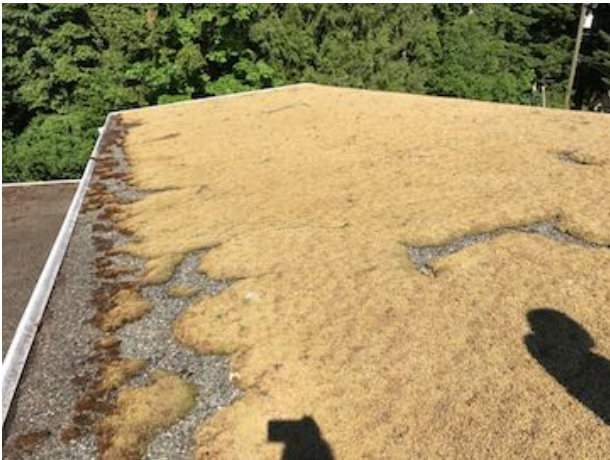
Photo 1 – An overview of Roof Type I

Reference	Recommendation	Time Frame	Order of Magnitude Costs (Consulting fees & GST not included)
Option 1 – Targeted Repair			
5.1.1	Replace both Roof Type I and Type II.	As soon as possible	\$250,000

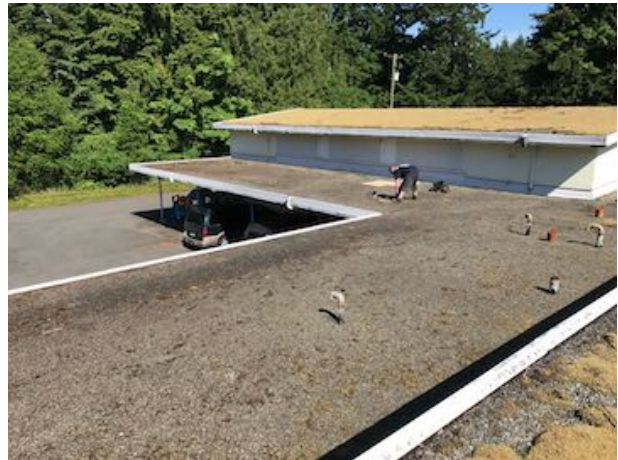
Photo 2 – An overview of Roof Type II

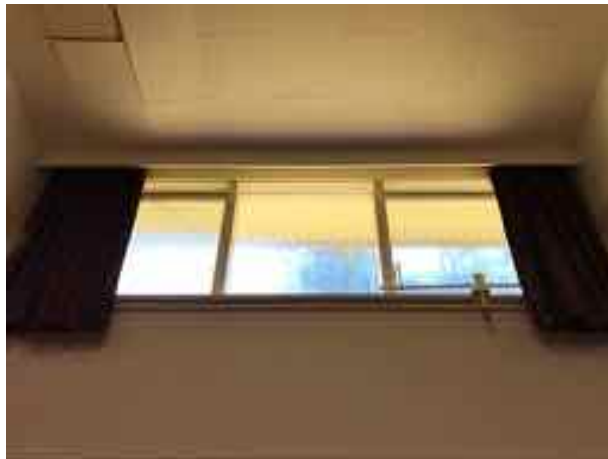
Photo 3 – Typical clerestory window

No sealant of any type was used at any of the window/wall interfaces that were observed. The lack of sealant will increase the likelihood of water infiltration and allow air to pass through the window/wall interfaces. The increased airflow will:

The windows and doors at the gymnasium have exceeded their expected service life. Most windows displayed moderate condensation. We recommend upgrading the aluminum windows and doors with new energy efficient windows and doors to meet the current building code requirements and to improve performance.

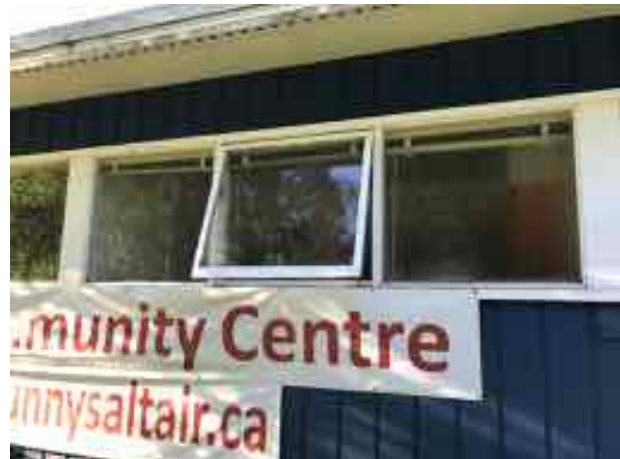
Photo 4 – Typical window at gymnasium kitchen

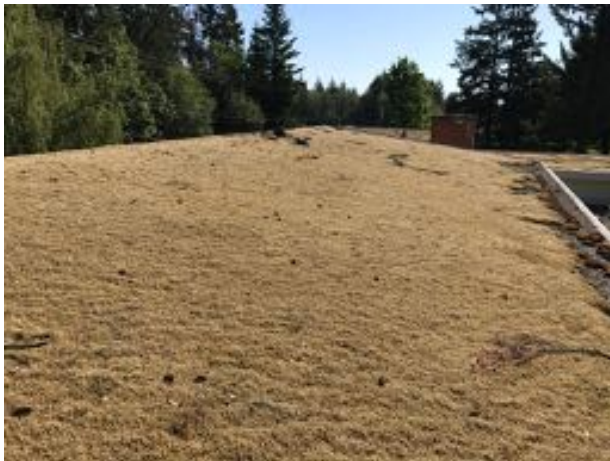
- Majority of the roof was covered with heavy moss growth. It was difficult to review the condition of the roof due to the thick moss growth. Refer to Photo 5.
- Scuppers and rainwater leaders were generally free of debris, however, they appeared to be in poor condition with stains, deteriorating sealants, and rusting fasteners. Refer to Photo 6.

Photo 5 – Extensive moss covering the roofing

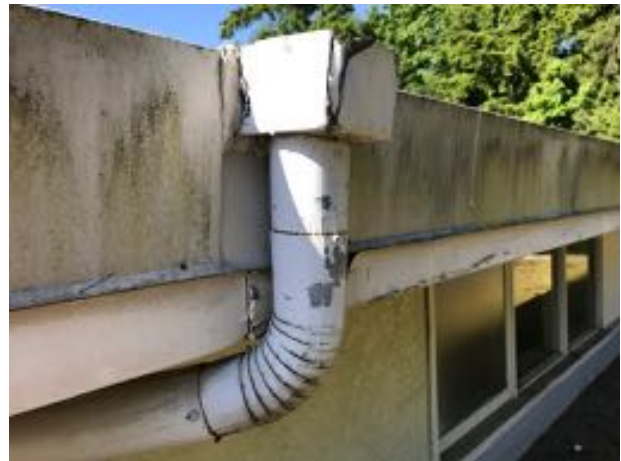
Photo 6 – View of a scupper and rainwater leader in poor shape

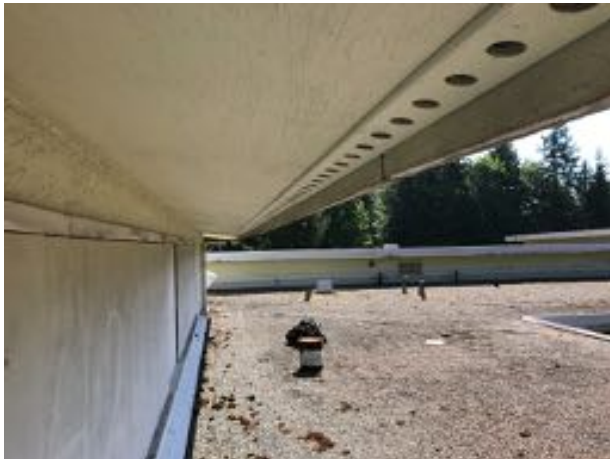
- Painted wood soffits with a series of vent openings appeared to be in fair condition. Refer to Photo 7.
- Metal flashing above the fascia boards at the perimeter of the roof were in poor condition with stains, deteriorating sealants, opening at corners, and deteriorating paint finish. Refer to Photo 8.
- Painted wood fascia boards at the perimeter of the roofs appeared to be in poor condition with peeling paint. Some fascia board reviewed were not painted. Refer to Photo 8.
- The moisture reading from the exploratory opening from were below 10% and the underlying roofing assembly appeared dry.

Photo 7 – Typical wood soffit with a vent strip

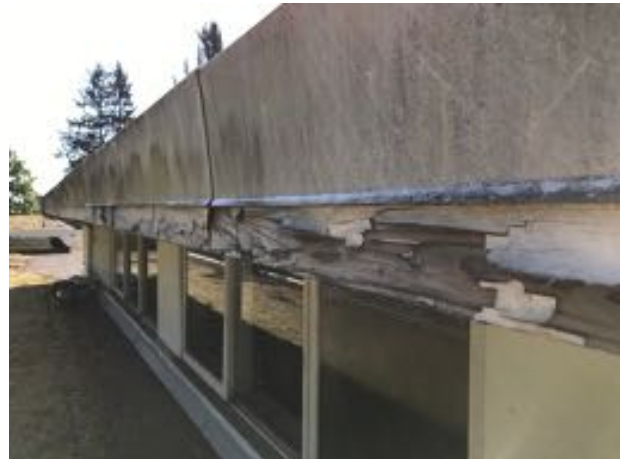
Photo 8 – Typical flashing and fascia boards

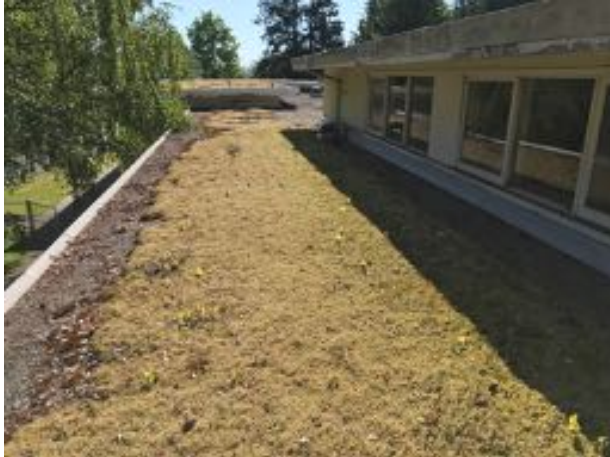
- North section of the roof was covered with heavy moss growth. It was difficult to review the condition of the roof due to the thick moss growth. Refer to Photo 9.

Photo 9 – Extensive moss covering the north side of the roof

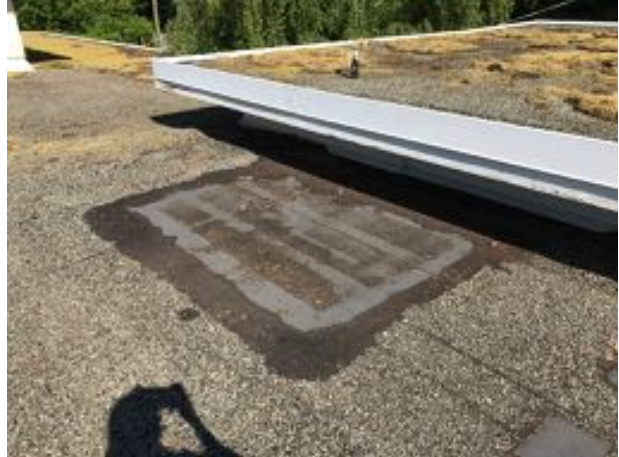
- Evidences of past repairs were noted in the middle of the roof area. Refer to Photo 10 and 11.
- Scuppers were generally free of debris, however they appeared to be in poor condition with stains, deteriorating sealants, and rusting fasteners.

Photo 10 – An evidence of past repair

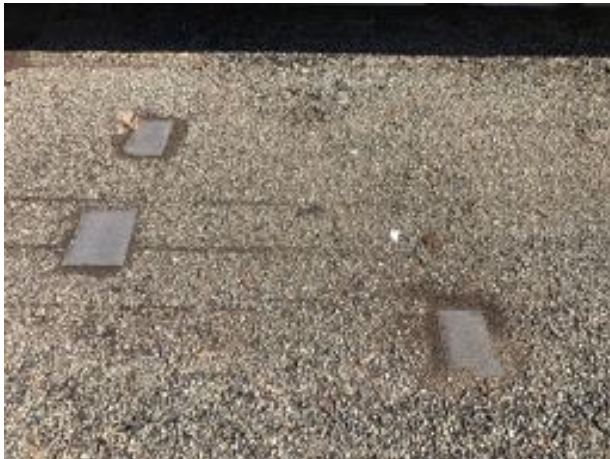
Photo 11 – Three additional repairs

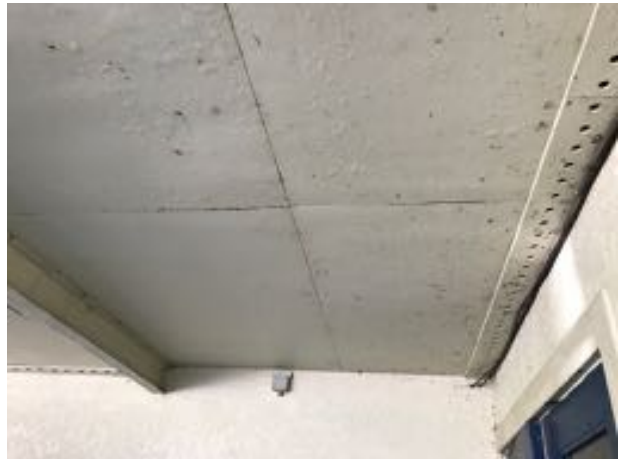
- Painted wood fascia boards at the perimeter of the roofs appeared to be in poor condition with peeling paint.
- Painted wood soffits at the southeast corner of the covered parking and pedestrian walkway were in poor condition with blistering paint finishes, rust stains, and microbial growth. Refer to Photo 12 and 13.

Photo 12 – Blistering paint finish and microbial growth on painted wood soffit

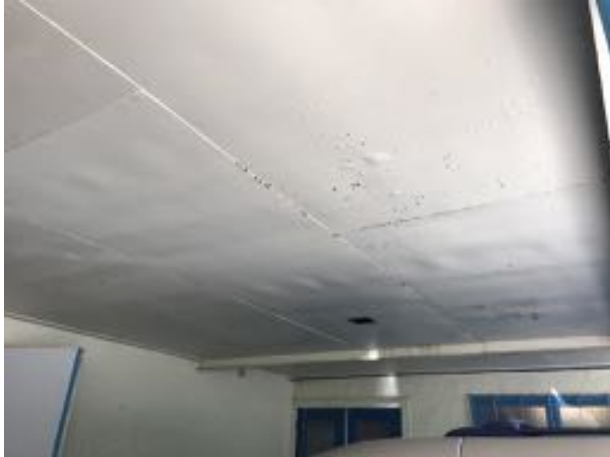
- We observed a rusted nail penetrating through the sheathing, water stains and microbial growth on wood members. Refer to Photo 13.

Photo 13 – Another example of blistering paint finish and microbial growth on painted wood soffit

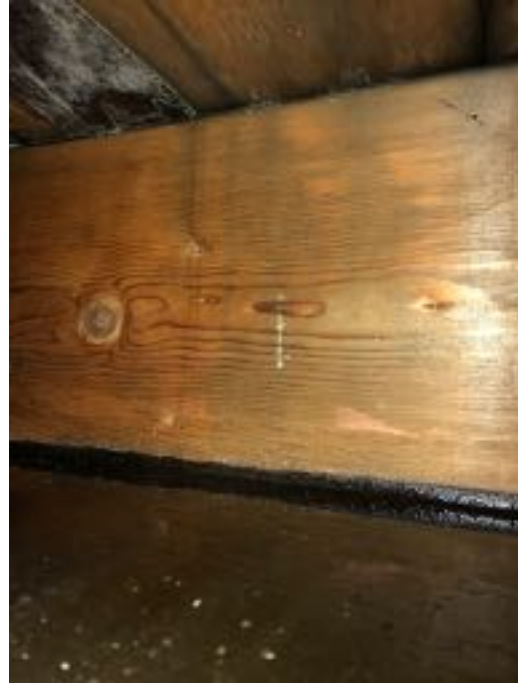
- Category 2, 3 and 4 readings were obtained from both soffit and roof openings on the west side of the roof.
- We observed pooling of water inside the framing cavity and the roof components were wet to touch. Refer to Photo 14 and 15.

Photo 14 – Pooling water sitting on soffit

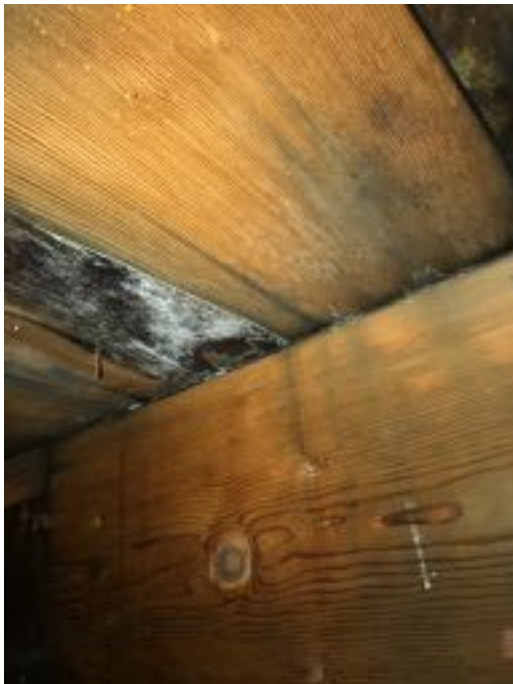
Photo 15 – Rusted nail penetrating through sheathing above and stains and microbial growth on wood members

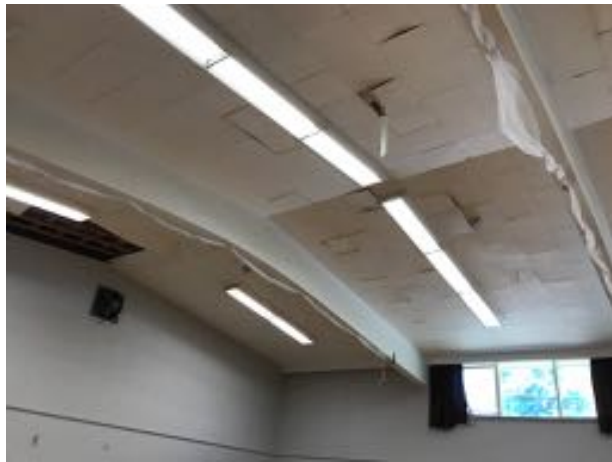
from the strapping manually. The backside of the ceiling tiles we reviewed were black or dark with microbial growth. The finishes of the fibreboard ceiling tiles were peeling or detaching from the fibreboard. Refer to Photo 16 and 17.

Photo 16 – Bulging and sagging ceiling tiles throughout

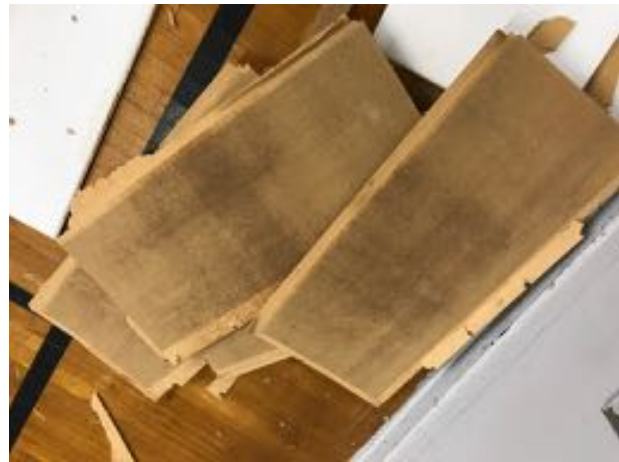
Photo 17 – Backside of the ceiling tiles that fell off from the ceiling

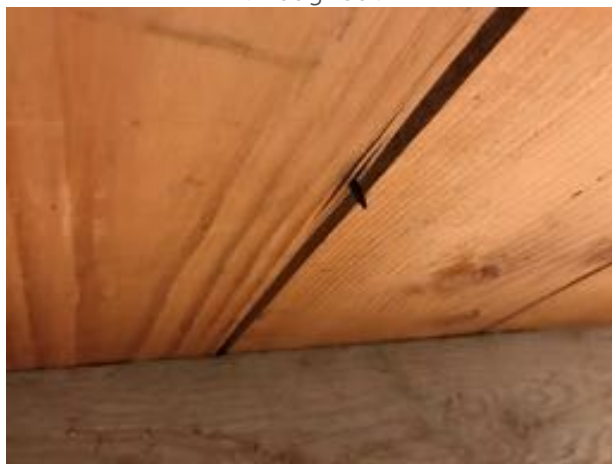
- The moisture readings from the interior ceiling openings varied between 9.5% to 25.6%. Category 2 and 3 readings were obtained from roof joists.
- At the east ceiling opening, we observed a nail penetration through the wood decking, and stains and microbial growth on wood members. Refer to Photo 18 and 19.
- We observed ghosting of the wood studs on the interior walls. Refer to Photo 20.
- It is our understanding that the gymnasium has not been used actively for the past 3 years and the exhaust fan has not been operating regularly. The fan was not tested; however, it appeared dated. Refer to Photo 20.

Photo 18 – A nail penetrating through the wood decking

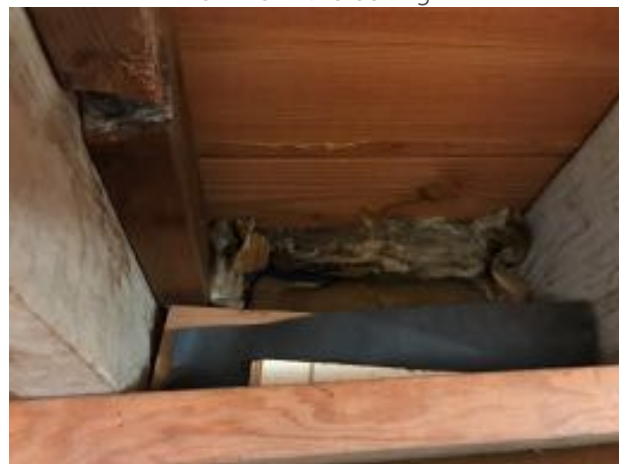
Photo 19 – Water stains and microbial growth on wood members

It is beyond MAE's area of expertise to evaluate or identify the mould or fungal colonies. We recommend engaging the services of a qualified indoor air quality consultant to review, evaluate evidence of mould and fungus colonies and advise on a course of action.

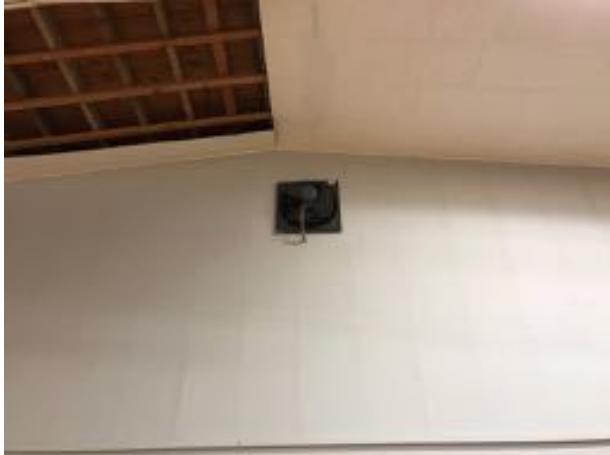
Photo 20 – Ghosting of studs on south wall and fan

- Upgrade gymnasium fan to a more powerful model;
- Install a humidistat which would automatically turn the fan on when the relative humidity reaches a preset level;
- Review of the fresh air intakes as required to ensure that adequate air exchange is occurring.

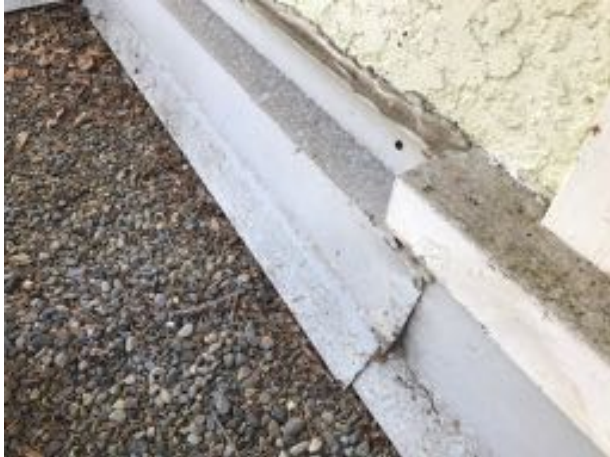
- Generally, flashing was not provided at exterior walls. Base wall flashing was found at the the interface of Roof Type II and gymnasium walls. It appeared as the existing stucco cladding was cut out and the base wall flashing and a continuous bead of sealant were installed. Refer to Photo 21.

Photo 21 – View of base wall flashing and sealant at roof-to-wall interface

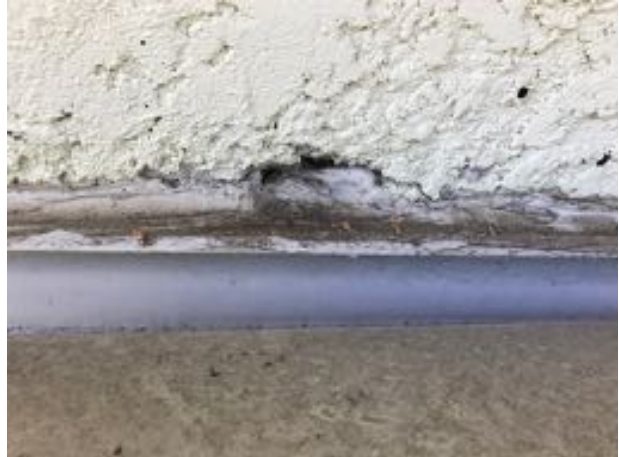
- Openings were found in uneven stucco cladding along the base wall flashing and sealant. Refer to Photo 22.
- Rainwater leaders are attached directly to the stucco cladding. No sealant was found around the fastener penetration through the stucco cladding. Refer to Photo 23.

Photo 22 – An opening above the flashing and sealant due to uneven stucco at base of wall

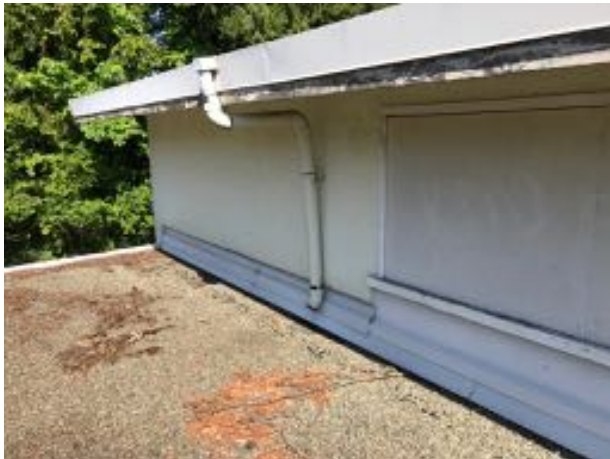
Photo 23 – Typical attachment of rain water leaders to the exterior wall without any sealant around the fasteners

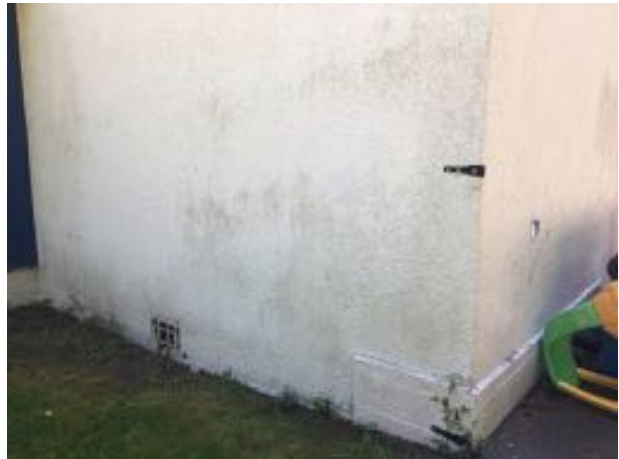
- The stucco cladding terminates at the grade on the north elevation. The best practice guide requires the cladding to terminate minimum 8 inches above finished grade. Refer to Photo 24.

Photo 24 – View of north wall where stucco cladding terminates at grade

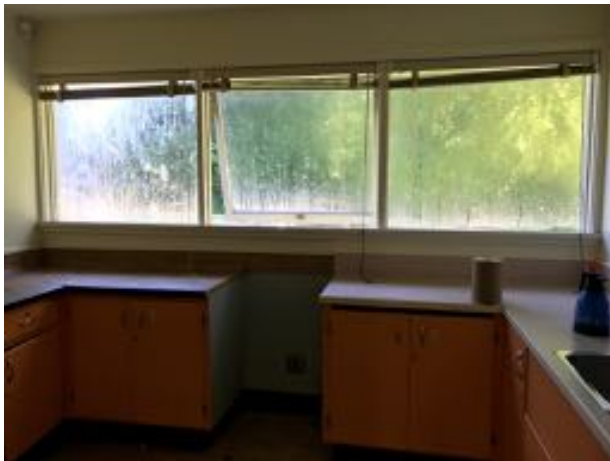
- Condensation and fogging were observed on the inside face of glazing. Refer to Photo 25 and 26.
- Microbial growth was observed around the glazing perimeter and window sills. Refer to Photo 27, 28 and 29.
- Window coverings at the storage rooms were stained black with microbial growth. Refer to Photo 30.
- The windows on the south wall of the gymnasium have been boarded up from outside and could not be reviewed. Refer to Photo 31.

Photo 25 – Condensation and fogging on the inside face of glazing

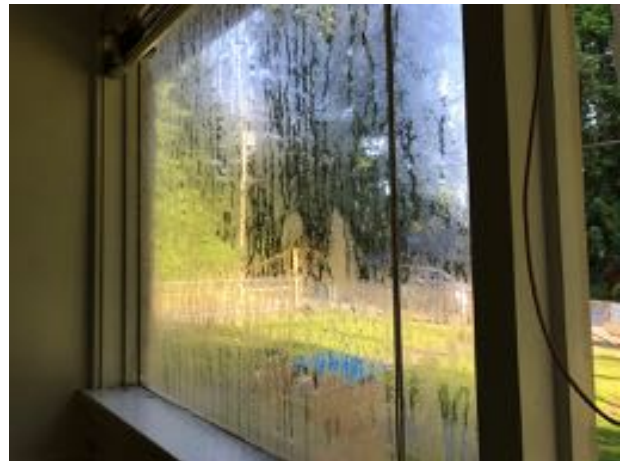
Photo 26 – Close up of the condensation on window glazing

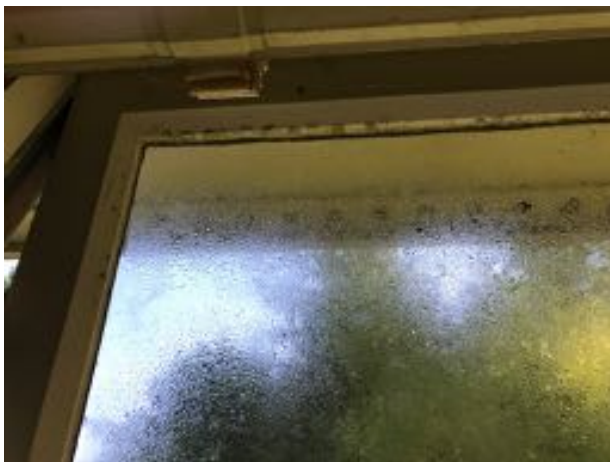
Photo 27 – Microbial growth around window around the glazing perimeter

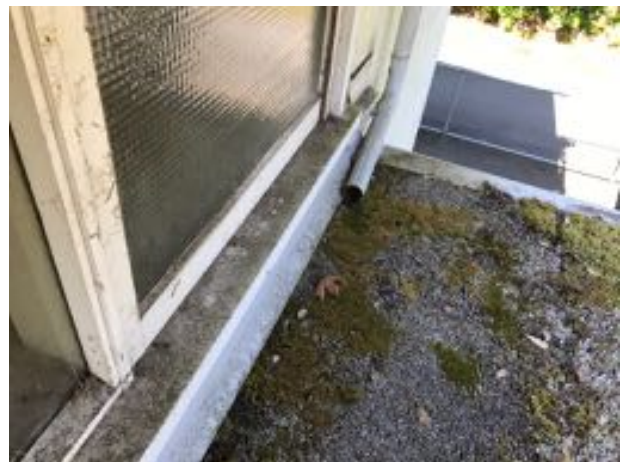
Photo 28 – Microbial growth on window sill

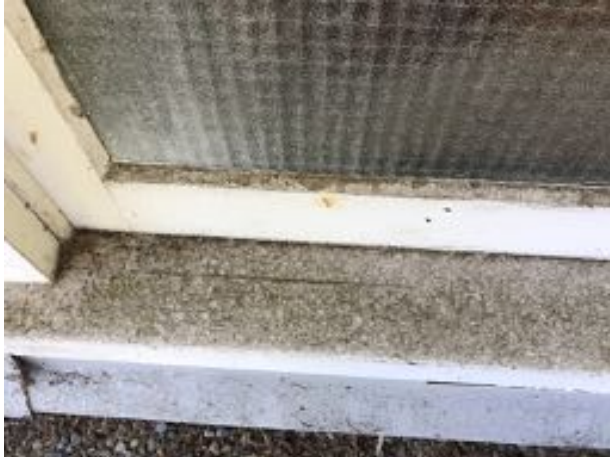
Photo 29 – Microbial growth and deteriorating paint finishes at window frame and sill

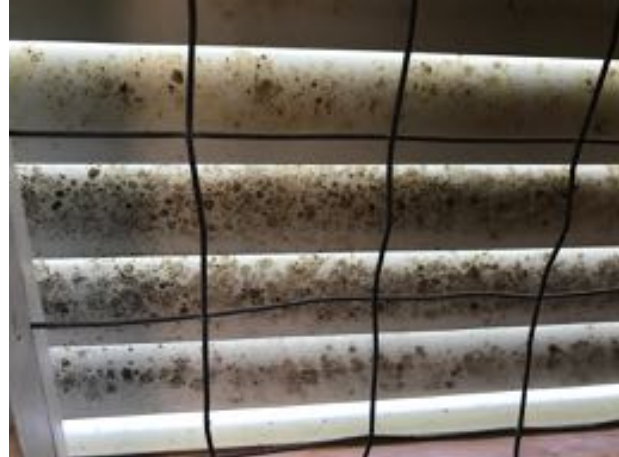
Photo 30 – Microbial growth on window covering

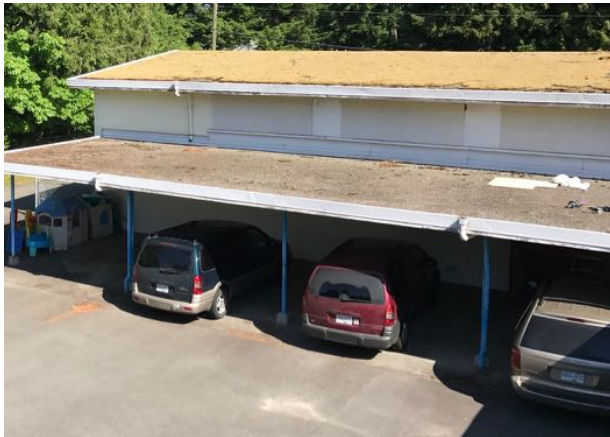
Photo 31 – Boarded up windows of on south elevation
