2020 Corporate Strategic Asset Management Plan

Appendix E Condition Assessment Framework Part 2 - Facilities

MH Project No. 5170700.00

**Cowichan Valley Regional District
Facility Condition Assessment and Capital Plan
CVRD Head Office, 175 Ingram Street, Duncan, BC**

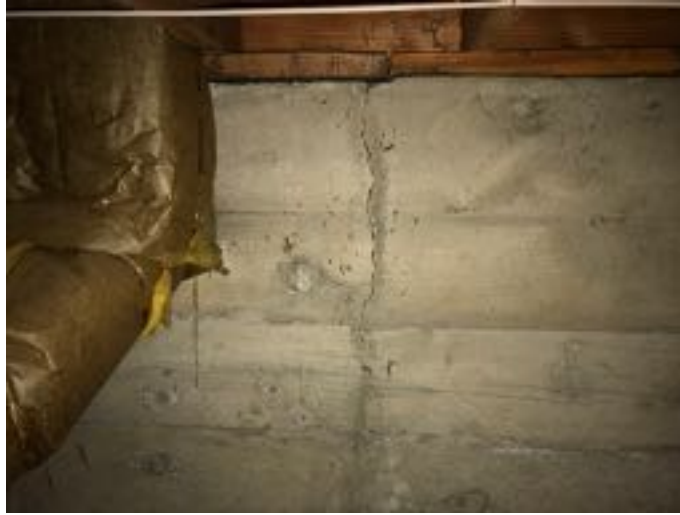
Photo 1 – General view of foundation crawlspace	Photo 2 – A crack in foundation wall
B10 – Superstructure	Wood Framing

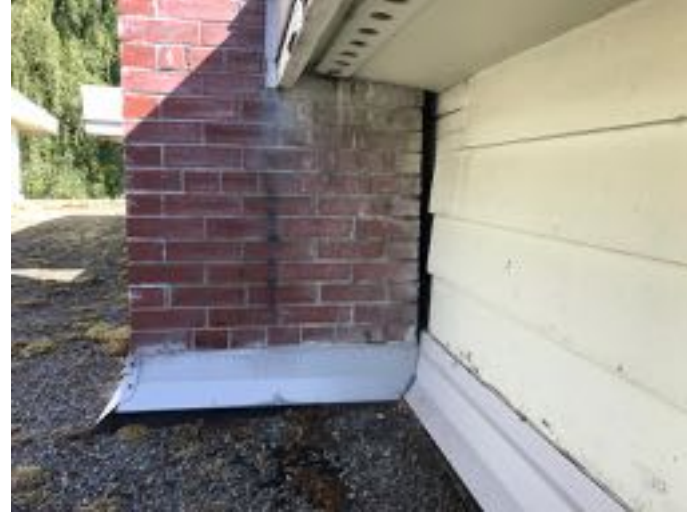
Photo 5 – Painted wood siding on north elevation	Photo 6 – Painted wood siding on southwest elevation	Photo 7 – Poor painted wood siding wall-to-brick chimney interface detail
B2010 – Exterior Walls	Painted Wood Soffit with Vent Strip

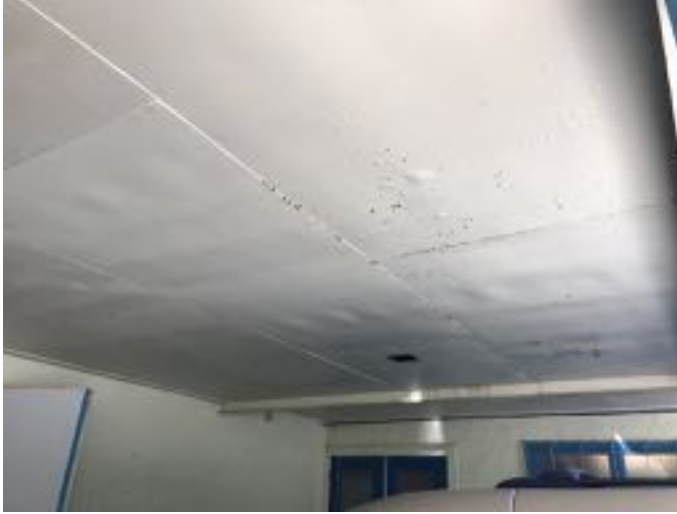
Photo 8 – Typical painted wood soffit with perimeter vent strips	Photo 9 – Painted wood soffit with blistering and microbial growth	Photo 10 – Moisture and microbial growth on painted wood soffit

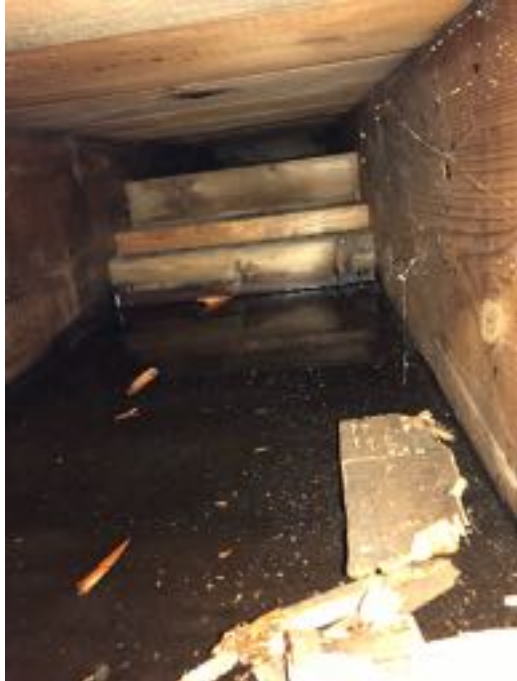
Photo 57 – Pooling water sitting on soffit	Photo 58 – Stains and microbial growth on framing members; rusted nail penetrating through sheathing above	Photo 59 – Damaged perimeter flashing

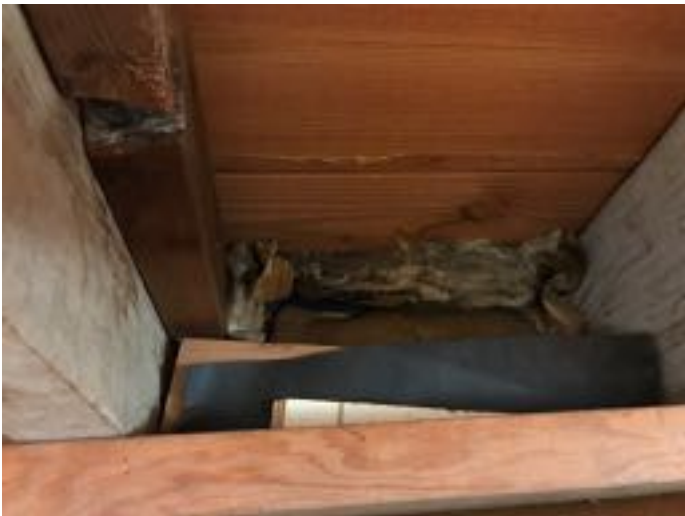
Photo 60 – Water stains and microbial growth on wood members within gymnasium roofing assembly	Photo 61 – A nail penetrating through the wood decking at gymnasium roofing assembly	Photo 62 – A disconnected rainwater leader; different rainwater leader materials

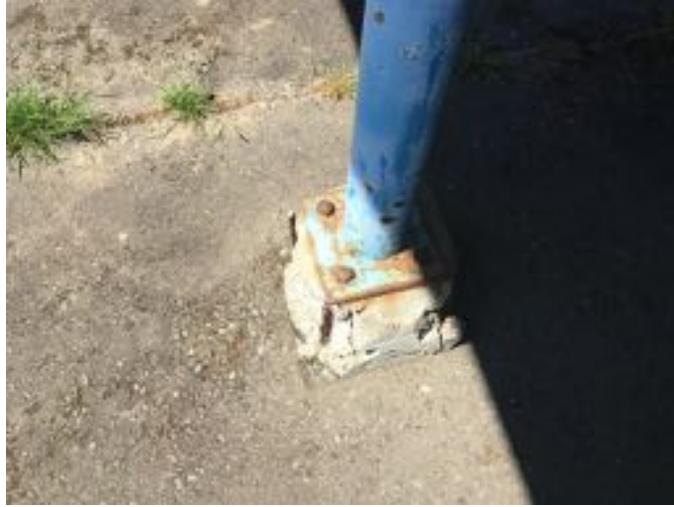
Photo 63 – Rusted base of column under gymnasium canopy	Photo 64 – Rusted base of column and damaged concrete column base under gymnasium canopy	Photo 65 – Damaged concrete column base under gymnasium canopy
C1030 – Fittings	Washroom Partitions

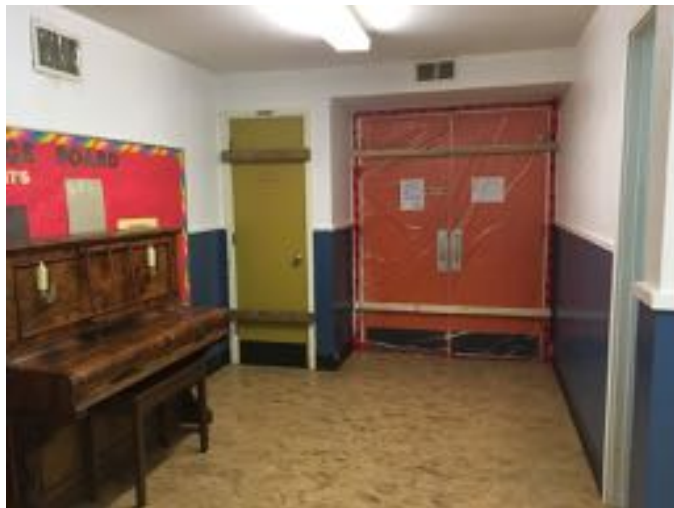
Photo 74 – Doors to gymnasium sealed and blocked to limit access

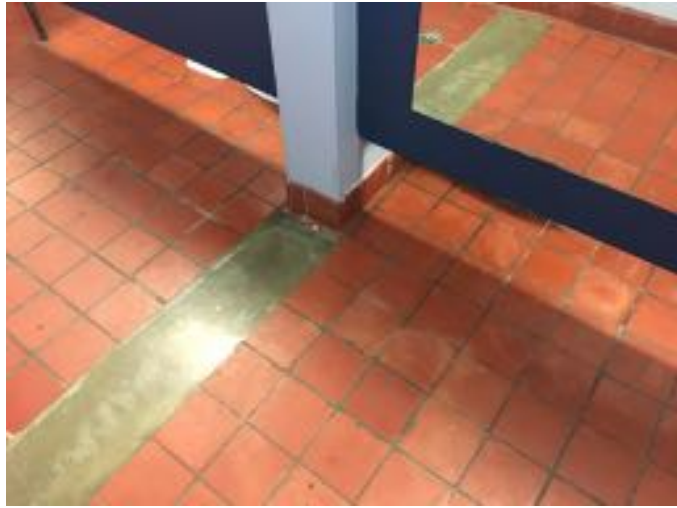
Photo 88 – Tiled flooring in Boys Lav 13 & Girls Lav 15	Photo 89 – Tiled flooring in Lav 10	
C3020 – Floor Finishes	Laminate Wood Flooring

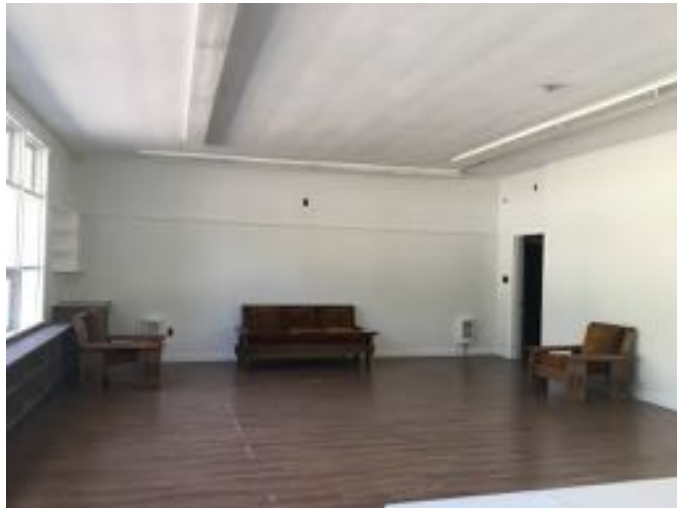
Photo 90 – Laminate wood flooring in Classroom 18

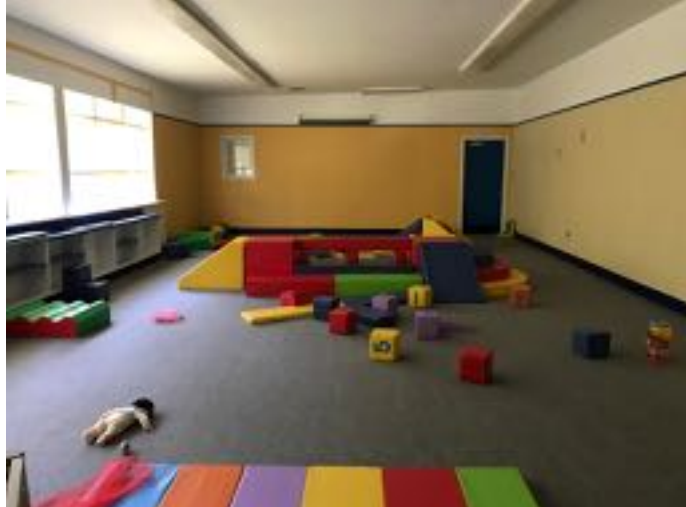
Photo 91 – Carpet flooring throughout daycare areas	
C3020 – Floor Finishes	Sports Flooring at Gymnasium

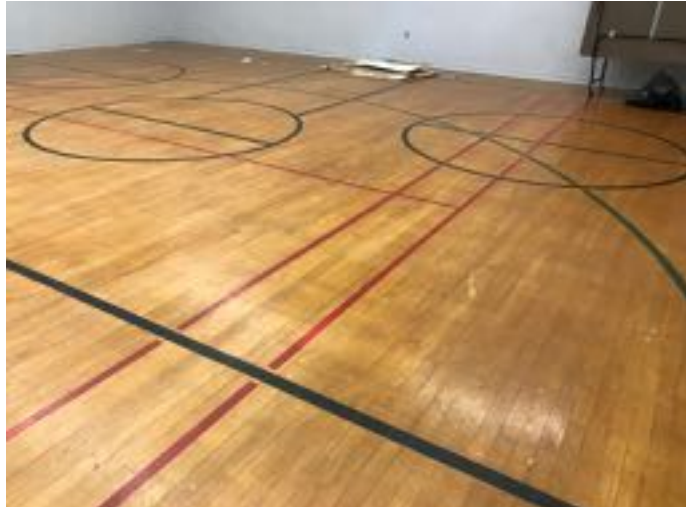
Photo 92 – Gymnasium flooring with game lines

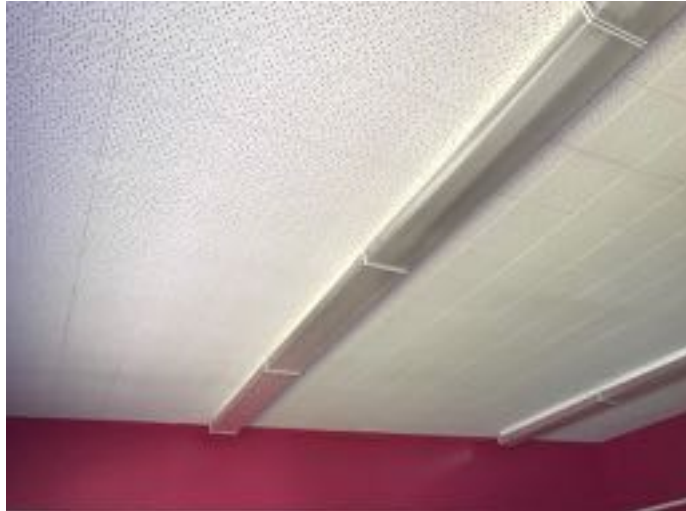
Photo 93 – Acoustic ceiling tiles at Library 6		
C3030 – Ceiling Finishes	Fibreboard Ceiling Tile at Gymnasium

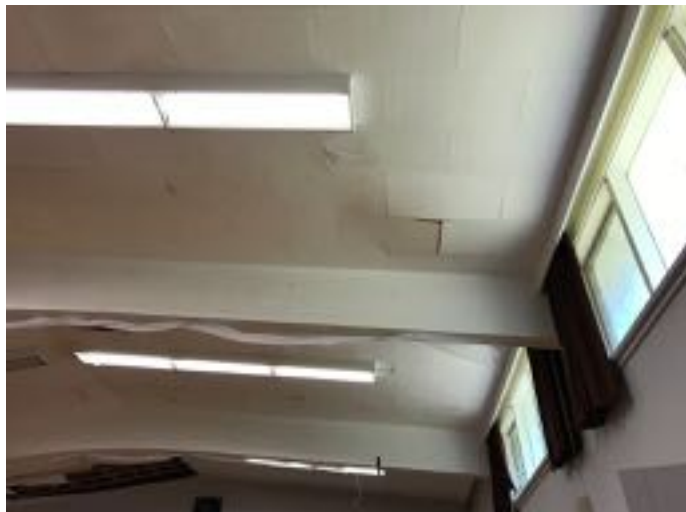
Photo 94 – Bulging and sagging tiles throughout gymnasium	Photo 95 – West gymnasium ceiling where multiple ceiling tiles have fallen off	Photo 96 – Microbial growth on the backside of ceiling tile

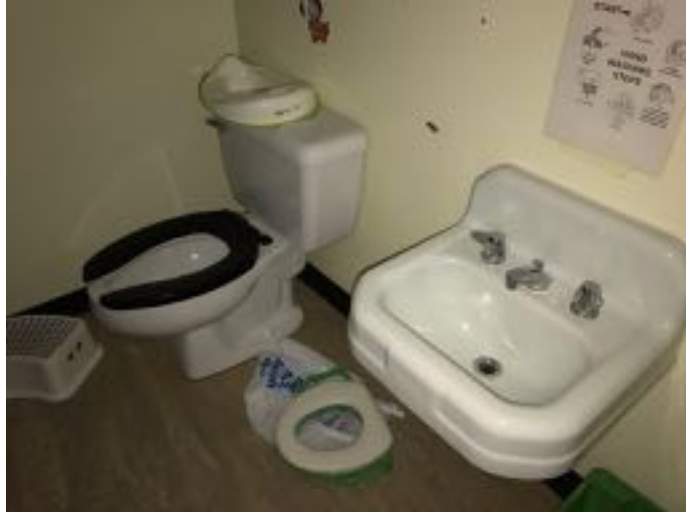
Photo 101 – Typical toilet and lavatory	Photo 102 – Typical toilet in Boys and Girls Lav	Photo 103 – Typical urinals in Boys Lav
D2010 – Plumbing Fixtures	Sinks & Lavatories

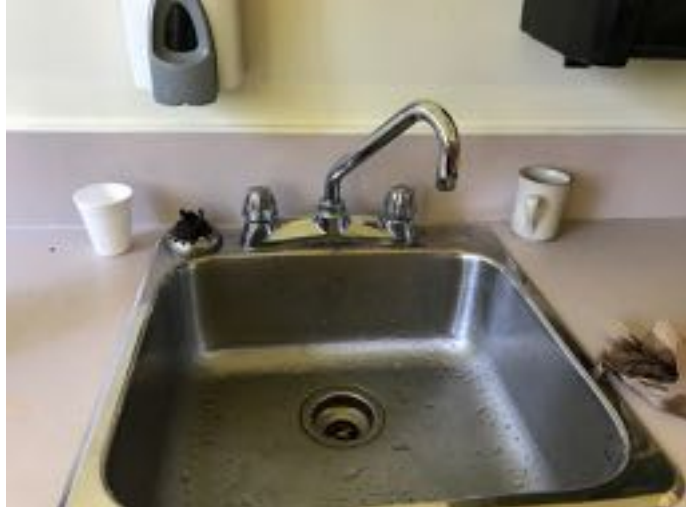
Photo 104 – Typical sink	Photo 105 – Lavatories in Boys and Girls Lav

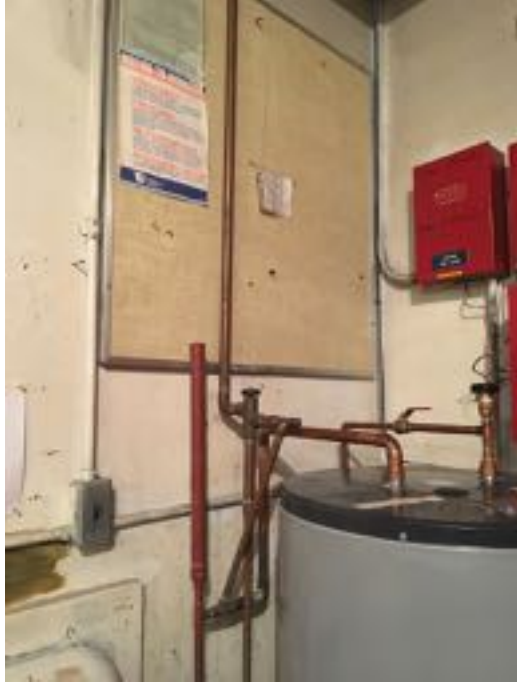
Photo 106 – Copper pipes from hot water tank		
D2030 – Sanitary Waste	Sanitary Waste System

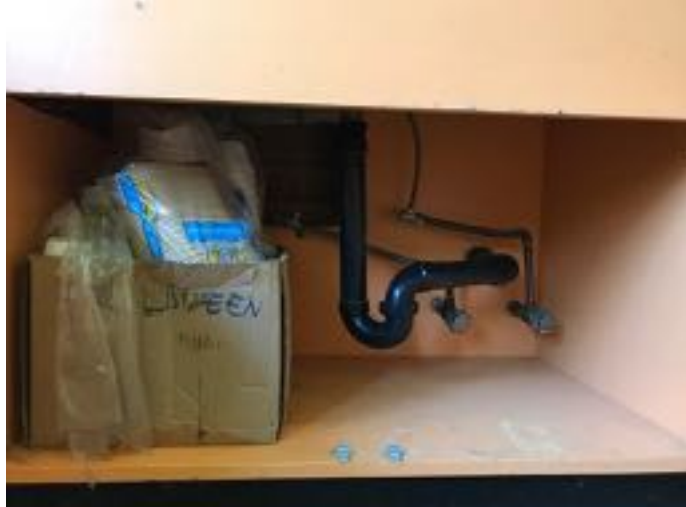
Photo 107 – Typical under sink pipes	Photo 108 – Copper pipes found under a sink

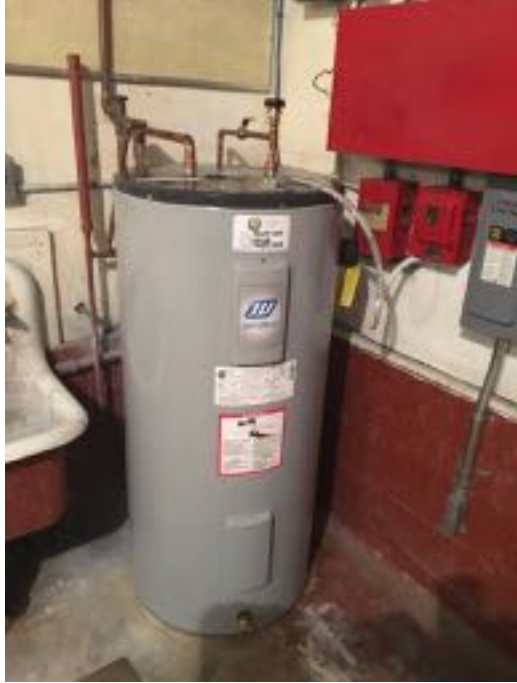
Photo 109 – Hot water storage and heating tank		
D3012 – Gas Supply System	Gas Distribution System

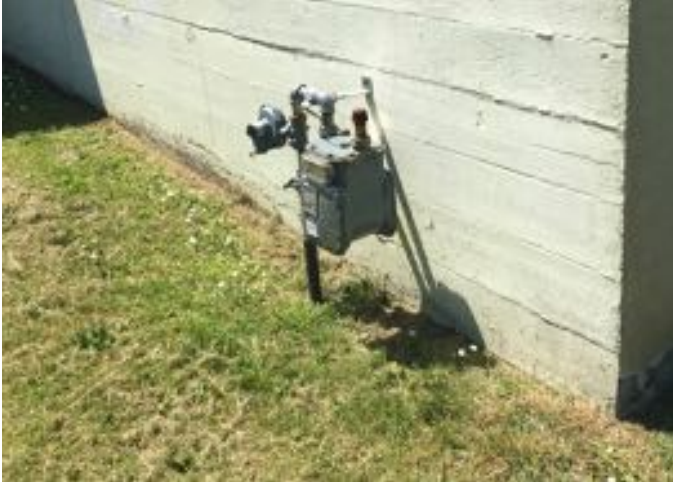
Photo 110 – Gas meter found at northeast corner of the building

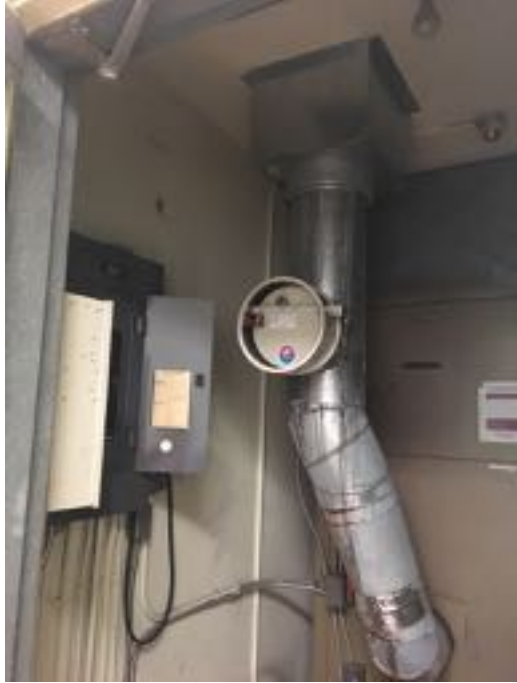
Photo 111 – Furnace 4 in Furnace Rm 9		
D3023 - Furnaces	Furnaces 1, 2 & 3

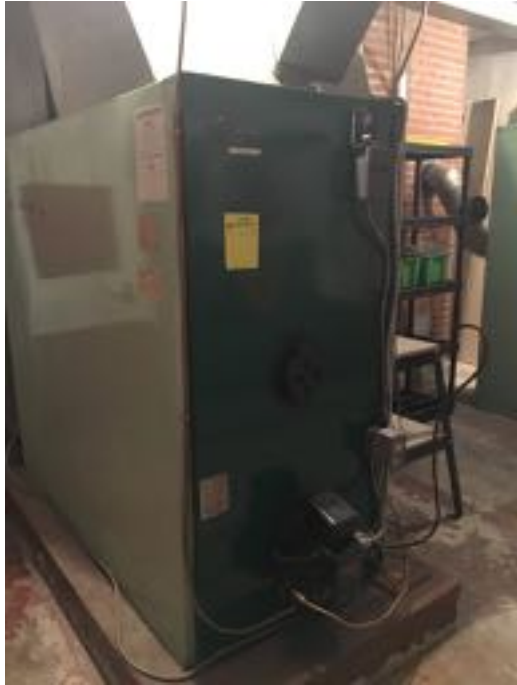
Photo 112 – Furnace 1 in Furnace Room 3	Photo 113 – View of ducting and Furnace 2	Photo 114 – View of Furnace 1 and 2

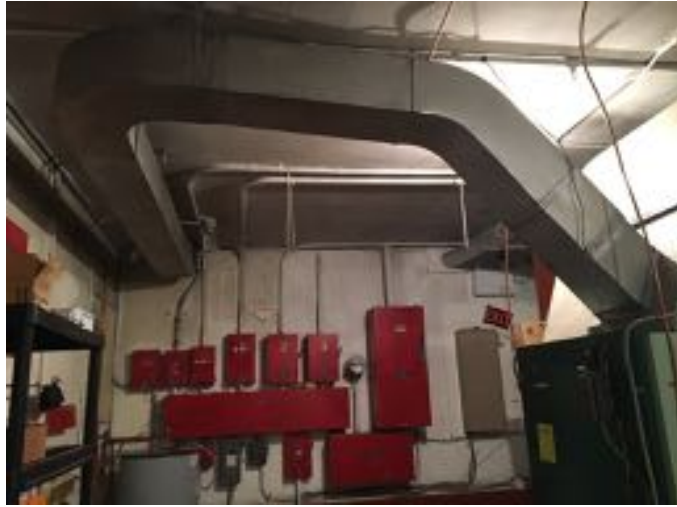
Photo 115 – Ducting inside Furnace Room 3		
D3045 – Exhaust Ventilation Systems	Washroom Exhaust Fans

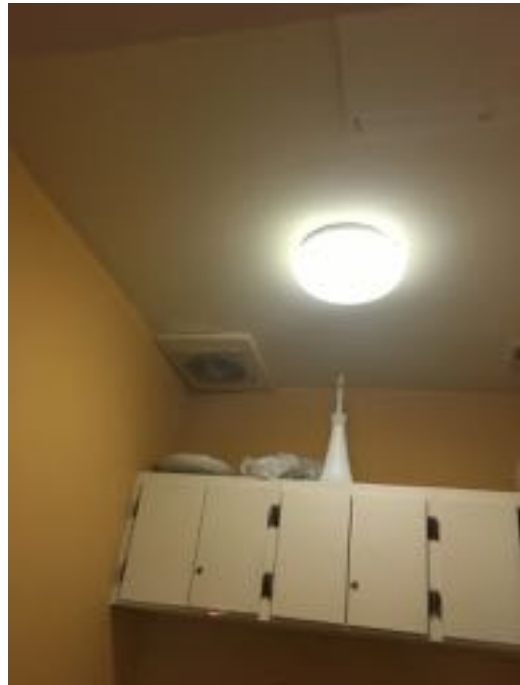
Photo 116 – Exhaust fan in Lav 10	Photo 117 – Exhaust fan in Boys Lav 13

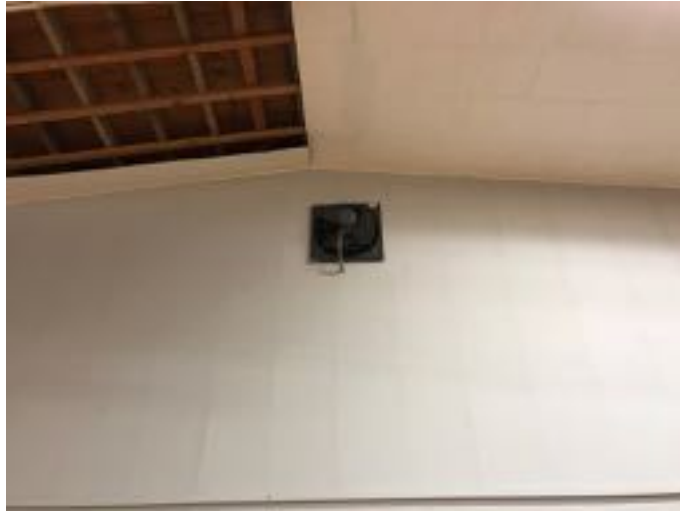
Photo 118 – Wall mounted gymnasium fan		
D3045 – Exhaust Ventilation Systems	Chimneys

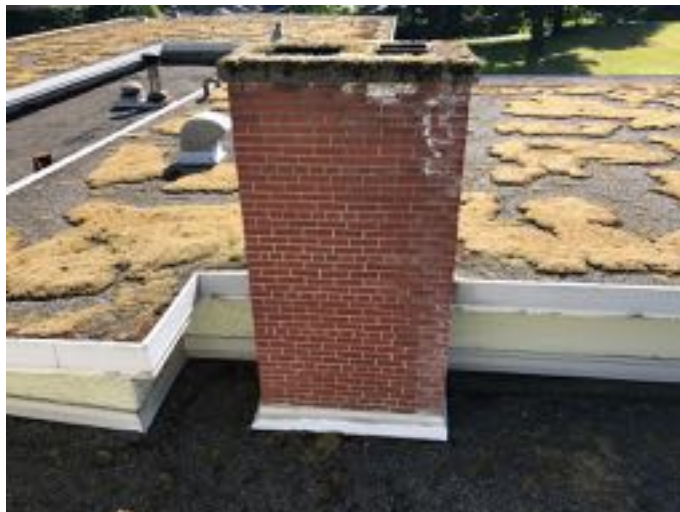
Photo 119 – Chimney found in the middle of the roofs	Photo 120 – Chimney found at the southeast corner of the building	Photo 121 – Moss growth, deteriorating brick and mortar, and efflorescence found on chimney

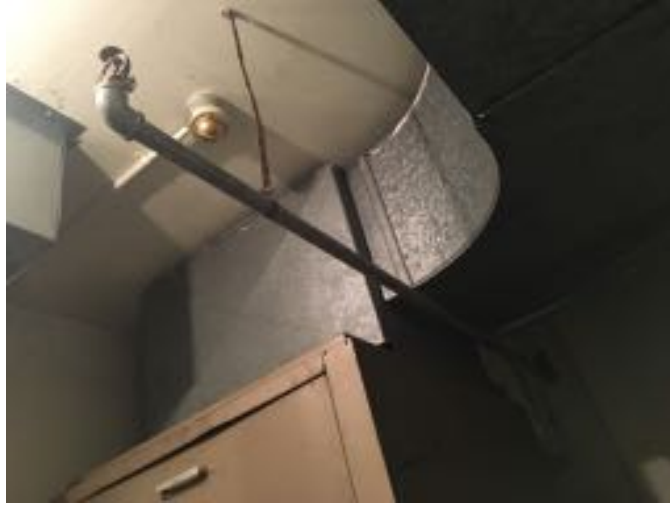
Photo 122 – View of sprinkler pipe and head	Photo 123 – Sprinkler valve found in Furn 9	
D5010 – Electrical Service and Distribution	Electrical Service and Distribution

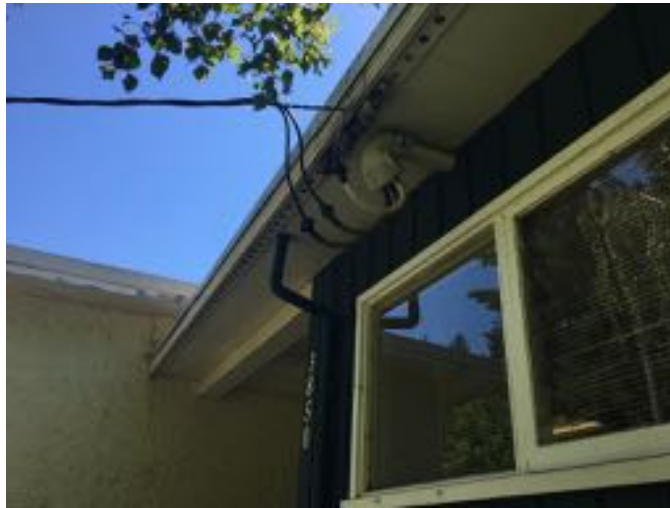
Photo 124 – Main incoming power	Photo 125 – Electrical service found in Furnace Room 3

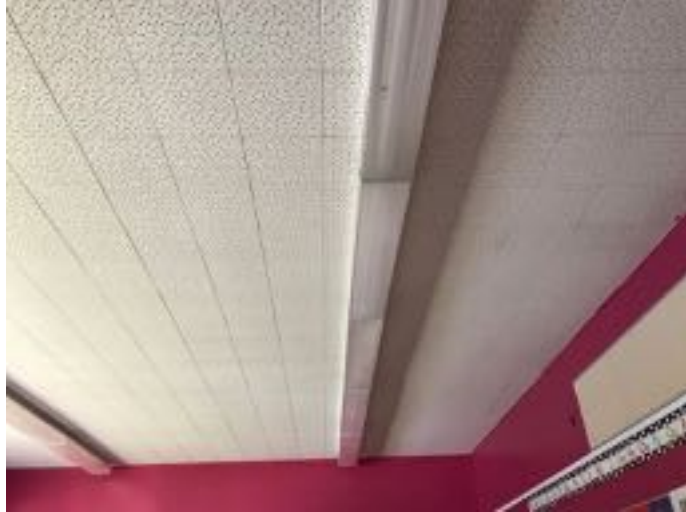
Photo 126 – Typical fluorescent lights	Photo 127 – View of T-8 fluorescent tubes	Photo 128 – A stain inside light fixture
D5022 – Lighting Equipment	Exterior Light Fixtures

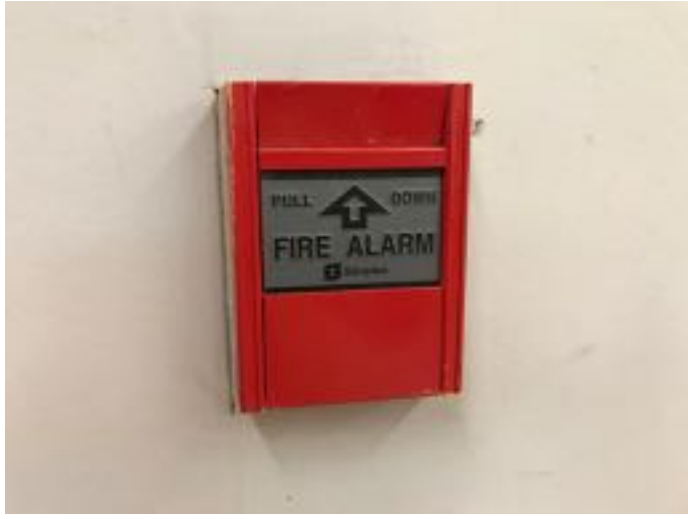
Photo 131 – Typical pull station	Photo 132 – Typical fire extinguisher	Photo 133 – Fire alarm panel found at the main entrance

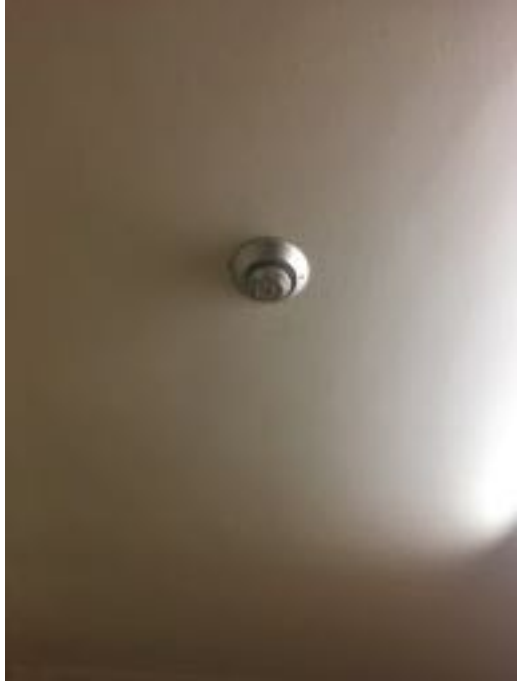
Photo 134 – Typical heat detector

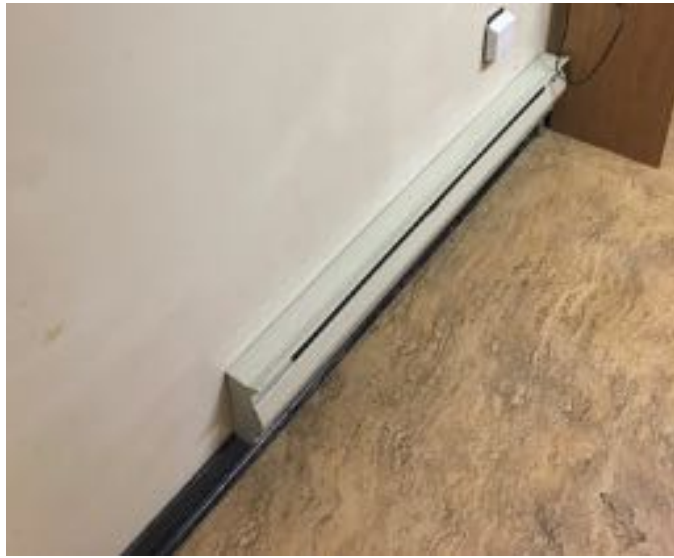
Photo 136 – Typical electric baseboard heater

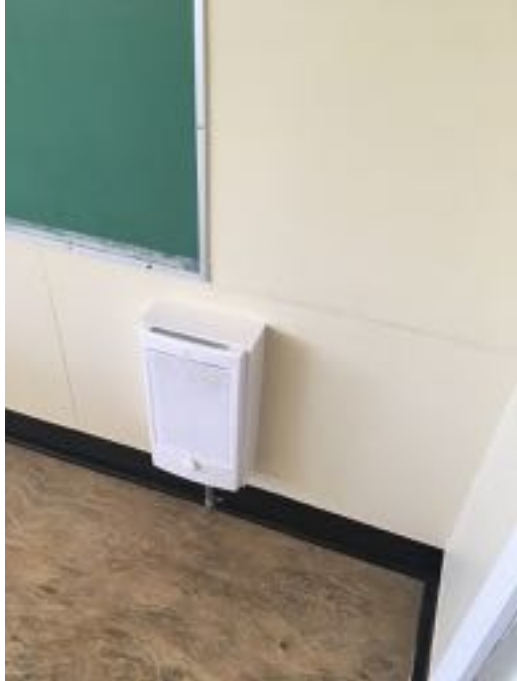
Photo 137 – Typical wall mounted electric cadet heater		
G2020 – Parking Lots	Asphalt Paved Parking

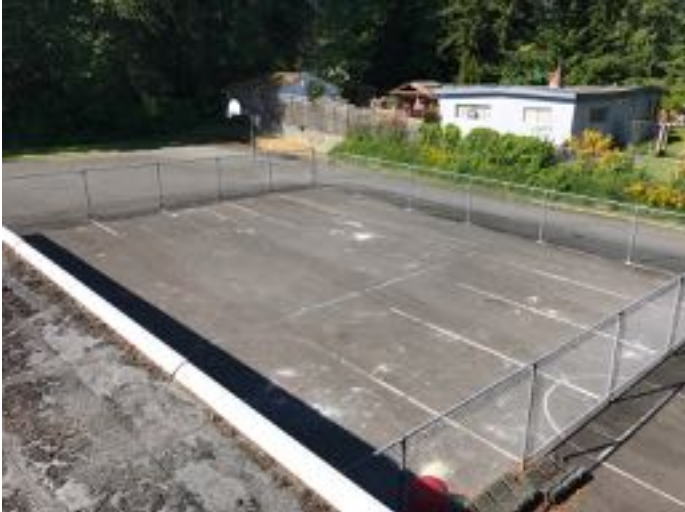
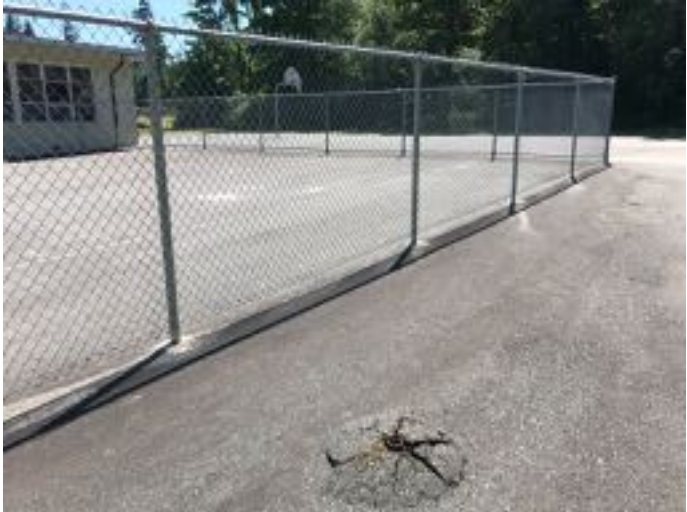
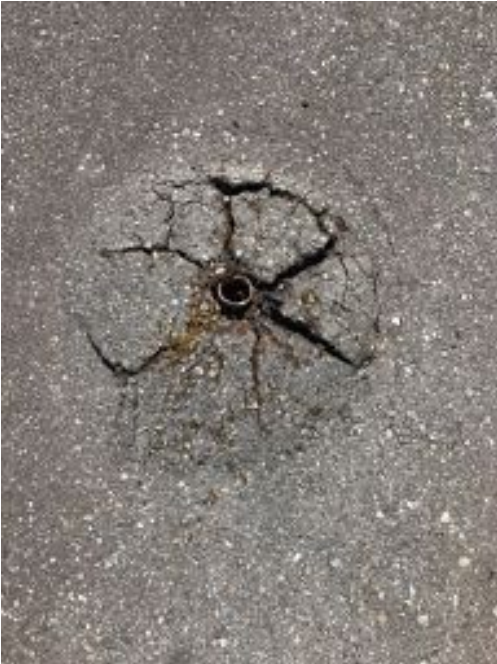
Photo 138 – View of asphalt paved fenced play area	Photo 139 – A potential trip hazard near fenced play area	Photo 140 – Close up of the trip hazard

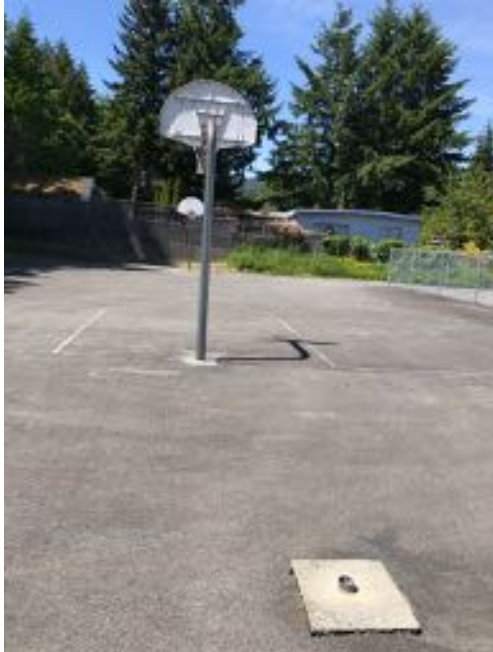
<p>Photo 141 - A potential trip hazard near basketball court</p>		
G2030 – Pedestrian Paving	Concrete Paved Pedestrian Walkway

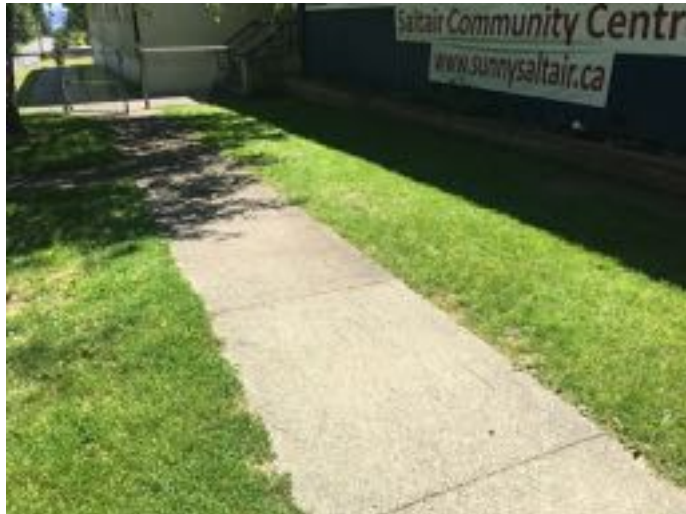
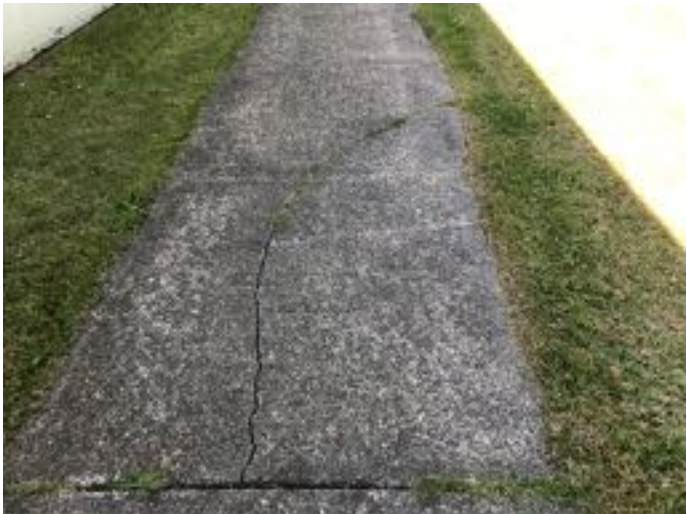
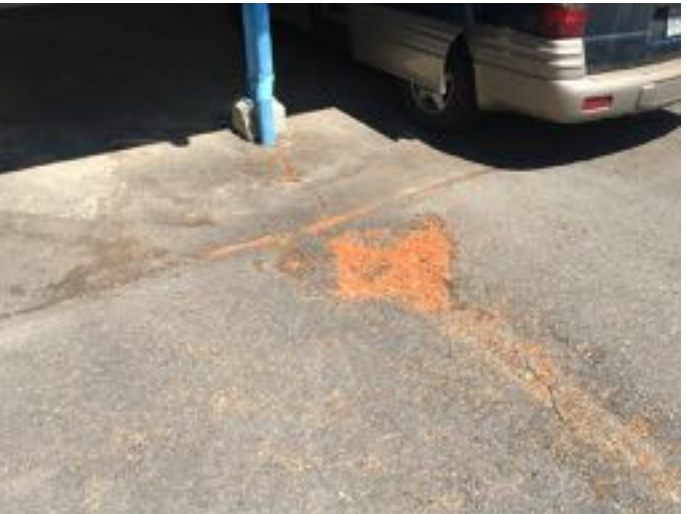
<p>Photo 142 – Typical concrete paved walkway</p>	<p>Photo 143 – Crack in concrete paved walkway</p>	<p>Photo 144 – Uneven walking surface near covered parking area</p>

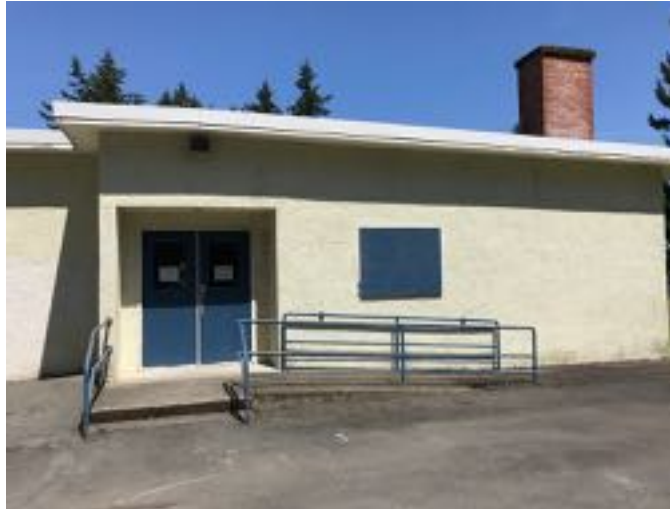
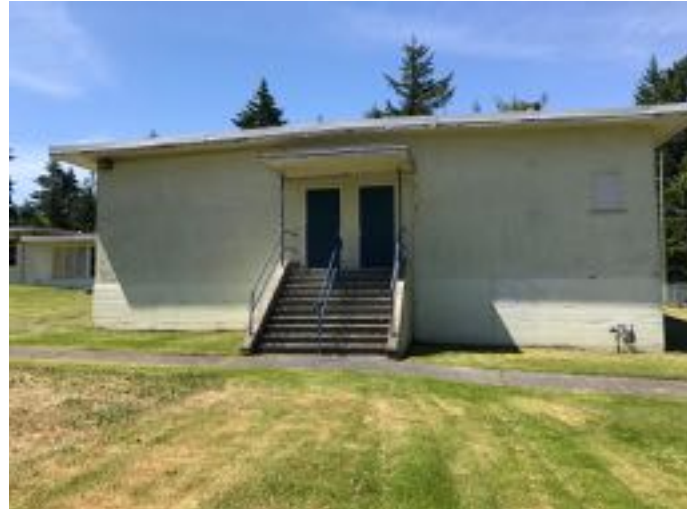
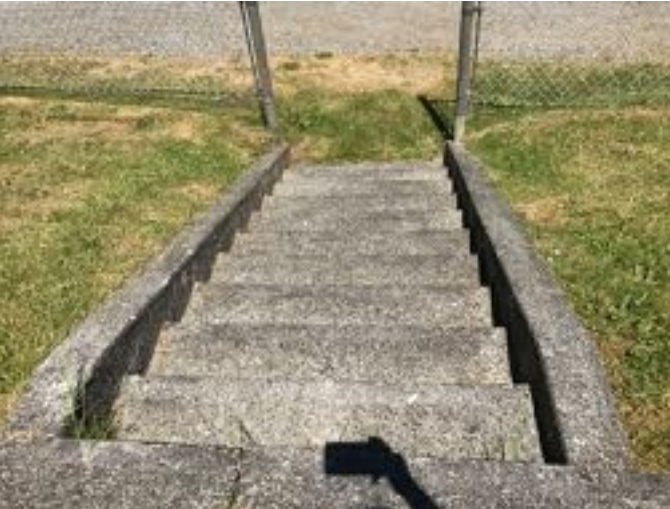
<p>Photo 146 – Stairs and ramp at south exit</p>	<p>Photo 147 – Stairs at east exit</p>	<p>Photo 148 – Stairs from street on north elevation</p>

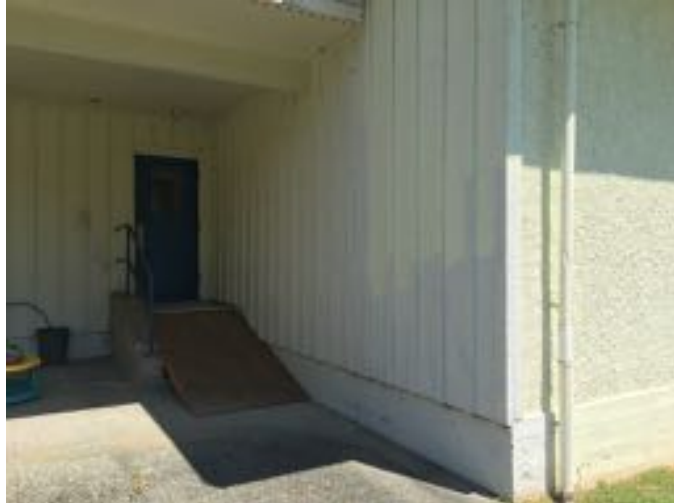
Photo 149 – A temporary ramp found on southeast corner of the building		
G3020 – Sanitary Sewer	Septic Tanks

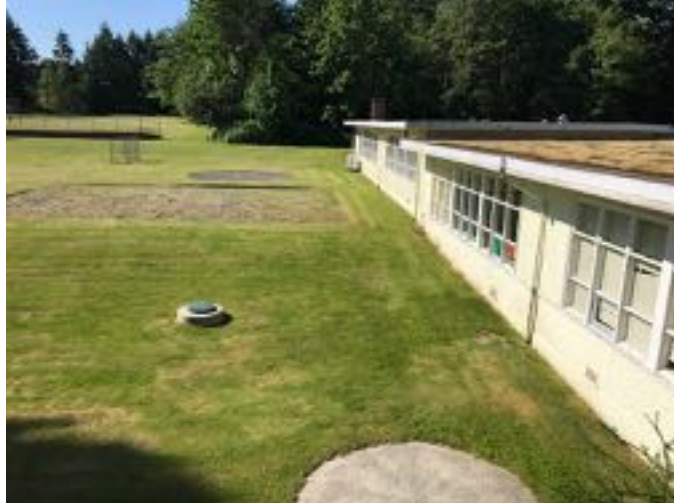
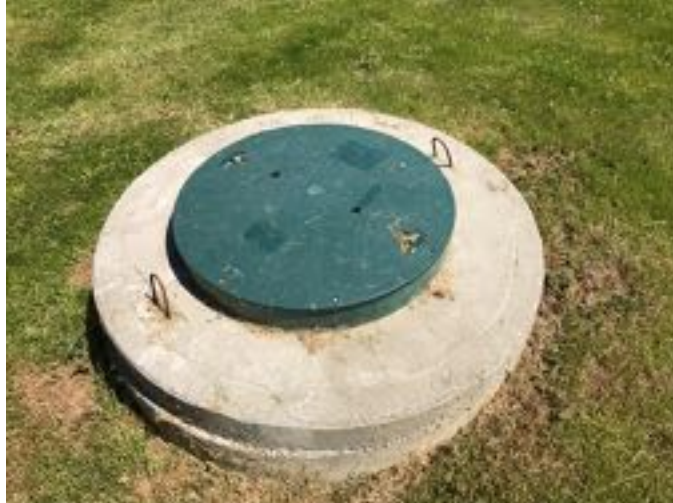
Photo 150 – View of septic system	Photo 151 – Septic system access point
