# **2020 Corporate Strategic Asset Management Plan**

## **Appendix E Condition Assessment Framework Part 5 - Water Systems**

**Re: CVRD Infrastructure Condition Assessments  
Final Deliverable Overview**

Cowichan Valley Regional District  
 Facility Condition Assessment and Capital Plan  
 Satellite Park - Water Treatment Building - Functional Code 601

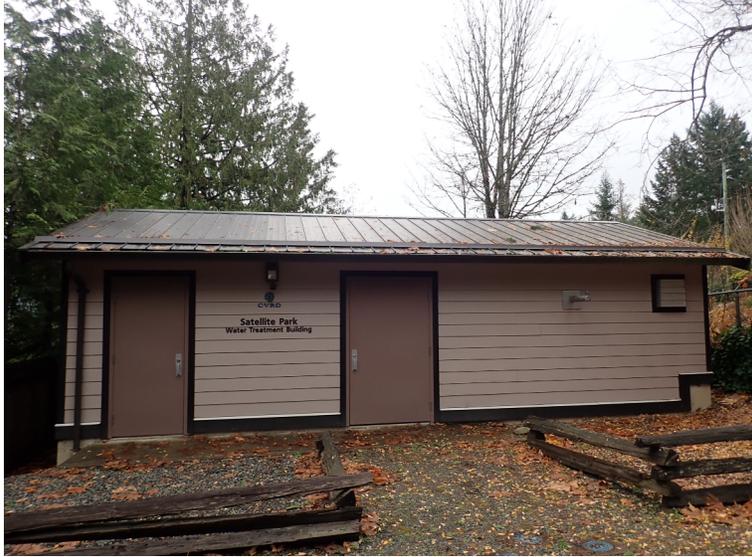
Photo 1

Satellite Park - Water Treatment Building - Functional Code 601

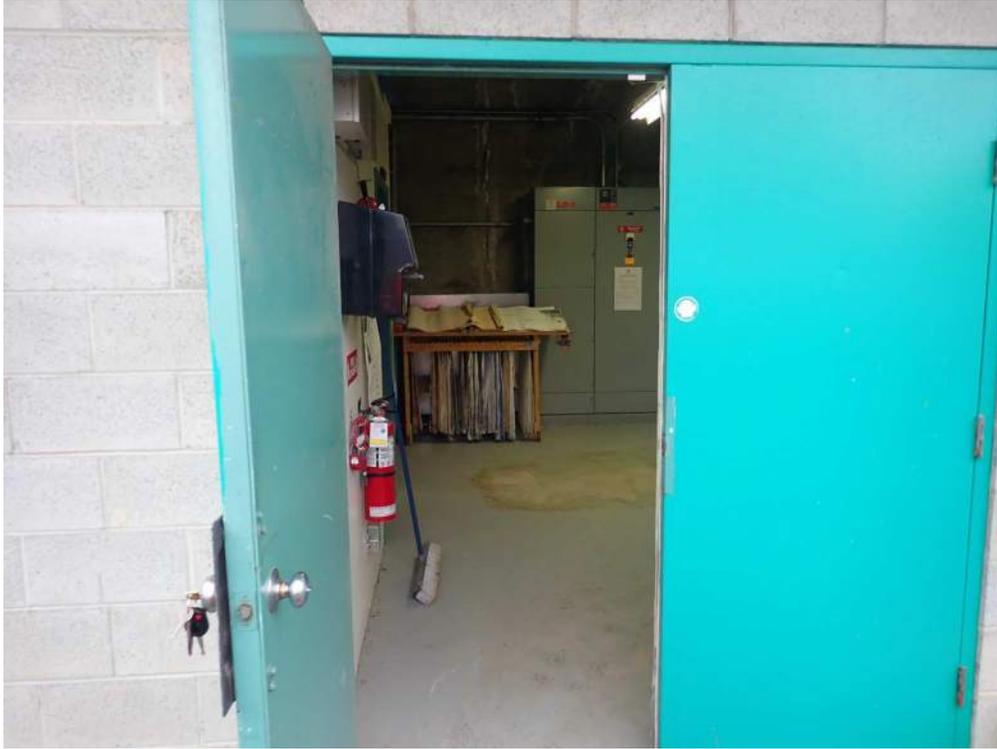
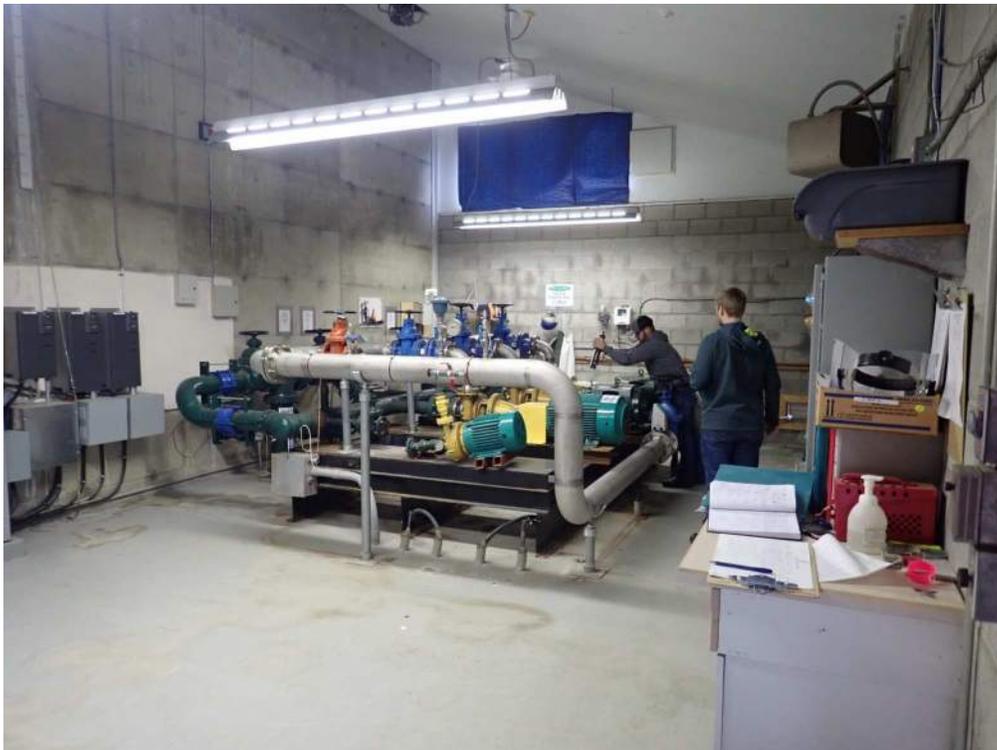
7	615	3717 Abutus Drive North	Reservoir (behind water treatment plant)	Site Visit / Photos	W RES	RES-1	RES-1	12, 13, 31	Reservoir - 1,291 x10 (280,000 Imp. Gall) concrete, located behind water treatment building	Concrete				1	LS	1987		40	0	\$1,300,000	\$1,300,000	Good - concrete in good shape				3	2	4	Inspects the condition of the reservoir for deterioration to determine replacement timing/strategy.	Operations	\$5,000	1-3 Year				
8	615	3717 Abutus Drive North	Country club parking pump station		W PS	PS-1	PS-1	NA	Pump station					1	ea	2006		28	0	\$10,000	\$10,000					3	2	4	Inspects the condition of the pump station and pumps for deterioration to determine replacement timing/strategy.	Operations	\$5,000	1-3 Year				
9	615	3717 Abutus Drive North	Country club parking pump station		W PS	PS-2	PS-2	NA	Pump, 5HP	Moruech	ZKRM			1	ea	2006		20	0	\$5,000	\$5,000					2	2	4	Inspects the condition of the pumps for deterioration to determine replacement timing/strategy.	Operations	Included above	1-3 Year

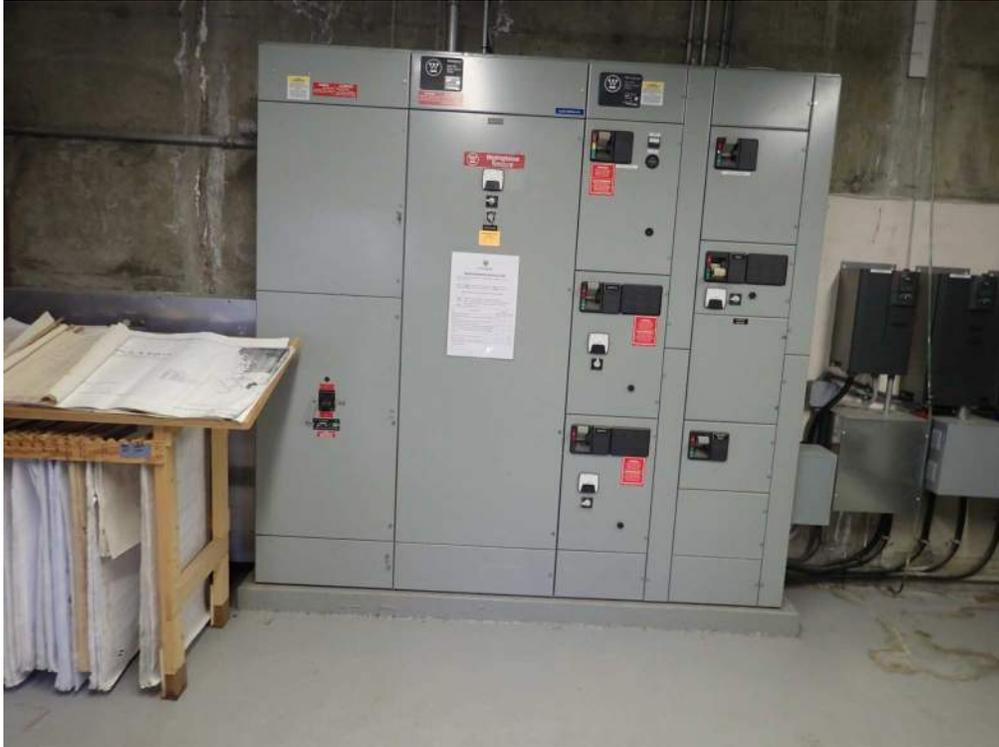
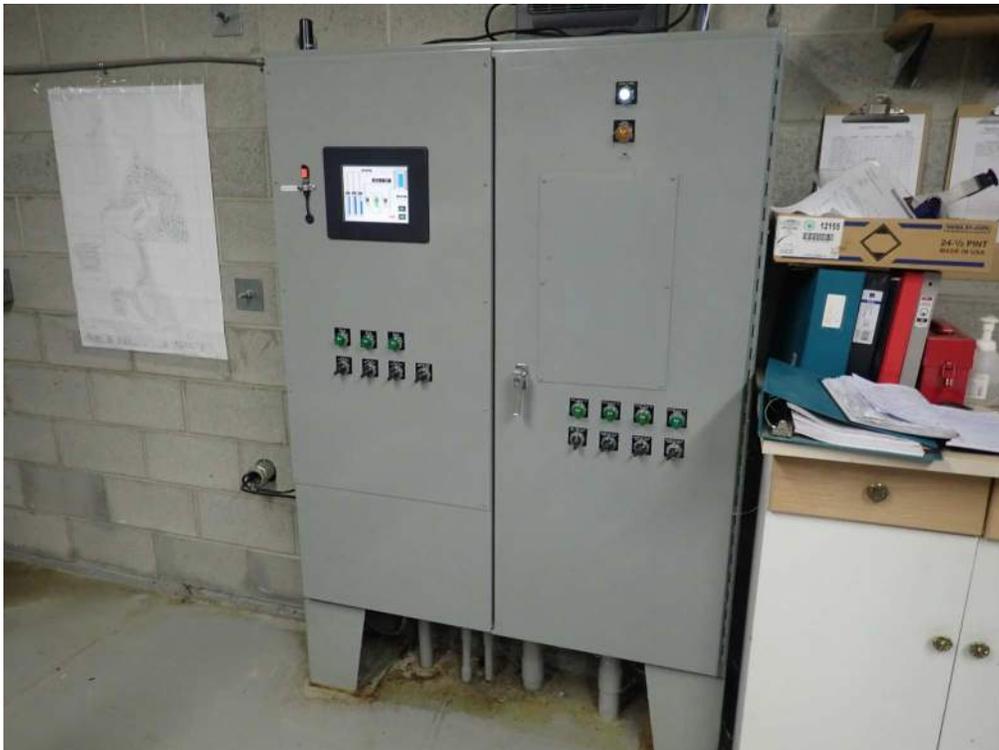
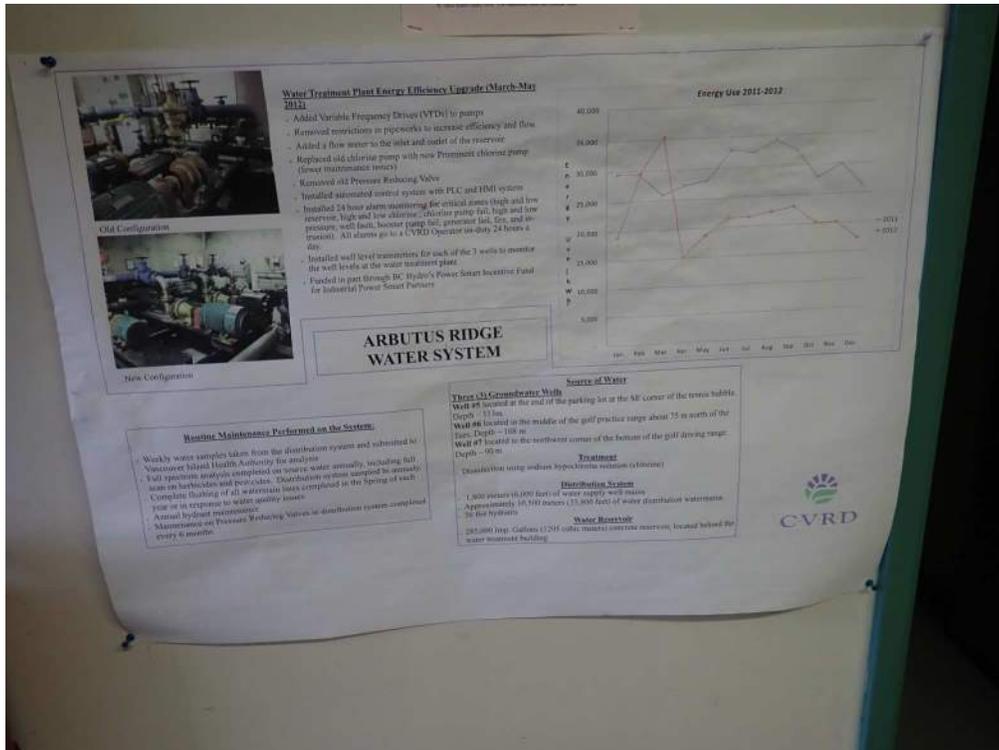
3	615	3717 Abutus Drive North	Water treatment plant	Site Visit / Photos	W WTP	WTP-3	WTP-3	21, 24 to 26	Chlorine system					1	ea	1987		20	0	\$10,000	\$10,000	Good				3	2	3	Inspects the condition of the chlorine system.	Operations	Included above	1-3 Year				
4	615	3717 Abutus Drive North	Water treatment plant	Site Visit / Photos	W WTP	WTP-4	WTP-4	30	Backup generator, assumed 150 kW for replacement value					1	ea	1987		40	0	\$120,000	\$120,000	Good				3	2	3	Inspects the condition of the generator.	Operations	Included above	1-3 Year				
5	615	3717 Abutus Drive North	Water treatment plant	Site Visit / Photos	W WTP	WTP-5	WTP-5	13, 18 to 21, 21, 21, 33	Communications (WTP)					2	LS	1987		20	0	\$9,000	\$9,000	Good - added radio communications between well and WTP				2	2	4	Inspects the condition of the communications.	Operations	Included above	1-3 Year				
6	615	3717 Abutus Drive North	Water treatment plant	Site Visit / Photos	W WTP	WTP-6	WTP-6	12, 14 to 18, 24 to 29	Process piping (w/ valves, pipes, tees)					1	LS	1987		40	0	\$50,000	\$50,000	Fair - older pipe headers (ludox header)				2	2	4	Repair aging pipe headers. Inspect/assess the condition of the rest of the process piping for deterioration.	Capital Upgrade/New	\$10,000	1-3 Year

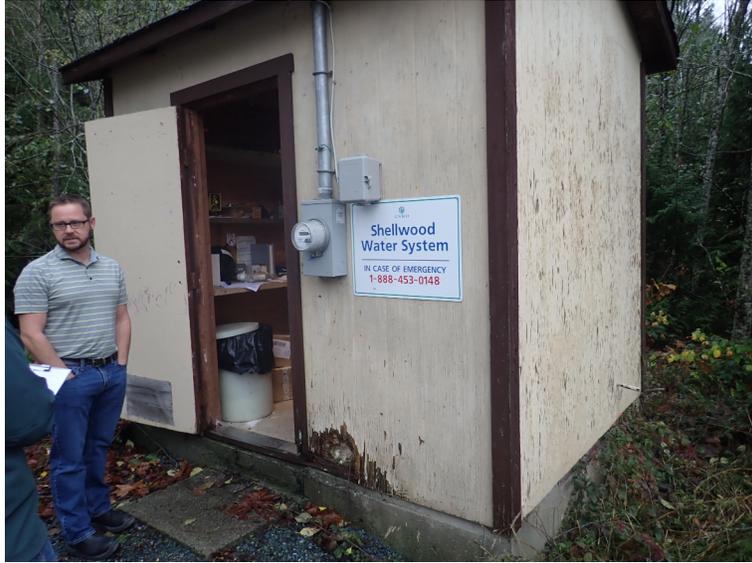
Photo 1

Shellwood - Pump House- Functional Code 617

Shellwood - Pump House	Pump House	617	B Shell	B10 Superstructure	B10 Superstructure	B10 Superstructure	Interior of Building/ General Superstructure	1	The superstructure is comprised of wood framing on all four walls and roof trusses, supported on a cast-in-place concrete foundation.  Deterioration of the wood cladding was observed at the base of the wall, this has resulted in exposed wood framing. Areas of the wood framing appear to be showing signs of deterioration.	4	4	2013	21-Nov-17	MH	5	50	45	Interior protected structural components are expected to last the life of the building. Complete repairs to the exterior cladding to ensure the wood framing is not exposed to the exterior elements. Membrane and flashing should be installed at the base of the wall to eliminate the potential for water to sit on the concrete slab-on-grade and affect the wood framed structure.	Not Applicable	Not Applicable	Yes	Yes	Yes	No	100	\$40	SF	\$4,000	0%	5%	5%	\$5,000

Shellwood - Pump House	Pump House	617	B Shell	B20 Exterior Enclosure	B2010 Exterior Walls	B201001 Exterior Enclosure	Exterior Walls/ Cementitious Siding	1	Painted wood siding and wood trim are present on the exterior walls.  Deterioration of the wood cladding was observed at the base of the wall, this has resulted in exposed wood framing. Areas of the wood framing appear to be showing signs of deterioration.	3	3	2013	21-Nov-17	MH	5	50	1	Repair the wood siding where required. Complete isoalted repairs to the wall assemblies as required at this time.	Repair Allowance	3 - Future Renewal	Yes	Yes	No	No	1	\$2,000	LS	\$2,000	0%	5%	5%	\$3,000
Shellwood - Pump House	Pump House	617	B Shell	B20 Exterior Enclosure	B2010 Exterior Walls	B201001 Exterior Enclosure	Exterior Walls/ Cementitious Siding	1	Painted wood siding and wood trim are present on the exterior walls.  Deterioration of the wood cladding was observed at the base of the wall, this has resulted in exposed wood framing. Areas of the wood framing appear to be showing signs of deterioration.	3	3	2013	21-Nov-17	MH	5	10	1	Repaint exsteior cladding.	Repair Allowance	3 - Future Renewal	Yes	Yes	No	No	1	\$1,000	LS	\$1,000	0%	5%	5%	\$2,000

Shellwood - Pump House	Pump House	617	B Shell	B20 Enclosure	E2030 Exterior Doors	B203001 Solid Doors	Exterior Walls/ Door	1	A wood door is present at the entrance.	4	4	2013	21-Nov-17	MH	5	20	15	Replace door assembly at the end of its service life.	Replacement	3 - Future Renewal	Yes	Yes	No	No	1	\$500	EA	\$500	0%	5%	5%	\$1,000
Shellwood - Pump House	Pump House	617	B Shell	D30 Roofing	B3010 Roof Coverings	B301001 High Slope Roof Coverings	Roof/Sloped Roof Assembly	1	The roof is sloped assembly with asphalt shingles installed.  The roof drains over the edge.	4	4	2013	21-Nov-17	MH	5	25	20	Replace the asphalt shingles at the end of their service life.  Ongoing maintenance of the roof should include review and resealing of penetrations.	Replacement	3 - Future Renewal	No	Yes	No	No	120	\$10	SF	\$1,200	0%	5%	5%	\$2,000

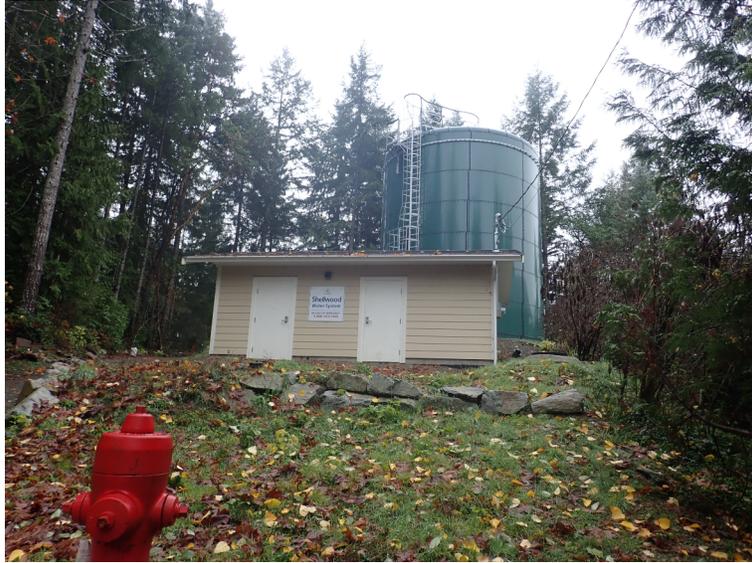
Photo 1

Shellwood - Water Treatment Building - Functional Code 617

Shellwood - Water Treatment Building	Water Treatment Building	617	A Substructure	A10 Foundations	A1030 Slab on Grade	A103001 Standard Slab on Grade	Interior of Building At-Grade/ Slab-on-Grade	1	The floor is concrete slab-on-grade (polished concrete throughout). Isolated hairline cracking was observed. No evidence of major settlement or heaving was reported or observed.	5	5	2015	21-Nov-17	MH	3	50	43	The concrete slab-on-grade is expected to remain serviceable for the life of the building, with isolated repairs, if needed. No capital expenses associated with this item are expected.	Not Applicable	Not Applicable	Yes	Yes	Yes	No	450	\$10	SF	\$4,500	0%	5%	5%	\$5,000
Shellwood - Water Treatment Building	Water Treatment Building	617	A Substructure	A10 Foundations	A1030 Slab on Grade	A103006 Foundation Drainage	Underground/ Perimeter Drains	1	Perimeter drain pipes are assumed to be installed at the footing level. No issues related to foundation drainage were noted by facility staff. No information was available regarding the scoping of the system to review for continuity.	5	5	2015	21-Nov-17	MH	3	10	3	Periodic camera inspection and isolated repairs as required.	Study	Not Applicable	No	N/A	No	N/A	1	\$500	LS	\$500	0%	0%	5%	\$1,000

Shellwood - Water Treatment Building	Water Treatment Building	617	B Shell	B20 Exterior Enclosure	B2010 Exterior Walls	B201001 Exterior Enclosure	Exterior Walls/ Cementitious Siding	1	Painted cementitious siding and wood trim are present on the exterior walls.	5	5	2015	21-Nov-17	MH	3	12	9	Repaint siding and trim.  At the time of painting, replace sealant joints and wood trim as required.	Repair Allowance	3 - Future Renewal	Yes	Yes	No	No	500	\$8	SF	\$4,000	0%	15%	5%	\$5,000
Shellwood - Water Treatment Building	Water Treatment Building	617	B Shell	B20 Exterior Enclosure	B2010 Exterior Walls	B201001 Exterior Enclosure	Exterior Walls/ Cementitious Siding	1	Painted cementitious siding and wood trim are present on the exterior walls.	5	5	2015	21-Nov-17	MH	3	50	47	The cementitious siding is expected to last the life of the building.  Note: isolated sealant and wood trim replacement should be completed as part of the ongoing painting.	Replacement	3 - Future Renewal	Yes	Yes	No	No	500	\$35	SF	\$17,500	0%	5%	5%	\$20,000

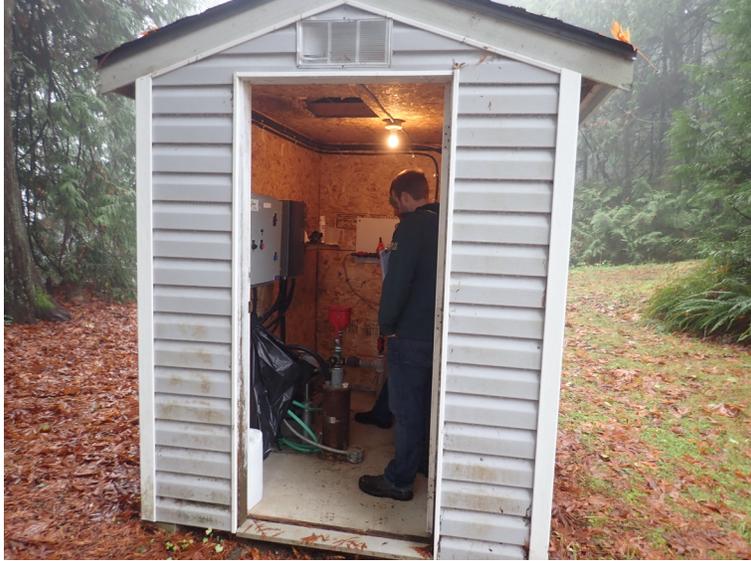
Photo 1

Burnum Lake - Water Building 1- Functional Code 619

Burnum Lake - Water Building #1	Water Treatment Building	619	A Substructure	A10 Foundations	A1030 Slab on Grade	A103001 Standard Slab on Grade	Interior of Building At-Grade/ Slab-on-Grade	1	The floor is concrete slab-on-grade. Isolated hairline cracking was observed. No evidence of major settlement or heaving was reported or observed.	4	4	2000	21-Nov-17	MH	18	50	32	The concrete slab-on-grade is expected to remain serviceable for the life of the building. No capital expenses associated with this item are expected.	Not Applicable	Not Applicable	Yes	Yes	Yes	No	40	\$10	SF	\$400	0%	5%	5%	\$1,000
Burnum Lake - Water Building #1	Water Treatment Building	619	B Shell	B10 Superstructure	B10 Superstructure	B10 Superstructure	Interior of Building/ General Superstructure	1	The superstructure is comprised of wood framing on all four walls and roof trusses, supported on a cast-in-place concrete foundation.  No settlement or other evidence of structural distress was observed or reported. There was no evidence or reports of long-term leakage that would allude to concealed structural damage.	4	4	2000	21-Nov-17	MH	18	50	32	Interior protected structural components are expected to last the life of the building. No major capital expenditures are expected to be required.	Not Applicable	Not Applicable	Yes	Yes	Yes	No	40	\$40	SF	\$1,600	0%	5%	5%	\$2,000

Burnum Lake - Water Building #1	Water Treatment Building	619	B Shell	CB20 Exterior Enclosure	B2010 Exterior Walls	B201001 Exterior Enclosure	Exterior Walls/ Vinyl Siding	1	Vinyl siding and wood trim are present on the exterior walls. Isolated areas of damaged siding were observed.	3	3	2000	21-Nov-17	MH	18	10	1	Repaint wood trim.  Replace sections of damaged vinyl siding as required.  At the time of painting, replace sealant joints and wood trim as required.	Repair Allowance	3 - Future Renewal	Yes	Yes	No	No	1	\$1,500	LS	\$1,500	0%	15%	5%	\$2,000
Burnum Lake - Water Building #1	Water Treatment Building	619	B Shell	CB20 Exterior Enclosure	B2010 Exterior Walls	B201001 Exterior Enclosure	Exterior Walls/ Vinyl Siding	1	Vinyl siding and wood trim are present on the exterior walls.	3	3	2000	21-Nov-17	MH	18	50	32	The vinyl siding is expected to last the life of the building.  Note: isolated sealant and wood trim replacement should be completed as part of the ongoing painting.	Replacement	3 - Future Renewal	Yes	Yes	No	No	150	\$15	SF	\$2,250	0%	5%	5%	\$3,000

Burnum Lake - Water Building #1	Water Treatment Building	619	B Shell	CB20 Exterior Enclosure	B2010 Exterior Walls	B201001 Exterior Enclosure	Exterior Walls/ Soffit	1	Perforated metal soffit is present at the roof overhangs.	4	4	2000	21-Nov-17	MH	18	50	32	The perforated metal soffit is expected to last the life of the building. No capital expenses associated with this item are expected.	Replacement	3 - Future Renewal	Yes	Yes	No	No	20	\$20	SF	\$400	0%	10%	5%	\$1,000
Burnum Lake - Water Building #1	Water Treatment Building	619	B Shell	B20 Enclosure	E2030 Exterior Doors	B203001 Solid Doors	Exterior Walls/ Door	1	One painted metal door is present on the building.	4	4	2000	21-Nov-17	MH	18	30	12	Replace door at the end of its service life.	Replacement	3 - Future Renewal	Yes	Yes	No	No	1	\$500	EA	\$500	0%	5%	5%	\$1,000
Burnum Lake - Water Building #1	Water Treatment Building	619	B Shell	D30 Roofing	B3010 Roof Coverings	B301001 High Slope Roof Coverings	Roof/Sloped Roof Assembly	1	The roof is a sloped assembly with asphalt shingles. Shingles have been installed over a previous skylight.  The roof drains via aluminum gutters to rain water leaders that drain into below grade piping.	4	4	2000	21-Nov-17	MH	18	30	12	Replace the asphalt shingles at the end of its service life. Remove skylight at the time of roof replacement.  Ongoing maintenance of the roof should include review of all exposed fasteners and resealing of penetrations.	Replacement	3 - Future Renewal	No	Yes	No	No	40	\$12	SF	\$480	0%	5%	5%	\$1,000

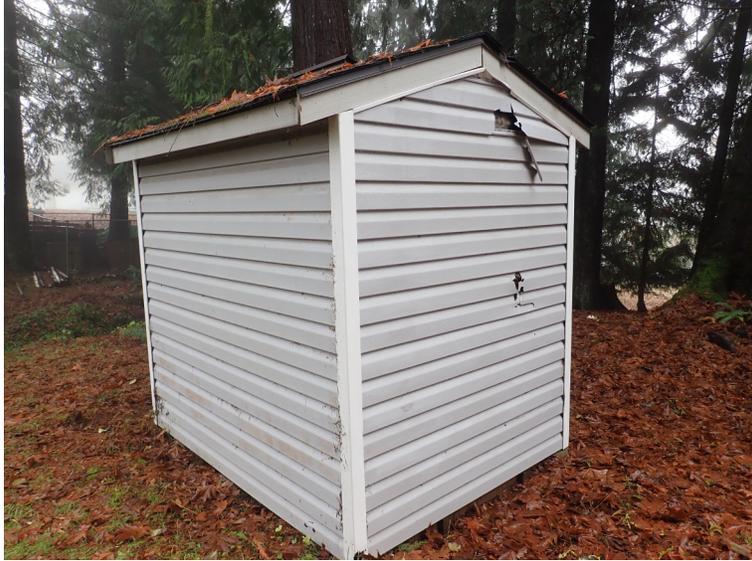
Photo 1

Burnum Lake - Water Building 2- Functional Code 619

Burnum Lake - Water Building #2	Water Treatment Building	619	A Substructure	A10 Foundations	A1010 Standard Foundations	A101001 Wall Foundations	Underground/ Foundations		1	The foundation is comprised of concrete blocks, these blocks were concealed from review. The age of the structure was not confirmed.	4	4	2000	21-Nov-17	MH	18	50	32	The foundations are expected to remain serviceable for the life of the building. No capital expenses associated with this item are expected.	Not Applicable	Not Applicable	Yes	Yes	Yes	No	40	\$20	SF	\$800	0%	5%	5%	\$1,000													
Burnum Lake - Water Building #2	Water Treatment Building	619	A Substructure	A10 Foundations	A1010 Slab on Grade	A101001 Standard Slab on Grade	Interior of Building At-Grade/ Slab-on-Grade		1	The floor is concrete slab-on-grade. Isolated hairline cracking was observed. No evidence of major settlement or heaving was reported or observed.	4	4	2000	21-Nov-17	MH	18	50	32	The concrete slab-on-grade is expected to remain serviceable for the life of the building, with isolated repairs, if needed. No capital expenses associated with this item are expected.	Not Applicable	Not Applicable	Yes	Yes	Yes	No	40	\$10	SF	\$400	0%	5%	5%	\$1,000

Burnum Lake - Water Building #2	Water Treatment Building	619	B Shell	B10 Superstructure	B10 Superstructure	B10 Superstructure	Interior of Building/ General Superstructure		1	The superstructure is comprised of wood framing on all four walls and roof trusses, supported on a cast-in-place concrete foundation. No settlement or other evidence of structural distress was observed or reported. There was no evidence or reports of long-term leakage that would allude to concealed structural damage.	4	4	2000	21-Nov-17	MH	18	50	32	Interior protected structural components are expected to last the life of the building. No major capital expenditures are expected to be required.	Not Applicable	Not Applicable	Yes	Yes	Yes	No	40	\$40	SF	\$1,600	0%	5%	5%	\$2,000													
Burnum Lake - Water Building #2	Water Treatment Building	619	B Shell	B20 Exterior Enclosure	B2010 Exterior Walls	B201001 Exterior Enclosure	Exterior Wall/ Vinyl Siding		1	Vinyl siding and wood trim are present on the exterior walls.	4	4	2000	21-Nov-17	MH	18	10	2	Repaint wood trim. Replace sections of damaged vinyl siding as required. At the time of painting, replace sealant joints and wood trim as required.	Repair Allowance	3 - Future Renewal	Yes	Yes	No	No	1	\$1,500	LS	\$1,500	0%	15%	5%	\$2,000		\$2,000				\$8,000

Burnum Lake - Water Building #2	Water Treatment Building	619	B Shell	B20 Exterior Enclosure	B2010 Exterior Walls	B201001 Exterior Enclosure	Exterior Wall/ Vinyl Siding		1	Vinyl siding and wood trim are present on the exterior walls.	4	4	2000	21-Nov-17	MH	18	50	32	The vinyl siding is expected to last the life of the building. Note: Isolated sealant and wood trim replacement should be completed as part of the ongoing painting.	Replacement	3 - Future Renewal	Yes	Yes	No	No	150	\$15	SF	\$2,250	0%	5%	5%	\$3,000													
Burnum Lake - Water Building #2	Water Treatment Building	619	B Shell	B20 Exterior Enclosure	B2010 Exterior Walls	B201001 Exterior Enclosure	Exterior Wall/ Soffit		1	Perforated metal soffit is present at the roof overhangs.	4	4	2000	21-Nov-17	MH	18	50	32	The perforated metal soffit is expected to last the life of the building. No capital expenses associated with this item are expected.	Replacement	3 - Future Renewal	Yes	Yes	No	No	20	\$20	SF	\$400	0%	10%	5%	\$1,000

Burnum Lake - Water Building #2	Water Treatment Building	619	B Shell	B20 Enclosure	B2030 Exterior Doors	B203001 Solid Doors	Exterior Wall/ Door		1	One painted metal door is present on the building.	4	4	2000	21-Nov-17	MH	18	30	12	Replace door at the end of its service life.	Replacement	3 - Future Renewal	Yes	Yes	No	No	1	\$500	EA	\$500	0%	5%	5%	\$1,000													
Burnum Lake - Water Building #2	Water Treatment Building	619	B Shell	D30 Roofing	B3010 Roof Coverings	B301001 High Slope Roof Coverings	Roof/Sloped Roof Assembly		1	The roof is a sloped assembly with asphalt shingles. Shingles have been installed over a previous skylight. The roof drains via aluminum gutters to rain water leaders that drain into below grade piping.	4	4	2000	21-Nov-17	MH	18	30	12	Replace the asphalt shingles at the end of its service life. Remove skylight at the time of roof replacement. Ongoing maintenance of the roof should include review of all exposed fasteners and resealing of penetrations.	Replacement	3 - Future Renewal	No	Yes	No	No	40	\$12	SF	\$480	0%	5%	5%	\$1,000

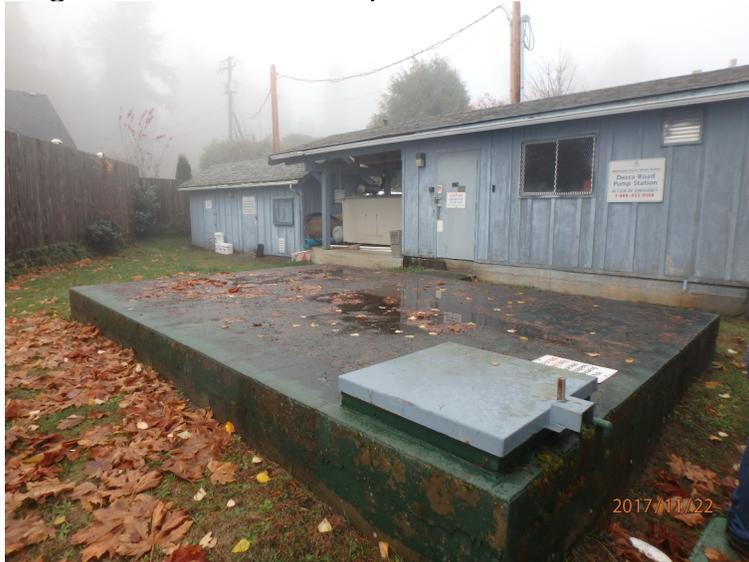
Photo 1

Shawnigan Lake Water - Pump Station - Functional Code 680

Shawmigan Lake - Pump Station	Pump Station	680	A Substructure	A10 Foundations	A1030 Slab on Grade	A103001 Standard Slab on Grade	Interior of Building At-Grade/ Slab-on-Grade	1	The floor is concrete slab-on-grade. Isolated hairline cracking was observed. No evidence of major settlement or heaving was reported or observed.	4	4	2010	21-Nov-17	MH	8	50	42	The concrete slab-on-grade is expected to remain serviceable for the life of the building, with isolated repairs, if needed. No capital expenses associated with this item are expected.	Not Applicable	Not Applicable	Yes	Yes	Yes	No	225	\$10	SF	\$2,250	0%	10%	5%	\$3,000
Shawmigan Lake - Pump Station	Pump Station	680	A Substructure	A10 Foundations	A1030 Slab on Grade	A103006 Foundation Drainage	Underground/ Perimeter Drains	1	Perimeter drain pipes are assumed to be installed at the footing level. No issues related to foundation drainage were noted by facility staff. No information was available regarding the scoping of the system to review for continuity.	4	4	2010	21-Nov-17	MH	8	10	2	Periodic camera inspection and isolated repairs as required.	Study	Not Applicable	No	N/A	No	N/A	1	\$500	LS	\$500	0%	0%	5%	\$1,000

Shawmigan Lake - Pump Station	Pump Station	680	B Shell	B20 Exterior Enclosure	B2010 Exterior Walls	B201001 Exterior Enclosure	Exterior Walls/Wood Elements	1	Wood cladding and wood trim (included roof framing) is present through sections of the building. The wood cladding sections appear to be retrofit areas. Some deterioration was noted in these elements.	4	4	2010	21-Nov-17	MH	8	12	4	Repaint wood cladding, install flashing over exposed wood roof framing.	Replacement	3 - Future Renewal	Yes	Yes	No	No	1	\$500	LS	\$500	0%	10%	5%	\$1,000
Shawmigan Lake - Pump Station	Pump Station	680	B Shell	B20 Exterior Enclosure	B2010 Exterior Walls	B201001 Exterior Enclosure	Exterior Walls/ Soffit	1	Perforated metal soffit is present at the roof overhangs.	4	4	2010	21-Nov-17	MH	8	50	42	The perforated metal soffit is expected to last the life of the building. No capital expenses associated with this item are expected.	Replacement	3 - Future Renewal	Yes	Yes	No	No	60	\$20	SF	\$1,200	0%	10%	5%	\$2,000

Shawmigan Lake - Pump Station	Pump Station	680	B Shell	B20 Enclosure	E2030 Exterior Doors	B203001 Solid Doors	Exterior Walls/ Door	1	Two painted metal doors are present on the building.	4	4	2010	21-Nov-17	MH	8	30	22	Replace door at the end of their service life.	Replacement	3 - Future Renewal	Yes	Yes	No	No	2	\$1,500	EA	\$3,000	0%	5%	5%	\$4,000
Shawmigan Lake - Pump Station	Pump Station	680	B Shell	D30 Roofing	B3010 Roof Coverings	B301001 High Slope Roof Coverings	Roof/Metal Roof Assembly	1	The roof is sloped assembly which has been waterproofed with with a metal roof assembly. The roof drains via aluminum gutters to rain water leaders.	4	4	2010	21-Nov-17	MH	8	30	22	Replace metal roofing at the end of its service life.  Ongoing maintenance of the roof should include review of all penetrations when required.	Replacement	3 - Future Renewal	No	Yes	No	No	255	\$8	SF	\$2,040	0%	5%	5%	\$3,000
Shawmigan Lake - Pump Station	Pump Station	680	C Interiors	C30 Interior Finishes	C3010 Wall Finishes	C301003 Gypsum Wallboard Finishes	Interior/Interior Finishes	2	Sections of the building have been finished with gypsum wall board and plywood.  The timeline of the last repainting cycle was not known and has been assumed.	4	4	2010	21-Nov-17	MH	8	20	12	Repaint interiors as required.  Note: a long service life has been included to reflect to building usage.	Repair Allowance	3 - Future Renewal	Yes	Yes	No	No	1	\$500	LS	\$500	0%	0%	5%	\$1,000

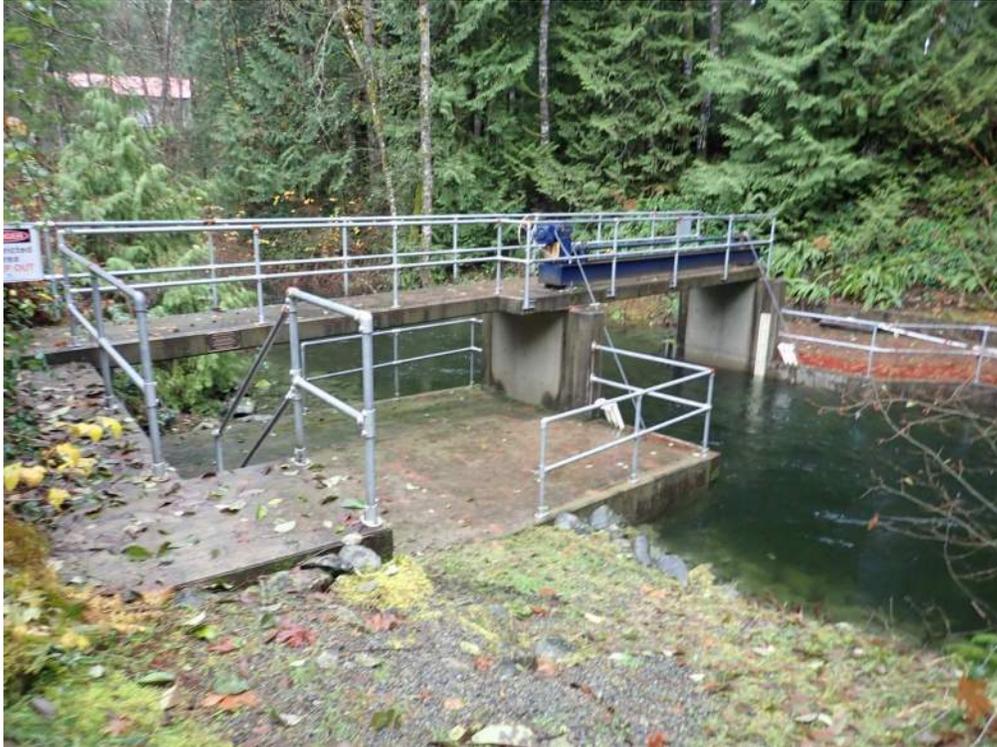
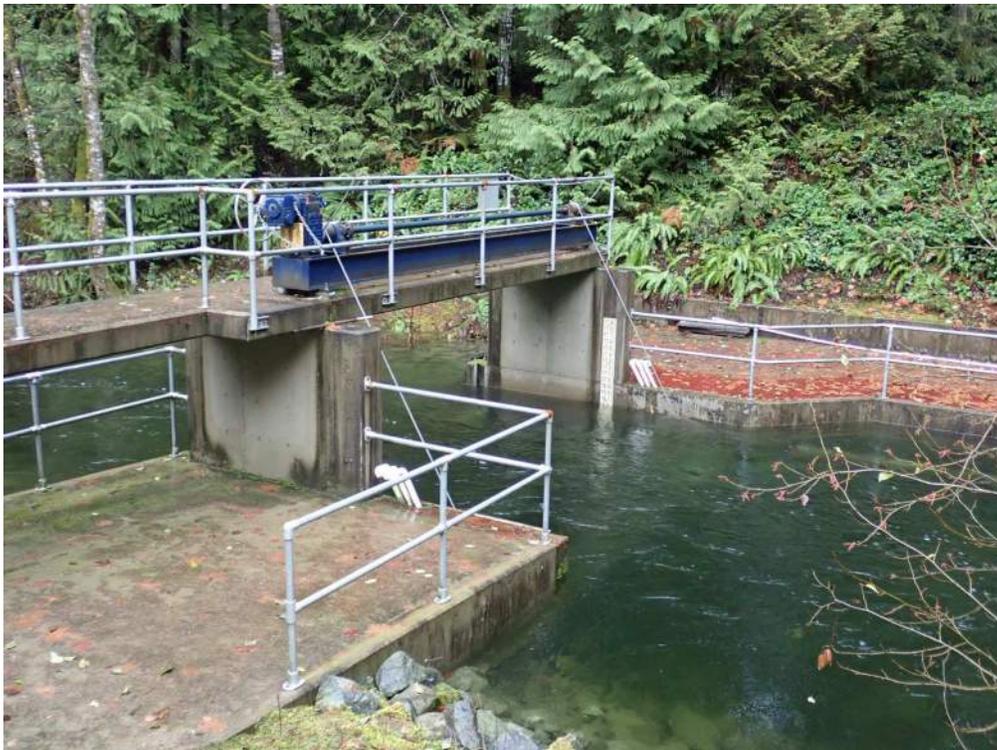
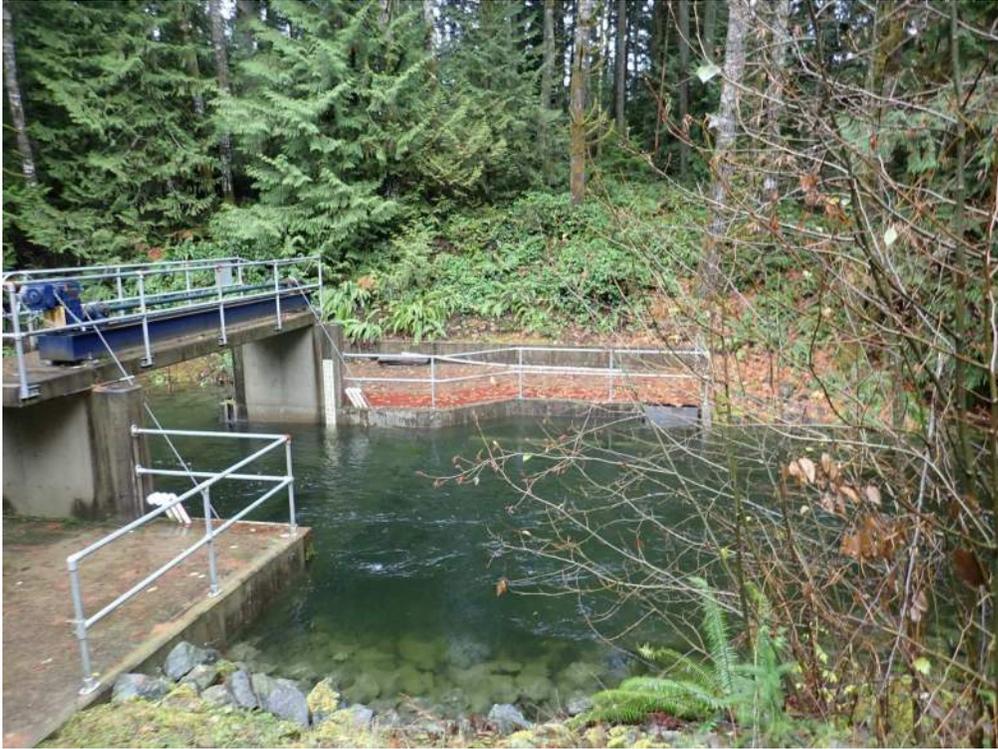
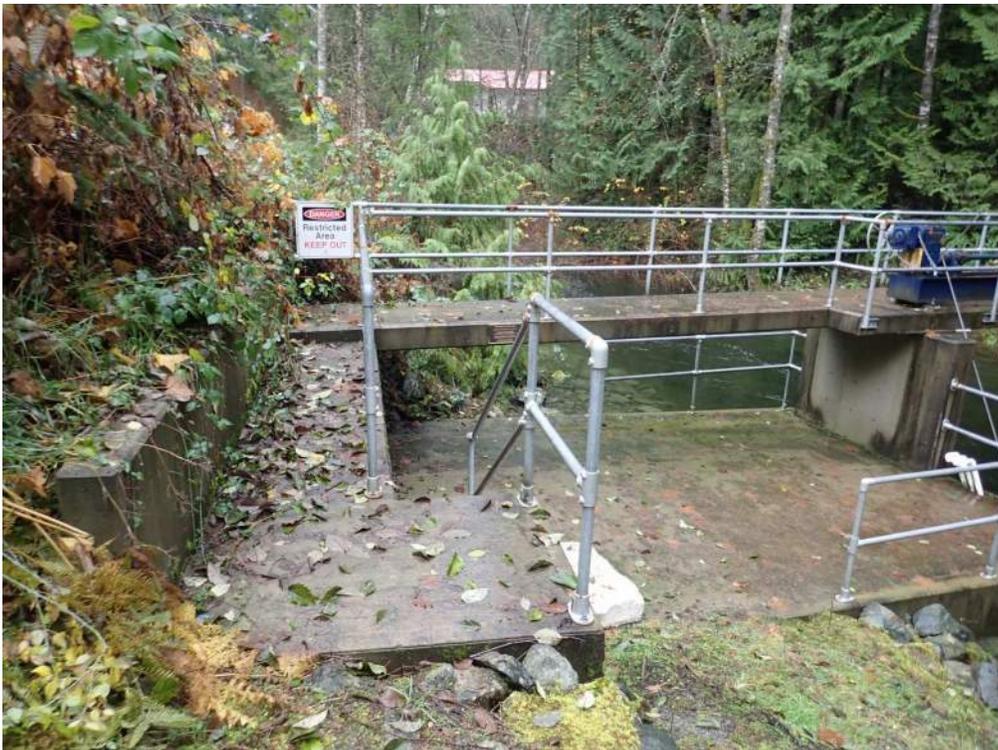
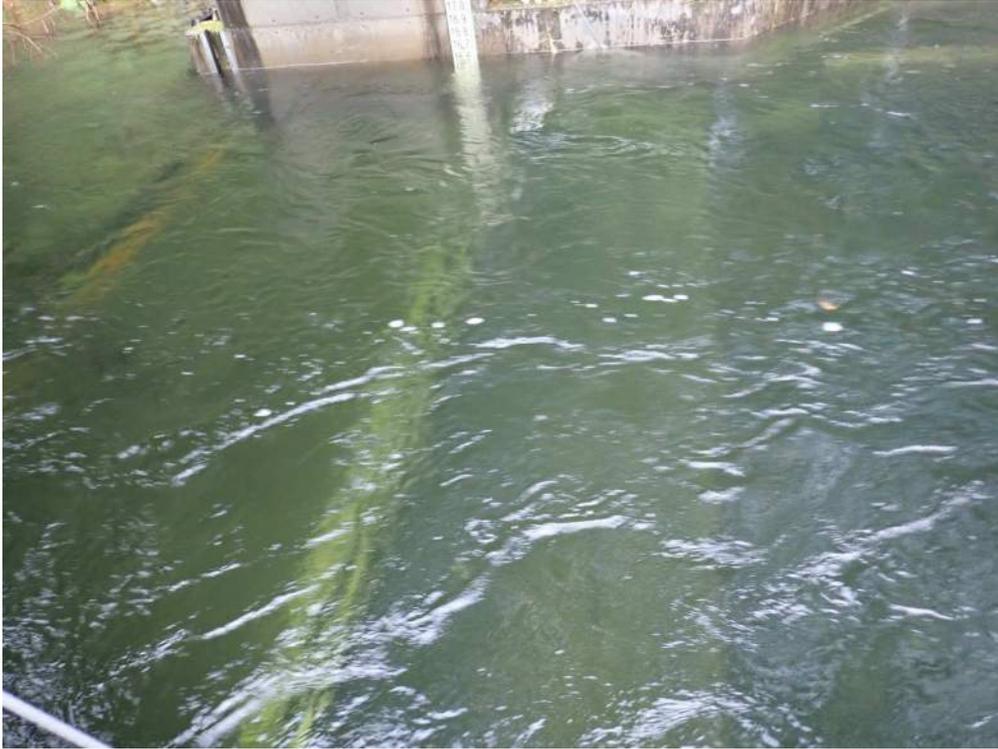
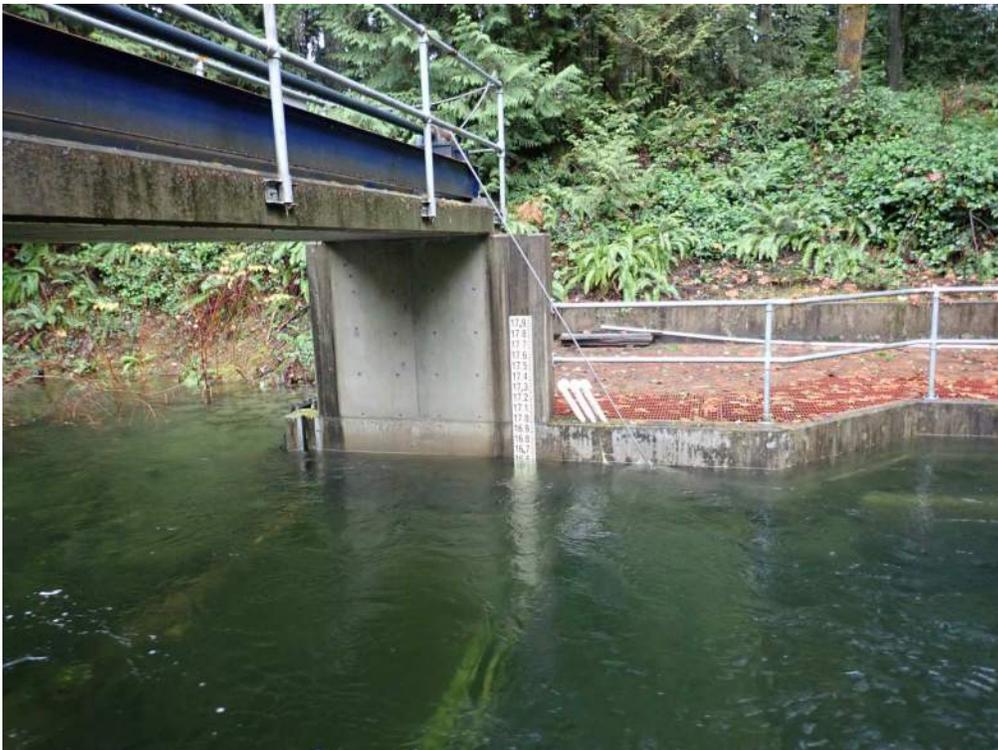
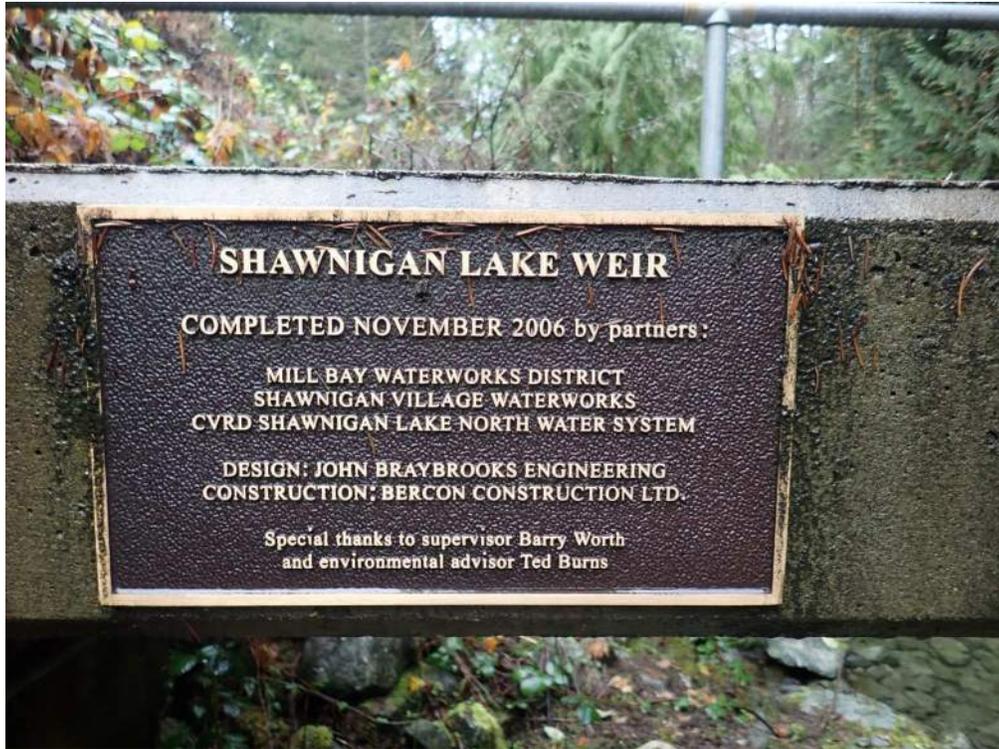
1	681	Shawinigan Lake Weir	Weir	Site visit / Photos	W	RES	BLD	3	W-RES-BLD-3	1 to 7	Concrete structure				1	ea	2006		40	28	\$150,000	\$150,000	Good	Meets standard		2	2	4	Inspect/assess the weir structure for det	Operations	Included above	5-10 Year

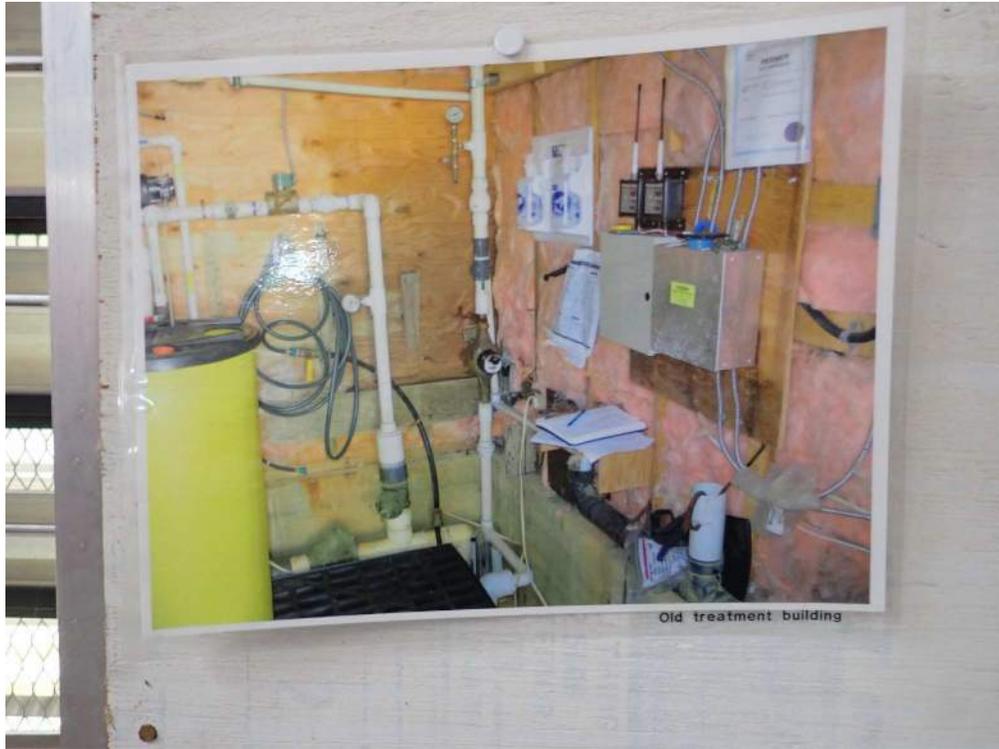
690 (19)

Old treatment building

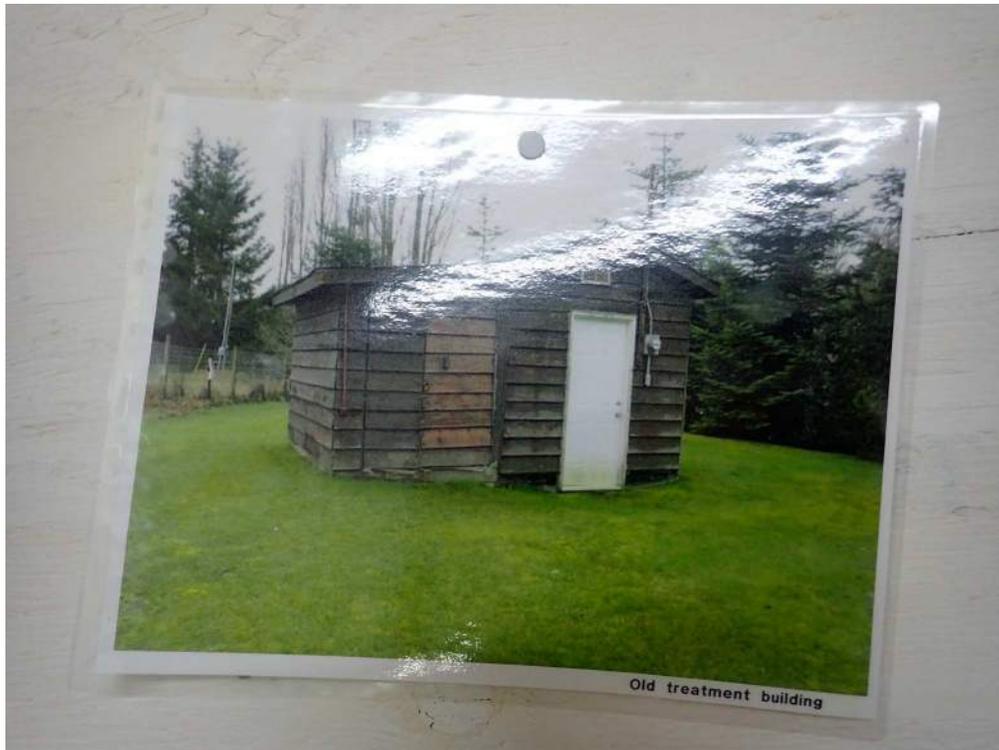
690 (20)  
10 of 20

Old treatment building
