STAFF REPORT TO GENERAL MANAGER, LAND USE SERVICES DEPARTMENT

DATE OF REPORT February 14, 2025
FROM: Yuli Siao, Development Services
Land Use Services Department
SUBJECT: Development Permit application for 4760 Brenton Page Rd, PID
027-772-900
FILE: DP24H04

The purpose of this report is to present a development permit application for the partial upland redevelopment of Raven Point marina at 4760 Brenton Page Rd (PID 027-772-900). This DP is applied for in conjunction with development variance permit application DVP24H04 for parking reduction on the site.

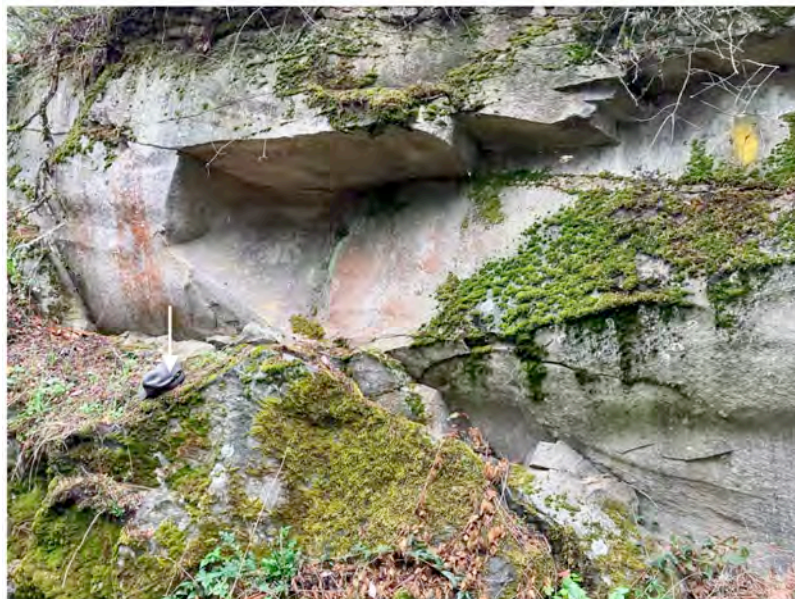
Figure 2. Exposure of relatively massive sandstone of De Courcey Formation looking north along north side of Brenton-Page Road, October 22, 2024. Note hat for scale by arrow.

Figure 1 shows the location of reported water wells at and in the vicinity of the subject property. Table 1 provides a summary of information available for the labeled wells shown in Figure 1. Figure 2 shows an exposure of the De Courcey Formation along Brenton-Page Road, 1.2 km northwest of the subject property.

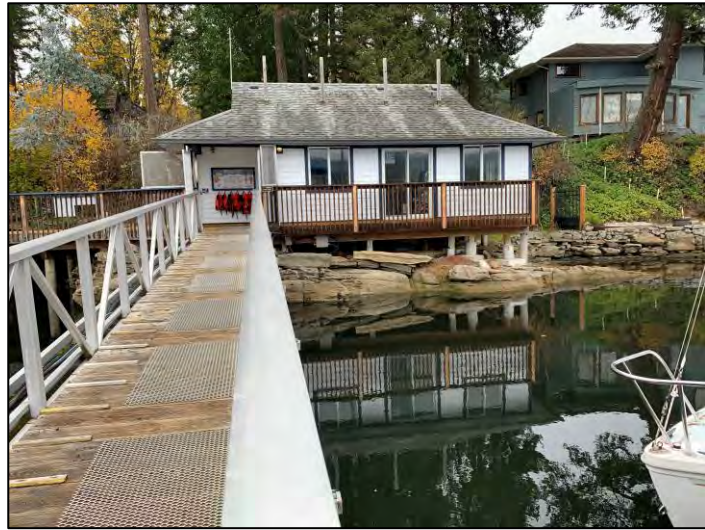
Photo 4. The marina office in the southern corner of the property is on piers above the shoreline and a gangway leads out to the existing marina docks.

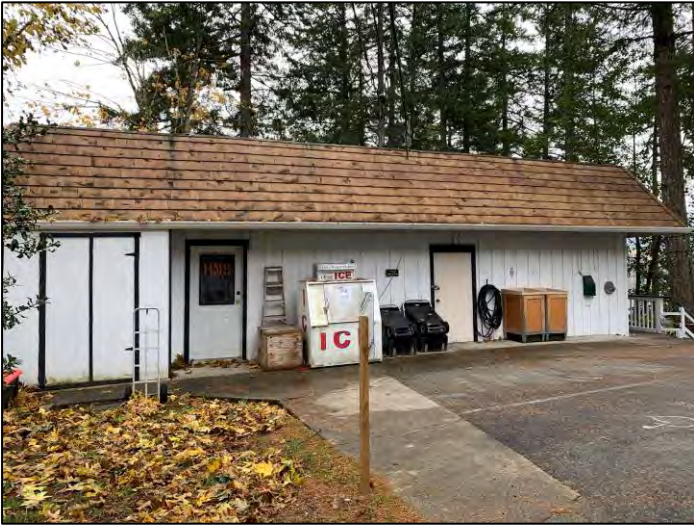
Photo 7. The existing accessory building with washrooms, laundry and shower facilities.

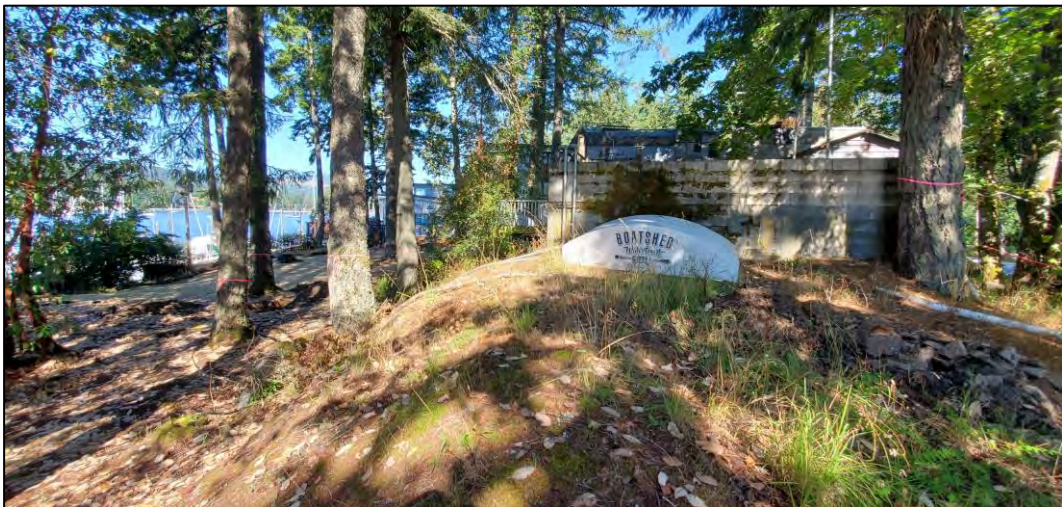
Photo 9. Trees to be removed and the concrete block fuel tank structure to be removed.

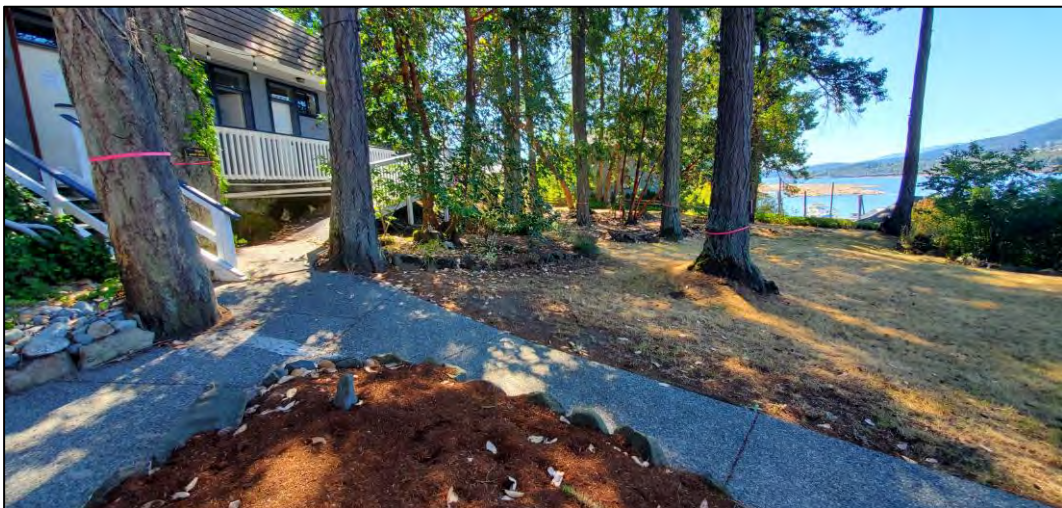
Photo 10. The temporary washroom building to be placed in front of the existing accessory building.

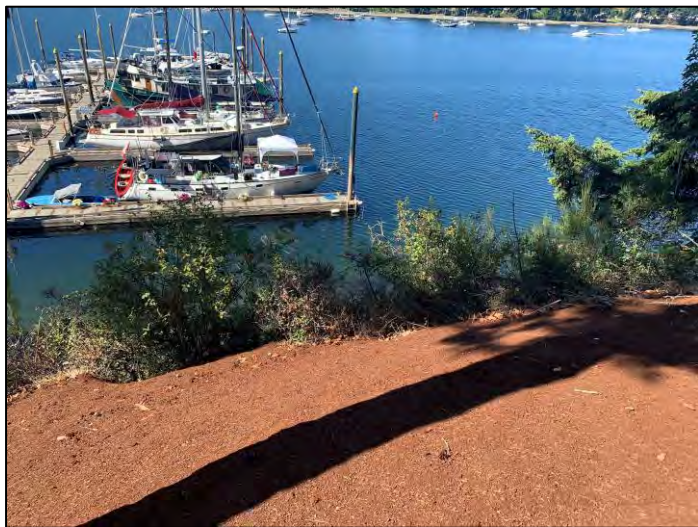
Photo 18. Scotch broom along the foreshore slope along the southwest boundary.

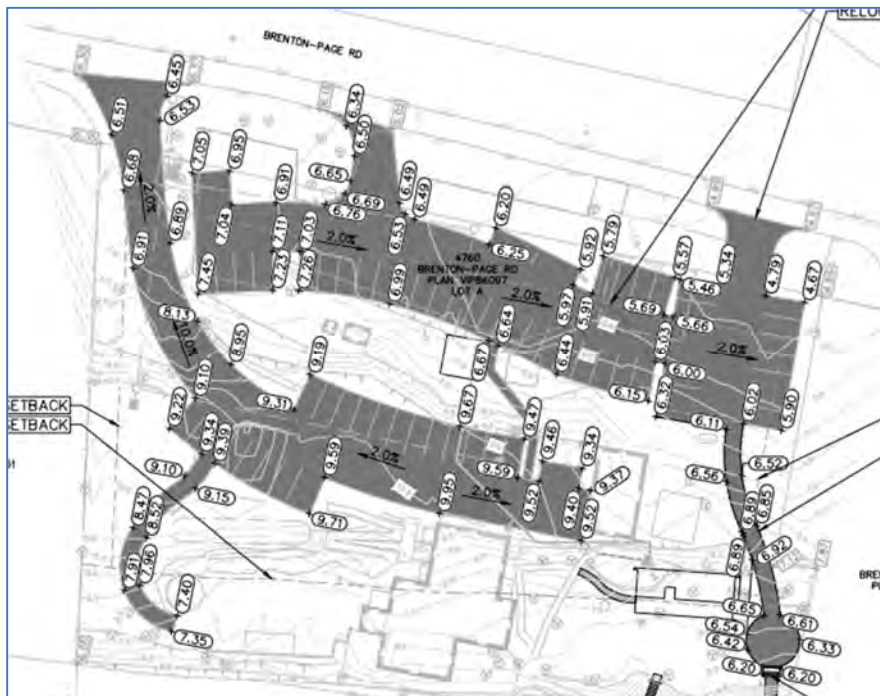
1. Please also update the rain water management report to assess impact of tree removal, as it recommends using existing vegetation for overland filtration.
2. Please clarify what surface materials will be used for the parking areas and driveways as shown on this plan:

5. The marina access, northeast section of the lower parking lot, and the path from the marina access to the washroom building will be asphalt. The upper parking lot and remaining pathways will be gravel-surfaced. This will allow some minimal infiltration through the surface structure to reduce runoff.
6. All proposed development is included in the Rainwater Management Plan calculations, using appropriate runoff coefficients.

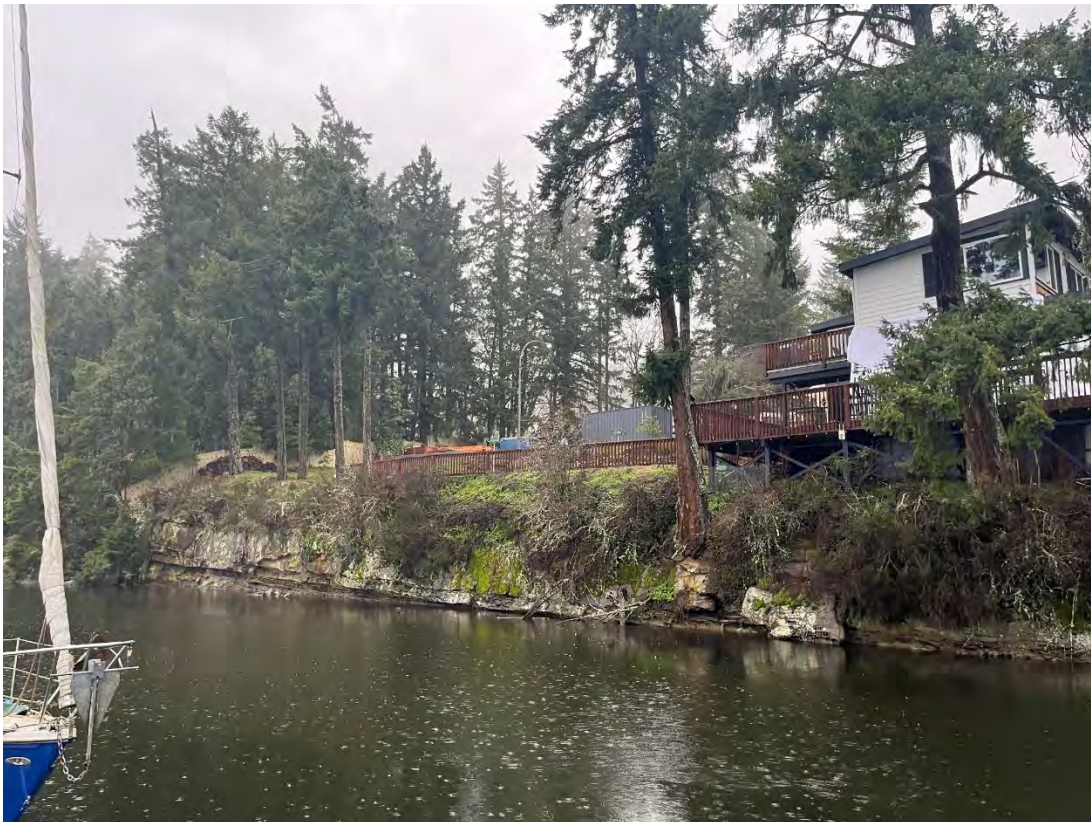
Photo 2.2.1: Foreshore area. Looking north.

- c. The PNB of the ocean is not clearly defined or easily recognized. The shoreline consists of an approximately 6.0m tall sandstone bank leading to a foreshore consisting of a natural, sandstone bedrock. Refer to Photo 2.2.1 below.
