Coastal Slope Stability Assessment

Saltair - Cowichan Valley Regional
District

February 14, 2022

Stantec Consulting Ltd.
In association with Palmer

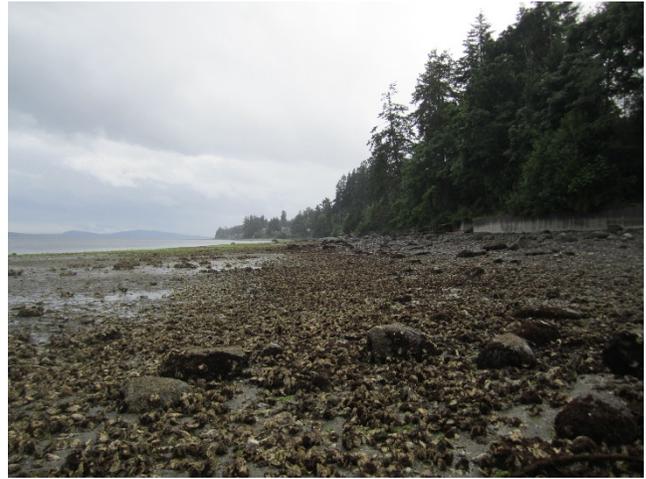
Photo 002: Photo of beach face at low tide looking SE. Upper beach face 4-degrees with D_{50} 45 mm. Scattered boulders observed. Oyster beds on lower beach face.

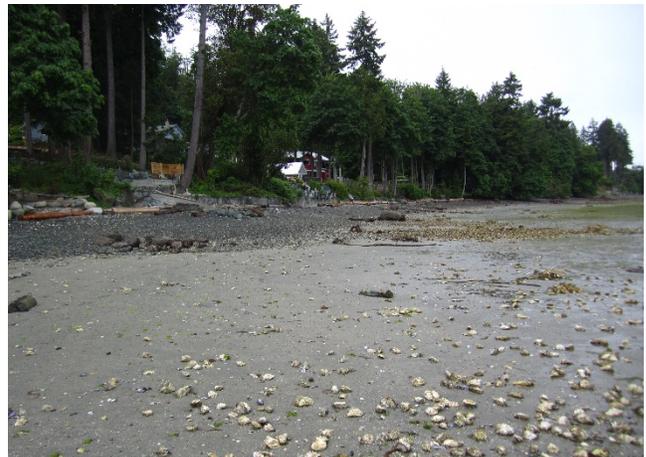
Photo 006: Looking NW across the beach at low tide. Upper beach face 3-degree slope with D_{50} of sand.

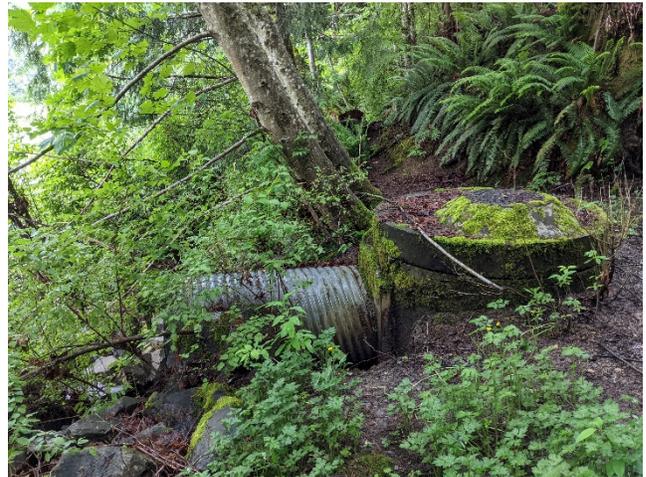
Photo 010: Stormwater outfall discharging to Davis Lagoon.

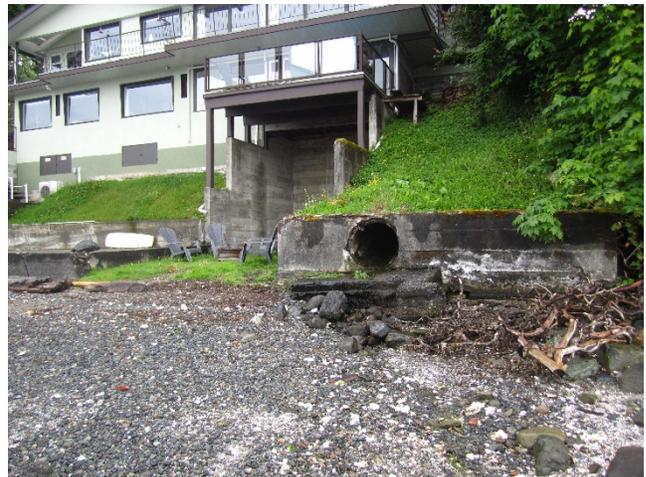
Photo 012: Stormwater outfall.

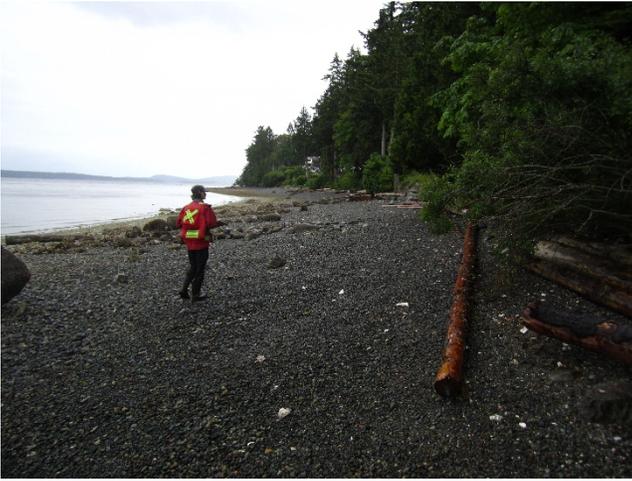
Photo 013: Looking SE across the beach. Upper shoreface 6-degree gradient with D_{50} of 25 mm.

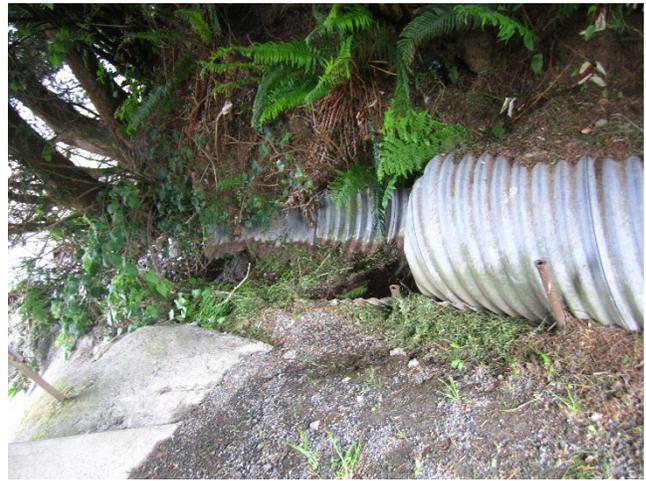
Photo 016: Stormwater outfall discharging to beach at Skinner Road Beach Access.

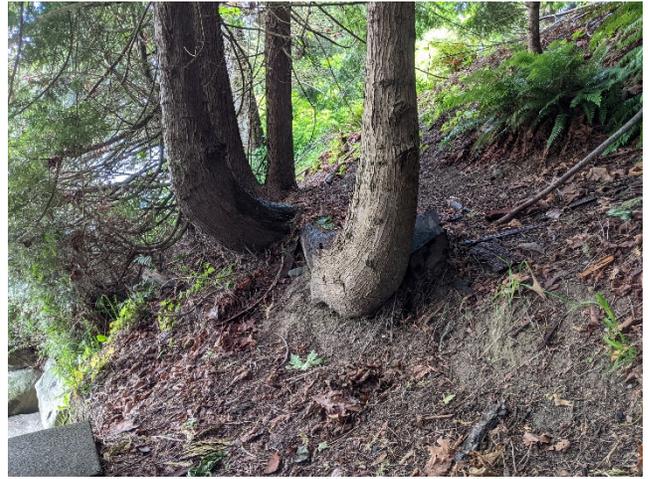
Photo 020: Pistol butt trees at Gardner Road Beach Access.

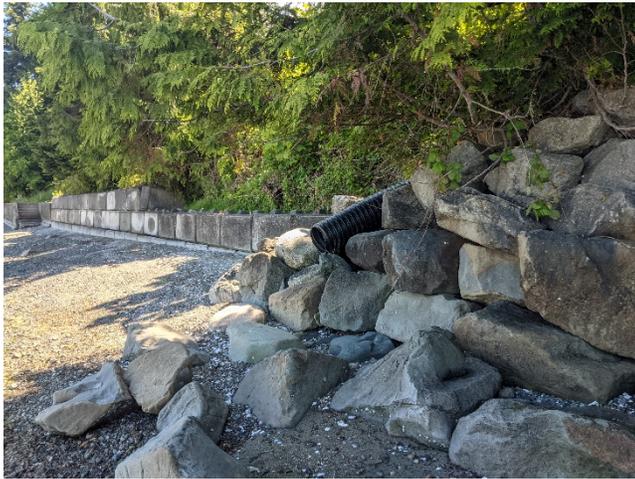
Photo 021: Stormwater outfall discharging onto beach SE of Gardner Road Beach Access.

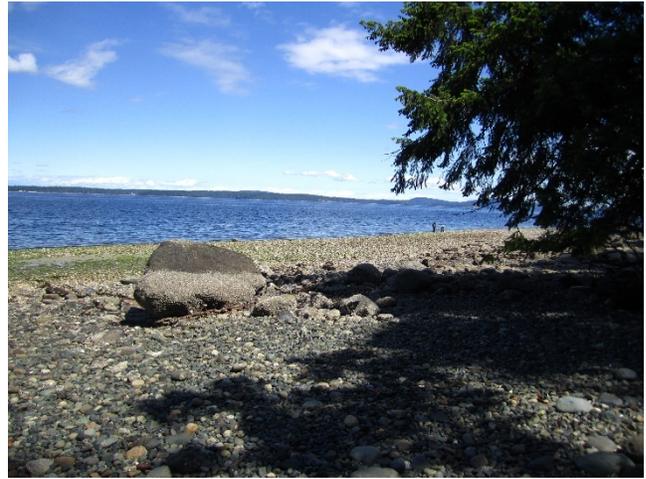
Photo 026: Looking SE over the beach. The upper beach face has 6-degree slope and D_{50} of 30 mm.

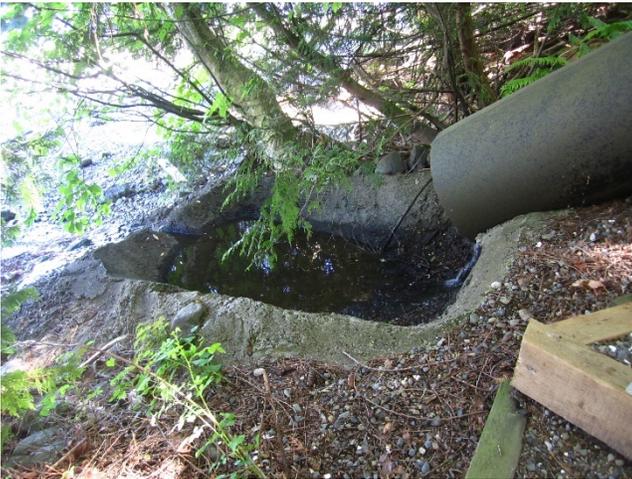
Photo 027: Stormwater discharge at Clifcoe Road Beach Access.

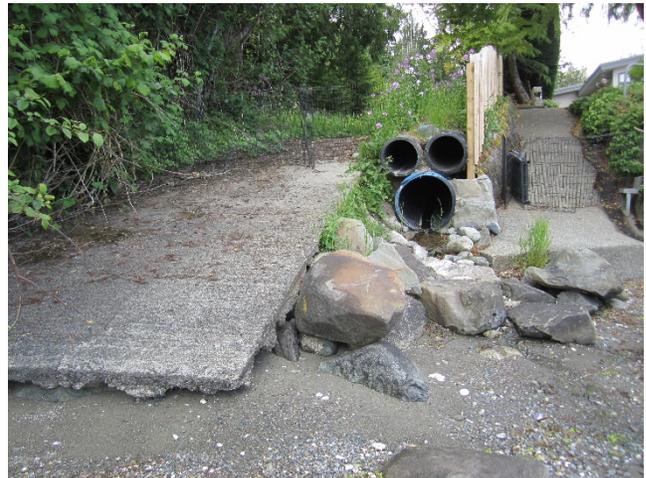
Photo 030: Stormwater discharge to beach.

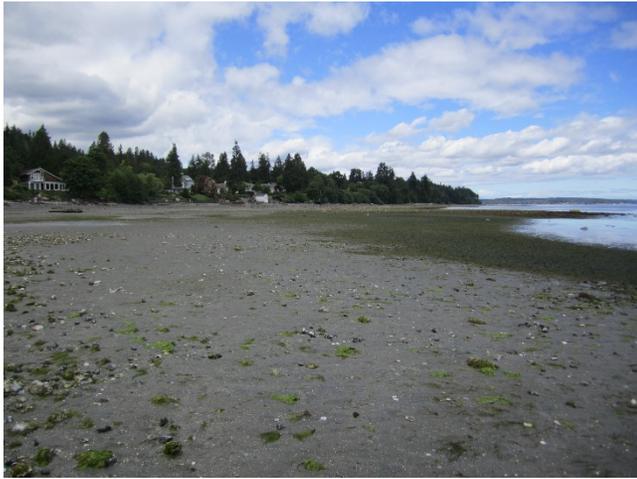
Photo 031: Looking NW across the beach at low tide. Beach slope of 2-degrees and D_{50} of sand.
